Report No.: J042025

Nature of Work: Reinspection of Asbestos Containing Materials

University of Gloucestershire
The Park
Cheltenham
Gloucestershire
GL50 2RH

Hardwick Campus
St Pauls Road
Cheltenham
Gloucestershire
GL50 4BS

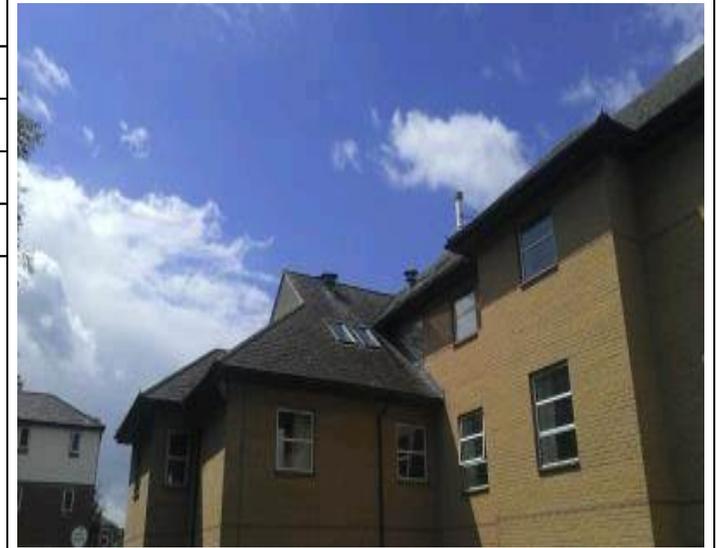
Material Assessment Total Score: 6		Likelihood of Disturbance Assessment Total Score: 2		Management Assessment Licensable: No Recommendations: Monitor condition Reinspection Interval: 12 Months Overall Risk Category: C8
Product Type:	1 (Asbestos Cement)	Location:	0 (Outdoors)	
Condition:	1 (Minor scratches)	Accessibility:	0 (Usually inaccessible or unlikely to be disturbed)	
Surface Treatment:	1 (Unencapsulated asbestos cement)			
Asbestos Type:	3 (Crocidolite)	Extent Score:	2 (>10 - <50 sq m or >10m - <50m pipe run)

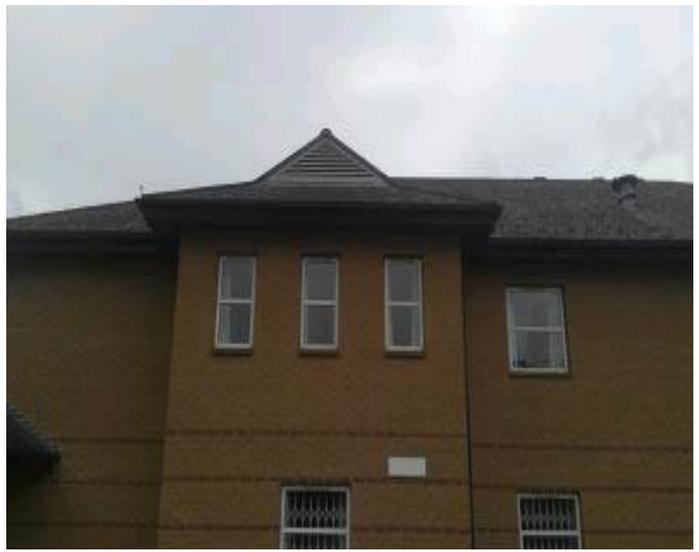
Crocidolite	Presumed			
Sample Analysed By:	Not applicable	Extent:	2 linear metres	
Comments: Asbestos content presumed as no safe access was available to sample the material.

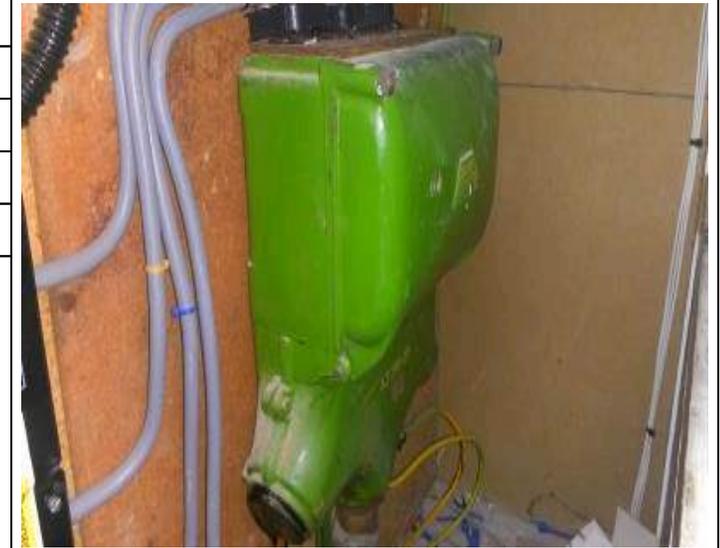
Material Assessment Total Score: 5		Likelihood of Disturbance Assessment Total Score: 2		<p>Management Assessment</p> <p>Licensable: No</p> <p>Recommendations: Monitor condition</p> <p>Reinspection Interval: 12 Months</p> <p>Overall Risk Category: C7</p>
Product Type:	2 (Asbestos Textiles/Paper)	Location:	2 (Rooms up to 100 sq m)	
Condition:	0 (Perfect)	Accessibility:	0 (Usually inaccessible or unlikely to be disturbed)	
Surface Treatment:	2 (Unencapsulated textile/paper)			
Asbestos Type:	1 (Chrysotile)	Extent Score:	0 (Small amounts or items)

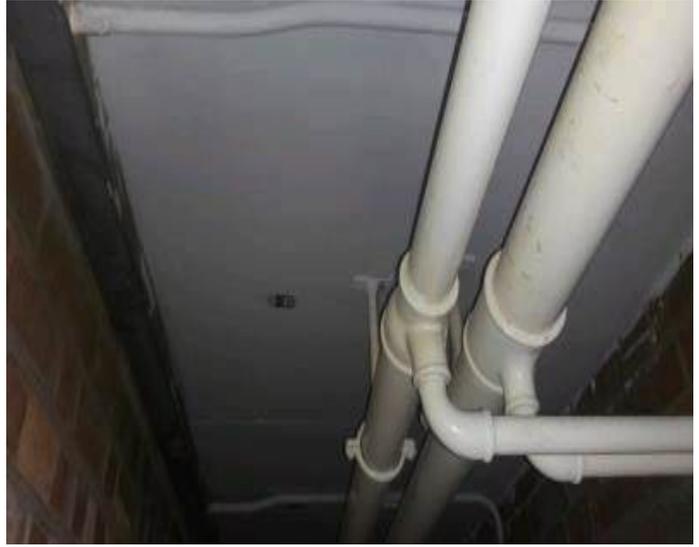
Item:	Asbestos Insulating board ceiling panels			
Asbestos Content:			Result Based on:	
Chrysotile Amosite		Analysis of sample using PLM		
Sample Analysed By:	Refer to original report	Extent:	3 sq m	
Comments: Previously item 073 in J016666. Labelled up, local damage to small part of plasterboard ceiling panel.

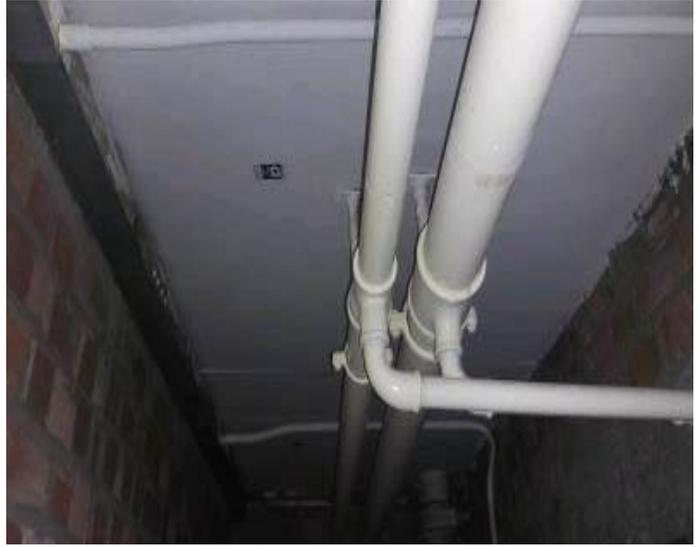
Item:	Asbestos Insulating board ceiling panels			
Asbestos Content:		Result Based on:		
Chrysotile Amosite		Strongly presumed		
Sample Analysed By:	Not applicable	Extent:	3 sq m	
Comments: Previously item 075 in J016666. Labelled up.

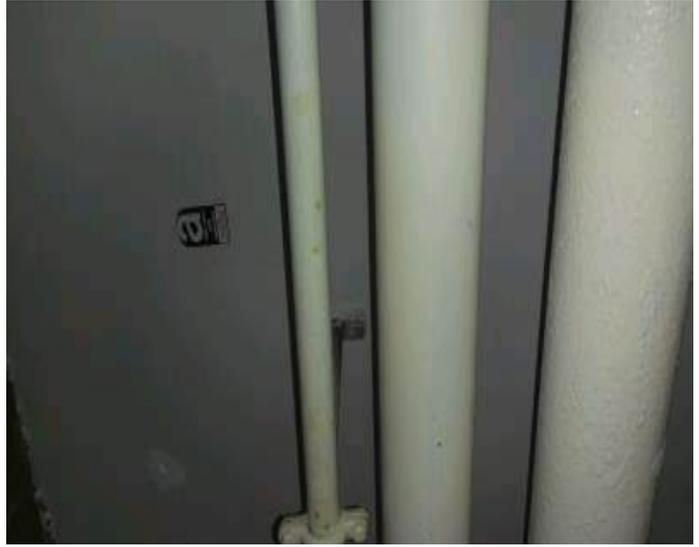
Item:	Asbestos Insulating board ceiling panels			
Asbestos Content:		Result Based on:		
Chrysotile Amosite		Analysis of sample using PLM		
Sample Analysed By:	Refer to original report	Extent:	3 sq m	
Comments: Previously item 076 in J016666. Labelled up.

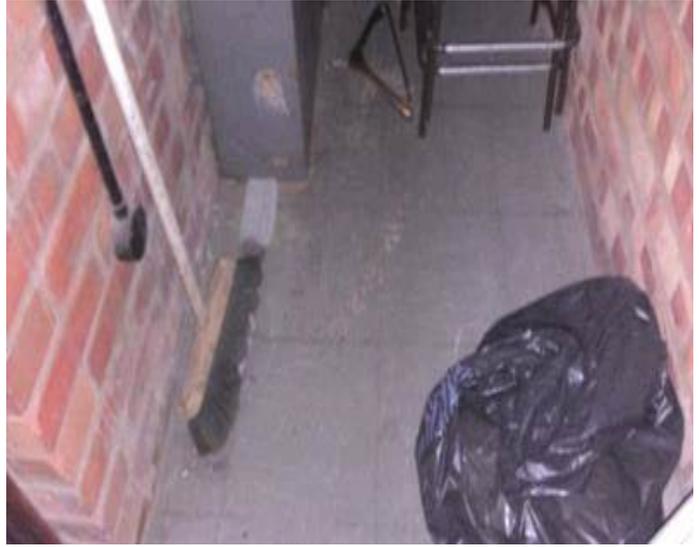
Item:	Asbestos Thermoplastic floor tiles			
Asbestos Content:		Result Based on:		
Chrysotile		Analysis of sample using PLM		
Sample Analysed By:	Refer to original report	Extent:	3 sq m	
Comments: Previously item 077 in J016666. Labelled up.

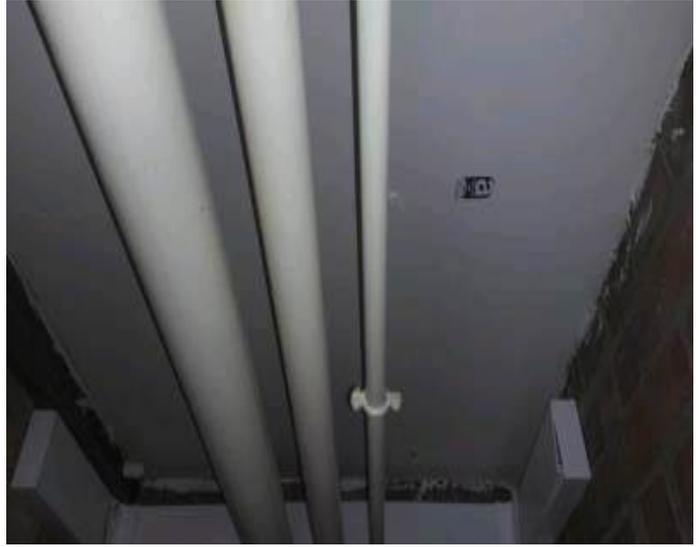
Item:	Asbestos Insulating board ceiling panels			
Asbestos Content:		Result Based on:		
Chrysotile Amosite		Strongly presumed		
Sample Analysed By:	Not applicable	Extent:	3 sq m	
Comments: Previously item 080 in J016666. Labelled up.
