MANAGEMENT SURVEY FOR ASBESTOS-CONTAINING MATERIALS

CLIENT: University of Gloucestershire

SITE: Centre for arts & photography, Hardwick Campus, St Pauls Road, Cheltenham, GL50 4BS

Job number	J020807	
Number of high risk materials	0	
Number of medium risk materials	0	
Number of low/ very low risk materials	2	
Issue	Date	Status
Version 1	08/08/2018	Issued

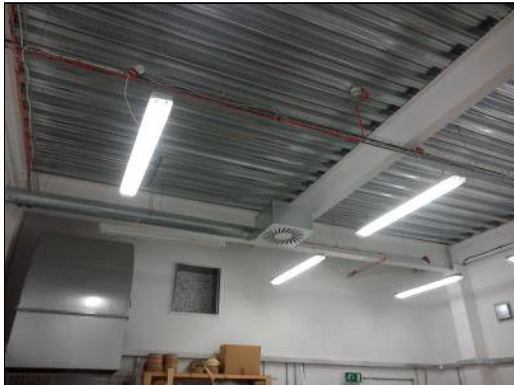
Assessment details				Comments	Photograph
Building	Art and Photography Building	Floor/ room	Ground Floor / 3D Studio	No access to high level ceilings throughout - high level access required

Assessment no.	001	Accessibility			
Material Risk					
Identification	Inaccessible (Presumed)	Condition	n/a		
Extent		Asbestos Type	n/a		
Location/ position	No access to high level ceilings throughout				
Surface treatment	n/a				
Product type	n/a				
Material risk		Material risk score			
Action	Inspect Prior to Disturbance

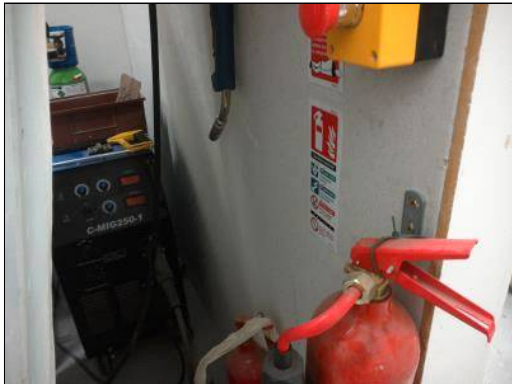
Assessment details				Comments	Photograph
Building	Art and Photography Building	Floor/ room	Ground Floor / 3D Studio	Within welding section only

Assessment no.	002	Accessibility			
Material Risk					
Identification	Identified	Condition			
Extent		Asbestos Type	No Asbestos Detected		
Location/ position	Insulating board wall panels				
Surface treatment					
Product type	n/a				
Material risk		Material risk score			
Action	No further action required

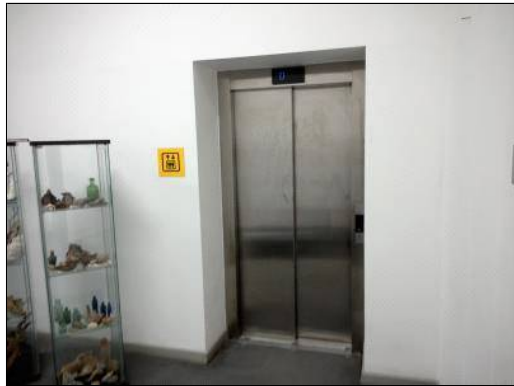
Assessment details				Comments	Photograph
Building	Art and Photography Building	Floor/ room	Ground Floor / Corridor 1	No access into lift shaft - lift engineer required

Assessment no.	003	Accessibility			
Material Risk					
Identification	Inaccessible (Presumed)	Condition	n/a		
Extent		Asbestos Type	n/a		
Location/ position	No access into lift shaft				
Surface treatment	n/a				
Product type	n/a				
Material risk		Material risk score			
Action	Inspect Prior to Disturbance

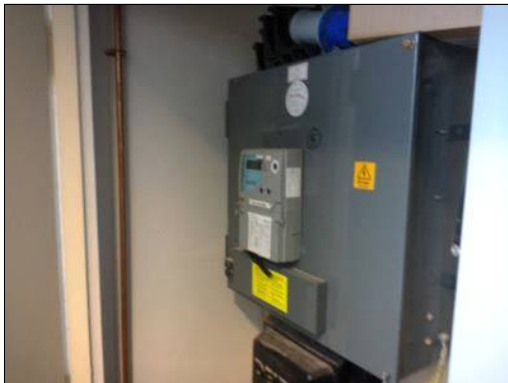
Assessment details				Comments	Photograph
Building	Art and Photography Building	Floor/ room	Ground Floor / Entrance Lobby	No access to electrics - live services

Assessment no.	004	Accessibility			
Material Risk					
Identification	Inaccessible (Presumed)	Condition	n/a		
Extent		Asbestos Type	n/a		
Location/ position	No access to electrics				
Surface treatment	n/a				
Product type	n/a				
Material risk		Material risk score			
Action	Inspect Prior to Disturbance

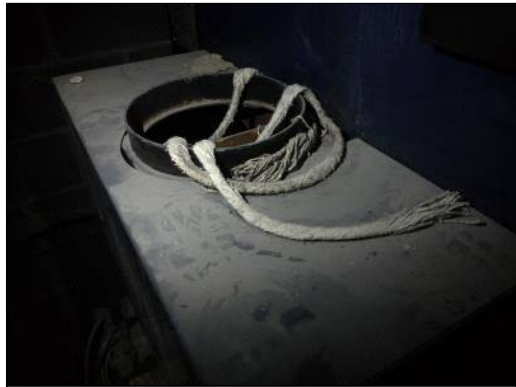
Assessment details				Comments	Photograph
Building	Art and Photography Building	Floor/ room	1st Floor / Store 1

Assessment no.	005	Accessibility	Usually inaccessible or unlikely to be disturbed		
Material Risk					
Identification	Identified	Condition	Low Damage		
Extent	2lm	Asbestos Type	Chrysotile		
Location/ position	Rope boiler lining				
Surface treatment	Unsealed				
Product type	Textiles				
Material risk	Low	Material risk score	6		
Action	Remove

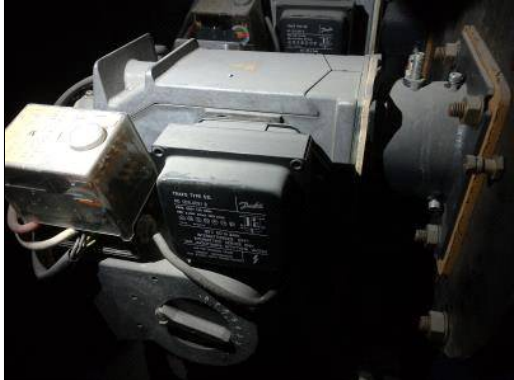
Assessment details				Comments	Photograph
Building	Art and Photography Building	Floor/ room	1st Floor / Store 1

Assessment no.	006	Accessibility			
Material Risk					
Identification	Identified	Condition			
Extent		Asbestos Type	No Asbestos Detected		
Location/ position	Gaskets boiler flange				
Surface treatment					
Product type	n/a				
Material risk		Material risk score			
Action	No further action required

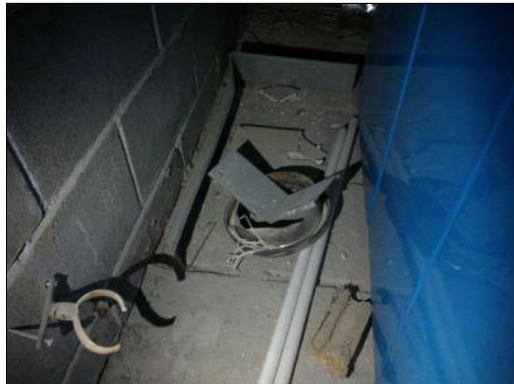
Art and Photography Building	1st Floor / Store 1	007	Rope Flue lining	Textiles	Unsealed	Low Damage	1lm	Usually inaccessible or unlikely to be disturbed	Strongly Presumed	Chrysotile	(6) Low		Remove

Assessment details				Comments	Photograph
Building	Art and Photography Building	Floor/ room	1st Floor / Store 1	Broken flue on floor

Assessment no.	007	Accessibility	Usually inaccessible or unlikely to be disturbed		
Material Risk					
Identification	Strongly Presumed	Condition	Low Damage		
Extent	1lm	Asbestos Type	Chrysotile		
Location/ position	Rope Flue lining				
Surface treatment	Unsealed				
Product type	Textiles				
Material risk	Low	Material risk score	6		
Action	Remove

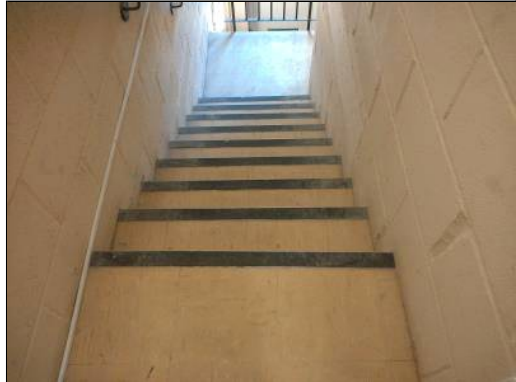
Assessment details				Comments	Photograph
Building	Art and Photography Building	Floor/ room	1st Floor / Fire exit stairwell

Assessment no.	008	Accessibility			
Material Risk					
Identification	Identified	Condition			
Extent		Asbestos Type	No Asbestos Detected		
Location/ position	Vinyl tiles floor/stairwell				
Surface treatment					
Product type	n/a				
Material risk		Material risk score			
Action	No further action required

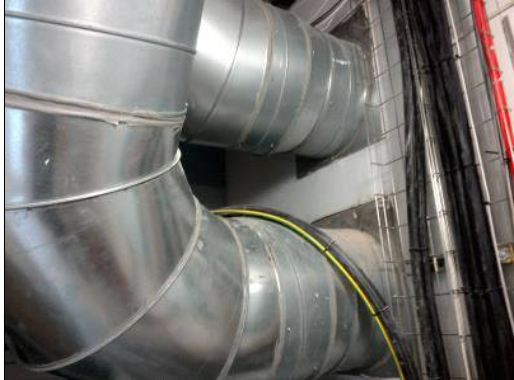
Assessment details				Comments	Photograph
Building	Art and Photography Building	Floor/ room	1st Floor / AP102A

Assessment no.	009	Accessibility			
Material Risk					
Identification	Identified	Condition			
Extent		Asbestos Type	No Asbestos Detected		
Location/ position	Mastic ducting lining				
Surface treatment					
Product type	n/a				
Material risk		Material risk score			
Action	No further action required

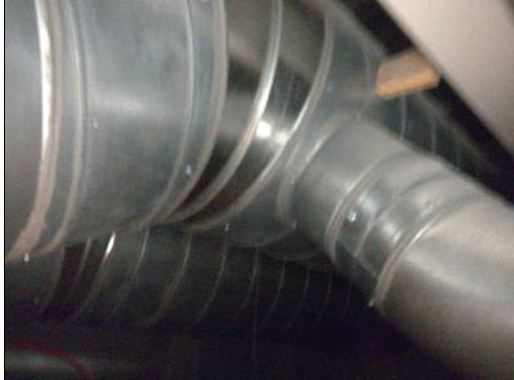
Art and Photography Building	1st Floor / Corridor 1	010	Mastic Ducting lining	Well Bound Material			100lm		Strongly Presumed	No Asbestos Detected	Throughout entire 1st floor

Assessment details				Comments	Photograph
Building	Art and Photography Building	Floor/ room	1st Floor / Corridor 1	Throughout entire 1st floor

Assessment no.	010	Accessibility			
Material Risk					
Identification	Strongly Presumed	Condition			
Extent		Asbestos Type	No Asbestos Detected		
Location/ position	Mastic Ducting lining				
Surface treatment					
Product type	n/a				
Material risk		Material risk score			
Action	No further action required

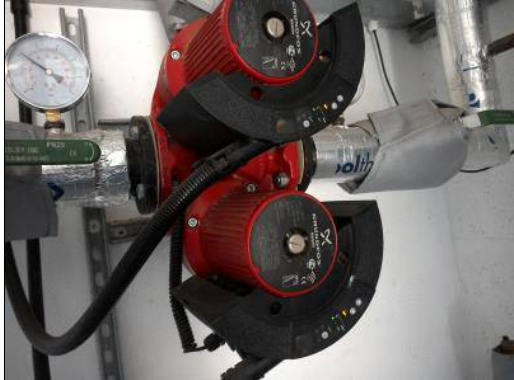
Building	Art and Photography Building	Floor/ room	Ground Floor / Plant room		
Assessment no.	011	Accessibility			
Material Risk					
Identification	Identified	Condition			
Extent		Asbestos Type	No Asbestos Detected		
Location/ position	Gaskets pipe flanges				
Surface treatment					
Product type	n/a				
Material risk		Material risk score			
Action	No further action required

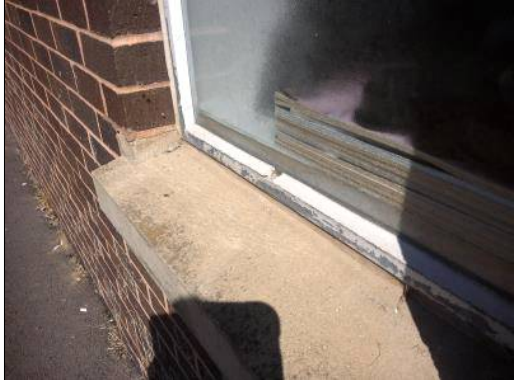
Assessment details				Comments	Photograph
Building	Art and Photography Building	Floor/ room	External / Externals

Assessment no.	012	Accessibility			
Material Risk					
Identification	Identified	Condition			
Extent		Asbestos Type	No Asbestos Detected		
Location/ position	Putty window lining				
Surface treatment					
Product type	n/a				
Material risk		Material risk score			
Action	No further action required

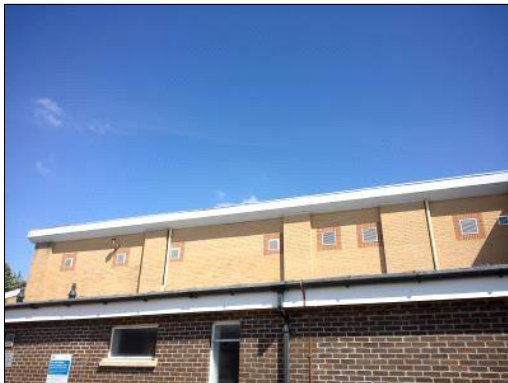
Assessment details				Comments	Photograph
Building	Art and Photography Building	Floor/ room	External / Externals	No access to high level areas - high level access required

Assessment no.	013	Accessibility			
Material Risk					
Identification	Inaccessible (Presumed)	Condition	n/a		
Extent		Asbestos Type	n/a		
Location/ position	No access to high level areas				
Surface treatment	n/a				
Product type	n/a				
Material risk		Material risk score			
Action	Inspect Prior to Disturbance
