Report No.: J042025

Nature of Work: Reinspection of Asbestos Containing Materials

University of Gloucestershire
The Park
Cheltenham
Gloucestershire
GL50 2RH

Hardwick Campus
St Pauls Road
Cheltenham
Gloucestershire
GL50 4BS

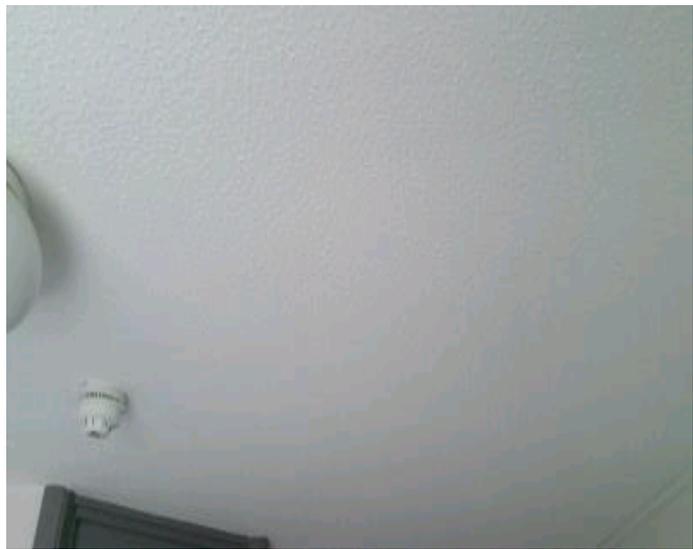
Location:	01 Bedroom	Block:	Avon Building	Floor Level: Ground Floor
Item No.:	1	Sample No.:	178/909 {AT004140}

Item:	Textured coating to ceiling			
Asbestos Content:		Result Based on:		
No Asbestos Detected		Analysis of sample using PLM		
Sample Analysed By:	Refer to original report	Extent:	15 sq m	
Comments: Present to ceilings throughout, representative sampling conducted.

Material Assessment Total Score: 0		Likelihood of Disturbance Assessment Total Score: 0		Management Assessment Licensable: Not applicable Recommendations: Not Applicable Reinspection Interval: Not Applicable Overall Risk Category: E0
Product Type:	0 Not Applicable	Location:	0 Not Applicable	
Condition:	0 Not Applicable	Accessibility:	0 Not Applicable	
Surface Treatment:	0 Not Applicable			
Asbestos Type:	0 Not Applicable	Extent Score:	0 Not Applicable

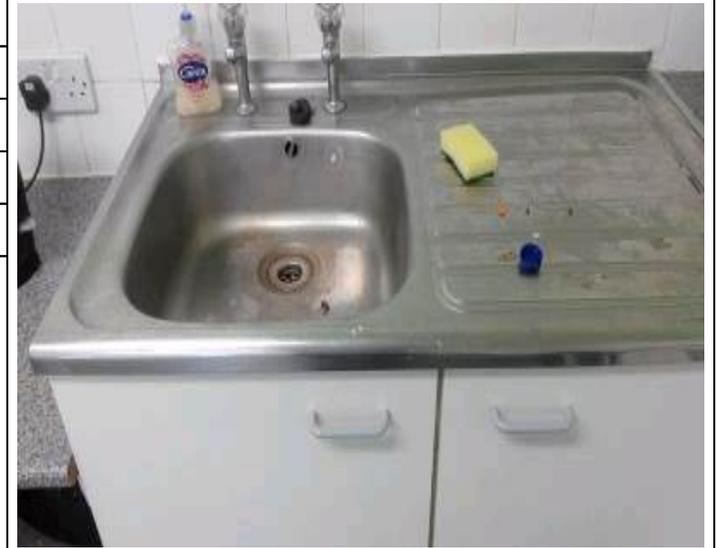
Location:	K01 Kitchen	Block:	Avon Building	Floor Level: Ground Floor
Item No.:	2	Sample No.:	178/910 {AT004141}	
Item:	Bitumen sink pad(s)			
Asbestos Content:		Result Based on:		
No Asbestos Detected		Analysis of sample using PLM		
Sample Analysed By:	Refer to original report	Extent:	<1 sq m	
Comments:

Material Assessment Total Score: 0		Likelihood of Disturbance Assessment Total Score: 0		Management Assessment Licensable: Not applicable Recommendations: Not Applicable Reinspection Interval: Not Applicable Overall Risk Category: E0
Product Type:	0 Not Applicable	Location:	0 Not Applicable	
Condition:	0 Not Applicable	Accessibility:	0 Not Applicable	
Surface Treatment:	0 Not Applicable			
Asbestos Type:	0 Not Applicable	Extent Score:	0 Not Applicable

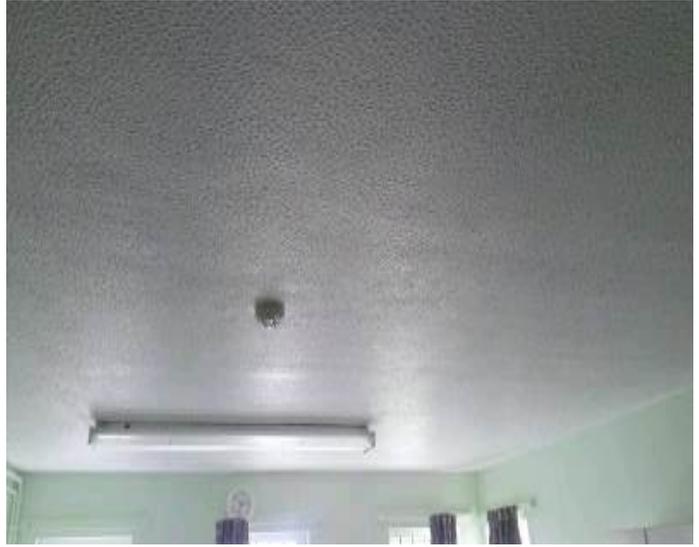
Location:	K01 Kitchen	Block:	Avon Building	Floor Level: Ground Floor
Item No.:	3	Sample No.:	178/911 {AT004142}

Item:	Textured coating to ceiling			
Asbestos Content:		Result Based on:		
No Asbestos Detected		Analysis of sample using PLM		
Sample Analysed By:	Refer to original report	Extent:	30 sq m	
Comments: Present to ceilings throughout, representative sampling conducted.

Material Assessment Total Score: 0		Likelihood of Disturbance Assessment Total Score: 0		Management Assessment Licensable: Not applicable Recommendations: Not Applicable Reinspection Interval: Not Applicable Overall Risk Category: E0
Product Type:	0 Not Applicable	Location:	0 Not Applicable	
Condition:	0 Not Applicable	Accessibility:	0 Not Applicable	
Surface Treatment:	0 Not Applicable			
Asbestos Type:	0 Not Applicable	Extent Score:	0 Not Applicable

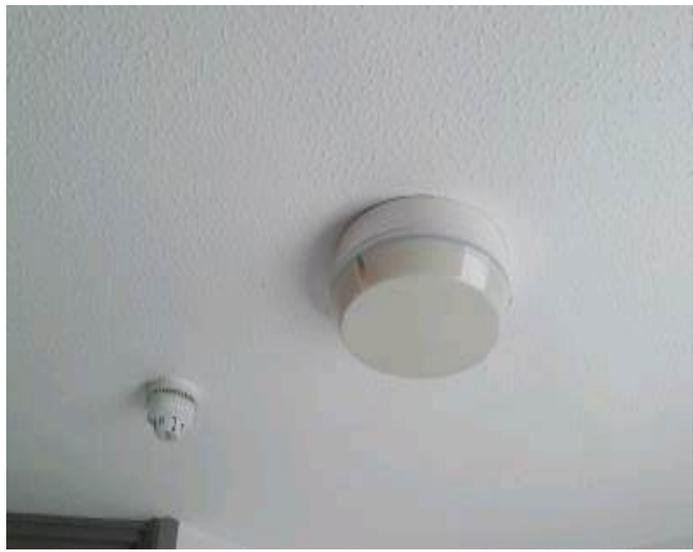
Location:	07 Bedroom	Block:	Avon Building	Floor Level: Ground Floor
Item No.:	4	Sample No.:	178/912 {AT004143}

Item:	Textured coating to ceiling			
Asbestos Content:		Result Based on:		
No Asbestos Detected		Analysis of sample using PLM		
Sample Analysed By:	Refer to original report	Extent:	25 sq m	
Comments: Present to ceilings throughout, representative sampling conducted.

Material Assessment Total Score: 0		Likelihood of Disturbance Assessment Total Score: 0		Management Assessment Licensable: Not applicable Recommendations: Not Applicable Reinspection Interval: Not Applicable Overall Risk Category: E0
Product Type:	0 Not Applicable	Location:	0 Not Applicable	
Condition:	0 Not Applicable	Accessibility:	0 Not Applicable	
Surface Treatment:	0 Not Applicable			
Asbestos Type:	0 Not Applicable	Extent Score:	0 Not Applicable

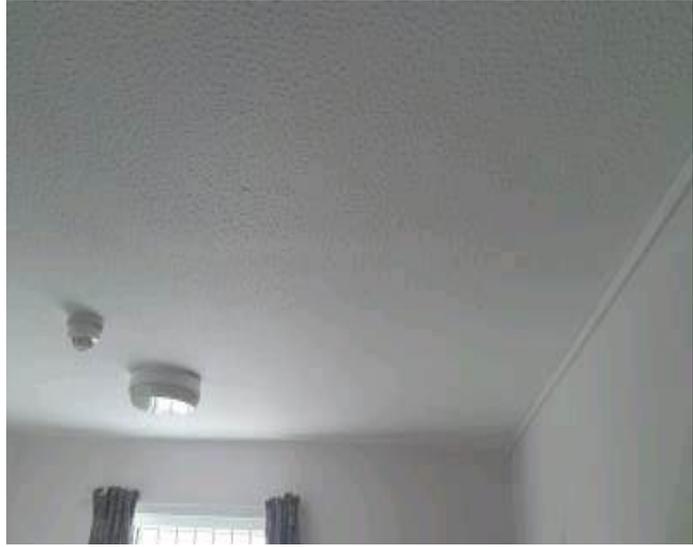
Location:	14 Bedroom	Block:	Avon Building	Floor Level: Ground Floor
Item No.:	5	Sample No.:	178/913 {AT004144}

Item:	Textured coating to ceiling			
Asbestos Content:		Result Based on:		
No Asbestos Detected		Analysis of sample using PLM		
Sample Analysed By:	Refer to original report	Extent:	15 sq m	
Comments: Present to ceilings throughout, representative sampling conducted.

Material Assessment Total Score: 0		Likelihood of Disturbance Assessment Total Score: 0		Management Assessment Licensable: Not applicable Recommendations: Not Applicable Reinspection Interval: Not Applicable Overall Risk Category: E0
Product Type:	0 Not Applicable	Location:	0 Not Applicable	
Condition:	0 Not Applicable	Accessibility:	0 Not Applicable	
Surface Treatment:	0 Not Applicable			
Asbestos Type:	0 Not Applicable	Extent Score:	0 Not Applicable

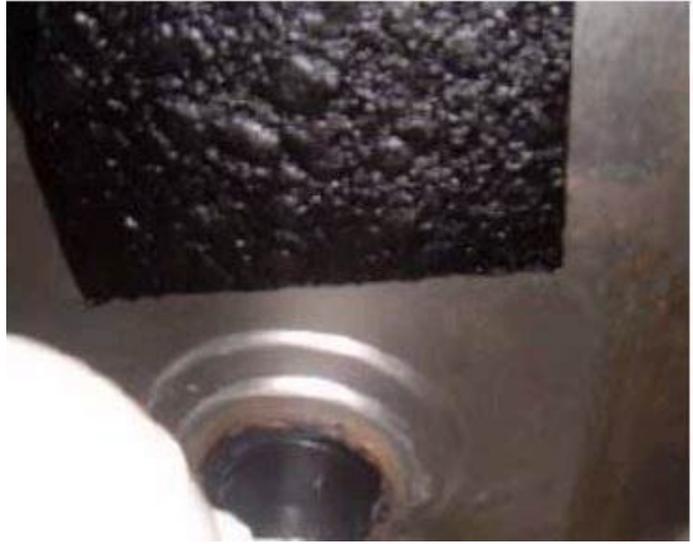
Location:	K02 Kitchen	Block:	Avon Building	Floor Level: Ground Floor
Item No.:	6	Sample No.:	178/914 {AT004145}

Item:	Bitumen sink pad(s)			
Asbestos Content:		Result Based on:		
No Asbestos Detected		Analysis of sample using PLM		
Sample Analysed By:	Refer to original report	Extent:	<1 sq m	
Comments:

Material Assessment Total Score: 0		Likelihood of Disturbance Assessment Total Score: 0		Management Assessment Licensable: Not applicable Recommendations: Not Applicable Reinspection Interval: Not Applicable Overall Risk Category: E0
Product Type:	0 Not Applicable	Location:	0 Not Applicable	
Condition:	0 Not Applicable	Accessibility:	0 Not Applicable	
Surface Treatment:	0 Not Applicable			
Asbestos Type:	0 Not Applicable	Extent Score:	0 Not Applicable

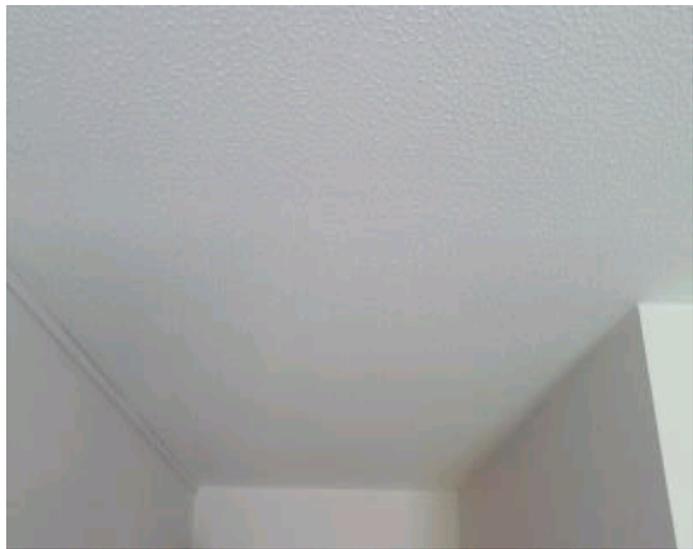
Location:	18 Bedroom	Block:	Avon Building	Floor Level: Ground Floor
Item No.:	7	Sample No.:	178/915 {AT004146}

Item:	Textured coating to ceiling			
Asbestos Content:		Result Based on:		
No Asbestos Detected		Analysis of sample using PLM		
Sample Analysed By:	Refer to original report	Extent:	15 sq m	
Comments: Present to ceilings throughout, representative sampling conducted.

Material Assessment Total Score: 0		Likelihood of Disturbance Assessment Total Score: 0		Management Assessment Licensable: Not applicable Recommendations: Not Applicable Reinspection Interval: Not Applicable Overall Risk Category: E0
Product Type:	0 Not Applicable	Location:	0 Not Applicable	
Condition:	0 Not Applicable	Accessibility:	0 Not Applicable	
Surface Treatment:	0 Not Applicable			
Asbestos Type:	0 Not Applicable	Extent Score:	0 Not Applicable

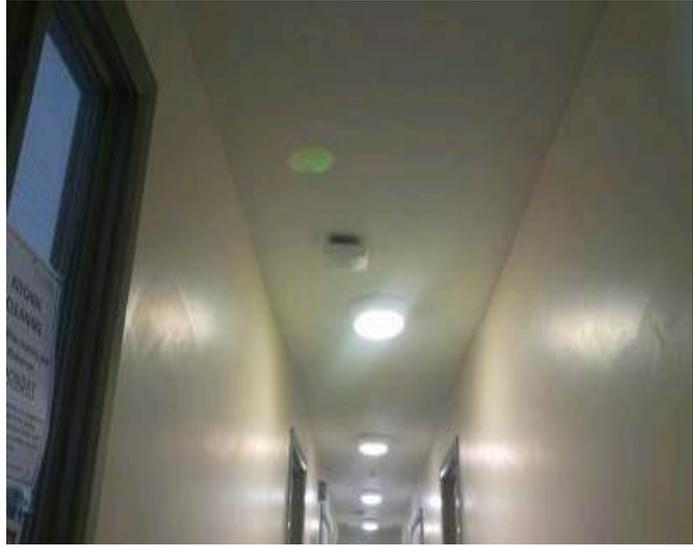
Location:	X065 Corridor	Block:	Avon Building	Floor Level: 1st Floor
Item No.:	8	Sample No.:	178/916 {AT004147}

Item:	Textured coating to ceiling			
Asbestos Content:		Result Based on:		
No Asbestos Detected		Analysis of sample using PLM		
Sample Analysed By:	Refer to original report	Extent:	35 sq m	
Comments: Present to ceilings throughout, representative sampling conducted.

Material Assessment Total Score: 0		Likelihood of Disturbance Assessment Total Score: 0		Management Assessment Licensable: Not applicable Recommendations: Not Applicable Reinspection Interval: Not Applicable Overall Risk Category: E0
Product Type:	0 Not Applicable	Location:	0 Not Applicable	
Condition:	0 Not Applicable	Accessibility:	0 Not Applicable	
Surface Treatment:	0 Not Applicable			
Asbestos Type:	0 Not Applicable	Extent Score:	0 Not Applicable

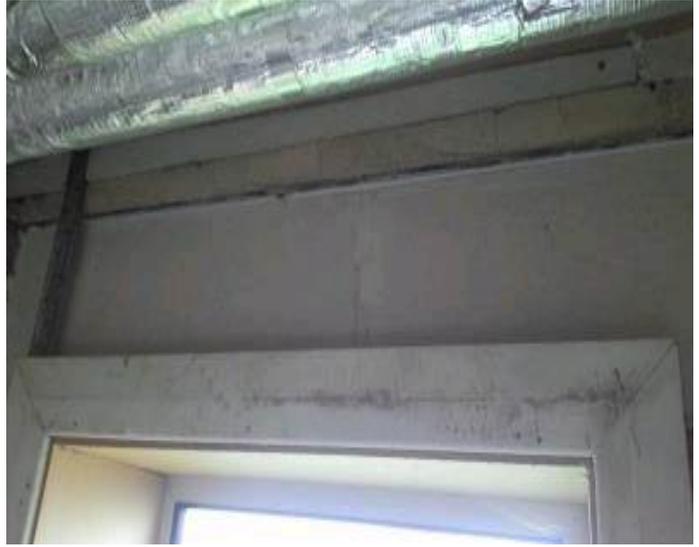
Location:	X077 Plantroom	Block:	Avon Building	Floor Level: 1st Floor
Item No.:	9	Sample No.:	178/917 {AT004148}

Item:	Insulating board ceiling and wall panels			
Asbestos Content:		Result Based on:		
No Asbestos Detected		Analysis of sample using PLM		
Sample Analysed By:	Refer to original report	Extent:	<1 sq m	
Comments:

Material Assessment Total Score: 0		Likelihood of Disturbance Assessment Total Score: 0		Management Assessment Licensable: Not applicable Recommendations: Not Applicable Reinspection Interval: Not Applicable Overall Risk Category: E0
Product Type:	0 Not Applicable	Location:	0 Not Applicable	
Condition:	0 Not Applicable	Accessibility:	0 Not Applicable	
Surface Treatment:	0 Not Applicable			
Asbestos Type:	0 Not Applicable	Extent Score:	0 Not Applicable	
Management Detail

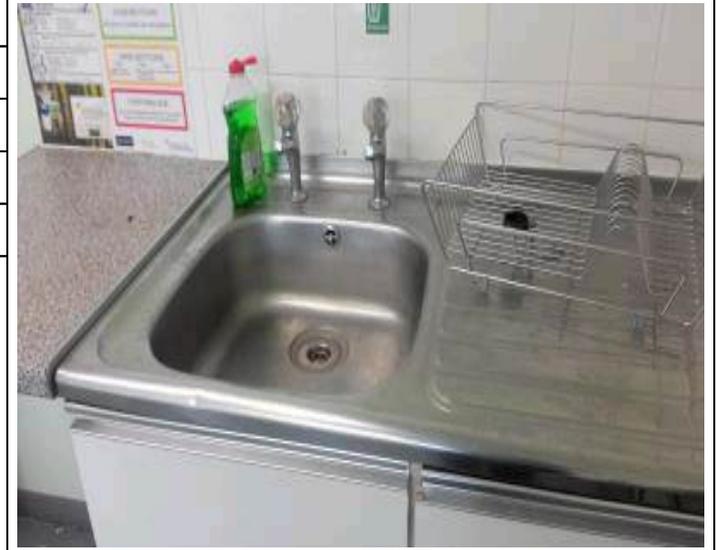
Location:	K03 Kitchen	Block:	Avon Building	Floor Level: 1st Floor
Item No.:	10	Sample No.:	178/918 {AT004149}	
Item:	Bitumen sink pad(s)			
Asbestos Content:		Result Based on:		
No Asbestos Detected		Analysis of sample using PLM		
Sample Analysed By:	Refer to original report	Extent:	<1 sq m	
Comments:

Material Assessment Total Score: 0		Likelihood of Disturbance Assessment Total Score: 0		Management Assessment Licensable: Not applicable Recommendations: Not Applicable Reinspection Interval: Not Applicable Overall Risk Category: E0
Product Type:	0 Not Applicable	Location:	0 Not Applicable	
Condition:	0 Not Applicable	Accessibility:	0 Not Applicable	
Surface Treatment:	0 Not Applicable			
Asbestos Type:	0 Not Applicable	Extent Score:	0 Not Applicable

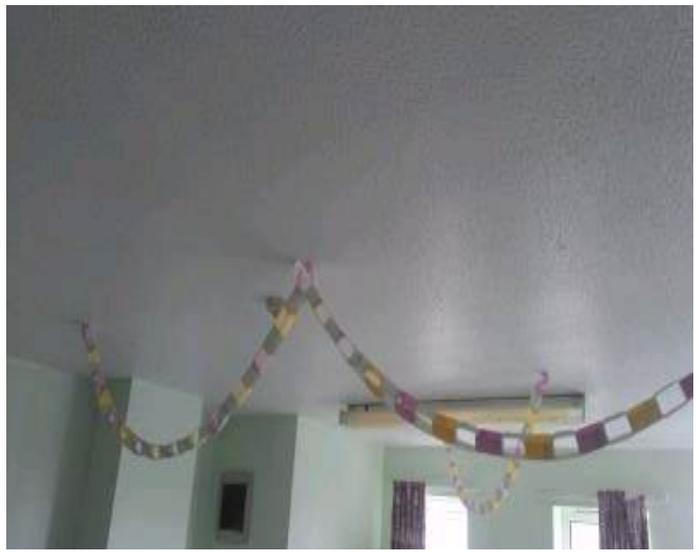
Location:	K03 Kitchen	Block:	Avon Building	Floor Level: 1st Floor
Item No.:	11	Sample No.:	178/919 {AT004150}

Item:	Textured coating to ceiling			
Asbestos Content:		Result Based on:		
No Asbestos Detected		Analysis of sample using PLM		
Sample Analysed By:	Refer to original report	Extent:	30 sq m	
Comments: Present to ceilings throughout, representative sampling conducted.

Material Assessment Total Score: 0		Likelihood of Disturbance Assessment Total Score: 0		Management Assessment Licensable: Not applicable Recommendations: Not Applicable Reinspection Interval: Not Applicable Overall Risk Category: E0
Product Type:	0 Not Applicable	Location:	0 Not Applicable	
Condition:	0 Not Applicable	Accessibility:	0 Not Applicable	
Surface Treatment:	0 Not Applicable			
Asbestos Type:	0 Not Applicable	Extent Score:	0 Not Applicable

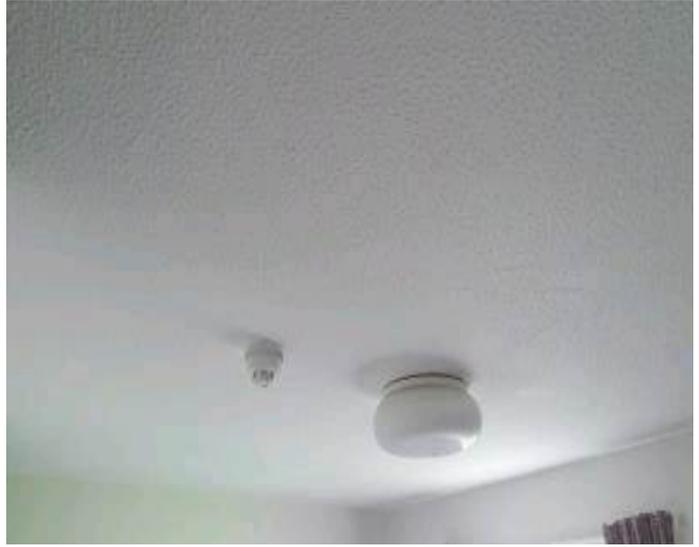
Location:	26 Bedroom	Block:	Avon Building	Floor Level: 1st Floor
Item No.:	12	Sample No.:	178/920 {AT004151}

Item:	Textured coating to ceiling			
Asbestos Content:		Result Based on:		
No Asbestos Detected		Analysis of sample using PLM		
Sample Analysed By:	Refer to original report	Extent:	25 sq m	
Comments: Present to ceilings throughout, representative sampling conducted.

Material Assessment Total Score: 0		Likelihood of Disturbance Assessment Total Score: 0		Management Assessment Licensable: Not applicable Recommendations: Not Applicable Reinspection Interval: Not Applicable Overall Risk Category: E0
Product Type:	0 Not Applicable	Location:	0 Not Applicable	
Condition:	0 Not Applicable	Accessibility:	0 Not Applicable	
Surface Treatment:	0 Not Applicable			
Asbestos Type:	0 Not Applicable	Extent Score:	0 Not Applicable

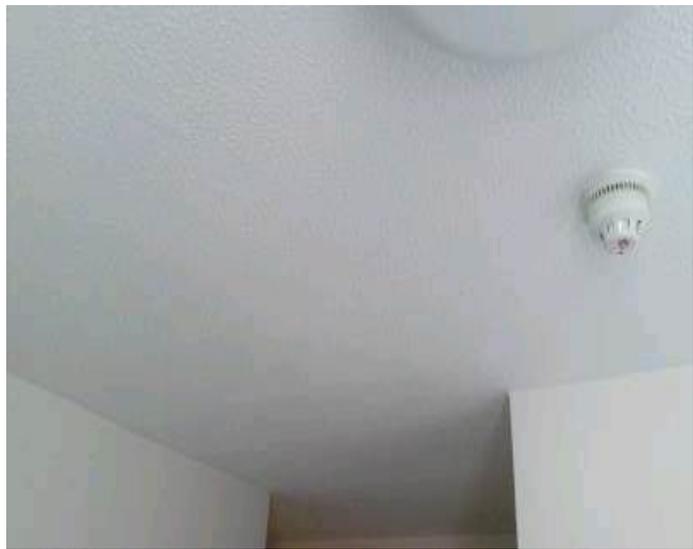
Location:	31 Bedroom	Block:	Avon Building	Floor Level: 1st Floor
Item No.:	13	Sample No.:	178/921 {AT004152}

Item:	Textured coating to ceiling			
Asbestos Content:		Result Based on:		
No Asbestos Detected		Analysis of sample using PLM		
Sample Analysed By:	Refer to original report	Extent:	15 sq m	
Comments: Present to ceilings throughout, representative sampling conducted.

Material Assessment Total Score: 0		Likelihood of Disturbance Assessment Total Score: 0		Management Assessment Licensable: Not applicable Recommendations: Not Applicable Reinspection Interval: Not Applicable Overall Risk Category: E0
Product Type:	0 Not Applicable	Location:	0 Not Applicable	
Condition:	0 Not Applicable	Accessibility:	0 Not Applicable	
Surface Treatment:	0 Not Applicable			
Asbestos Type:	0 Not Applicable	Extent Score:	0 Not Applicable

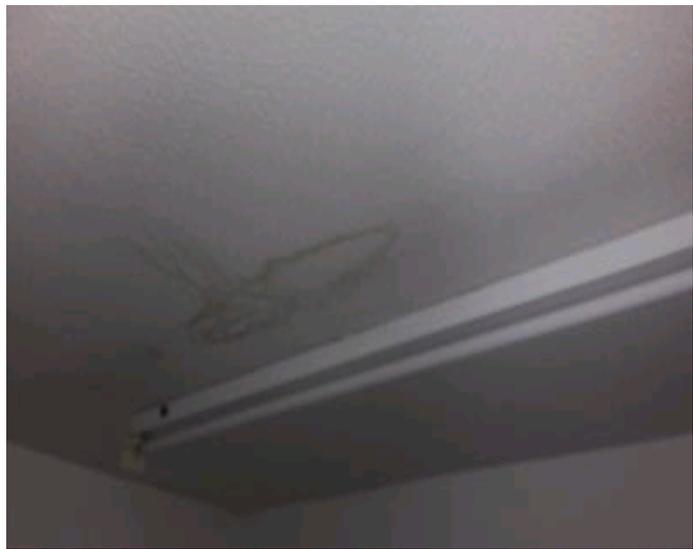
Location:	X84 Cleaners	Block:	Avon Building	Floor Level: 1st Floor
Item No.:	14	Sample No.:	178/922 {AT004153}

Item:	Textured coating to ceiling			
Asbestos Content:		Result Based on:		
No Asbestos Detected		Analysis of sample using PLM		
Sample Analysed By:	Refer to original report	Extent:	7 sq m	
Comments: Present to ceilings throughout, representative sampling conducted.

Material Assessment Total Score: 0		Likelihood of Disturbance Assessment Total Score: 0		Management Assessment Licensable: Not applicable Recommendations: Not Applicable Reinspection Interval: Not Applicable Overall Risk Category: E0
Product Type:	0 Not Applicable	Location:	0 Not Applicable	
Condition:	0 Not Applicable	Accessibility:	0 Not Applicable	
Surface Treatment:	0 Not Applicable			
Asbestos Type:	0 Not Applicable	Extent Score:	0 Not Applicable

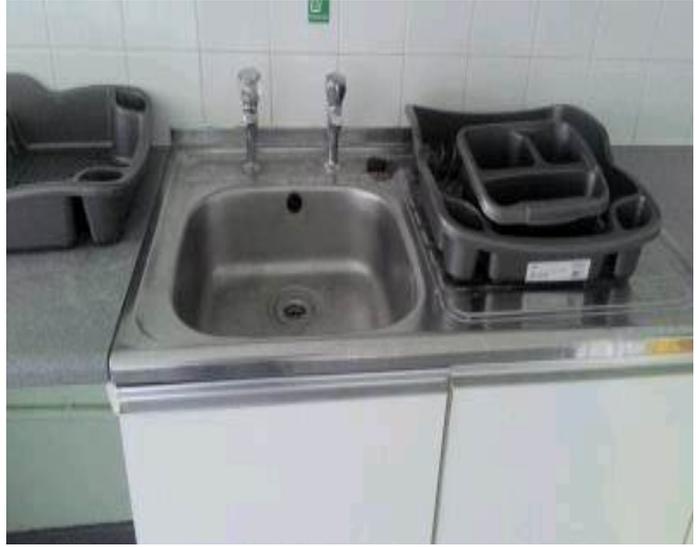
Location:	K04 Kitchen	Block:	Avon Building	Floor Level: 1st Floor
Item No.:	15	Sample No.:	178/923 {AT004154}

Item:	Bitumen sink pad(s)			
Asbestos Content:		Result Based on:		
No Asbestos Detected		Analysis of sample using PLM		
Sample Analysed By:	Refer to original report	Extent:	<1 sq m	
Comments:

Material Assessment Total Score: 0		Likelihood of Disturbance Assessment Total Score: 0		Management Assessment Licensable: Not applicable Recommendations: Not Applicable Reinspection Interval: Not Applicable Overall Risk Category: E0
Product Type:	0 Not Applicable	Location:	0 Not Applicable	
Condition:	0 Not Applicable	Accessibility:	0 Not Applicable	
Surface Treatment:	0 Not Applicable			
Asbestos Type:	0 Not Applicable	Extent Score:	0 Not Applicable

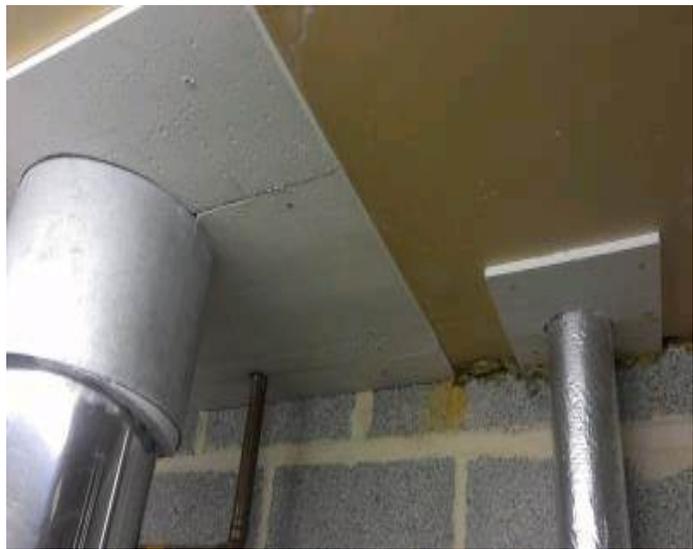
Location:	X86 Plantroom	Block:	Avon Building	Floor Level: 1st Floor
Item No.:	16	Sample No.:	178/924 {AT004155}

Item:	Insulating board ceiling panels			
Asbestos Content:		Result Based on:		
No Asbestos Detected		Analysis of sample using PLM		
Sample Analysed By:	Refer to original report	Extent:	2 sq m	
Comments:

Material Assessment Total Score: 0		Likelihood of Disturbance Assessment Total Score: 0		Management Assessment Licensable: Not applicable Recommendations: Not Applicable Reinspection Interval: Not Applicable Overall Risk Category: E0
Product Type:	0 Not Applicable	Location:	0 Not Applicable	
Condition:	0 Not Applicable	Accessibility:	0 Not Applicable	
Surface Treatment:	0 Not Applicable			
Asbestos Type:	0 Not Applicable	Extent Score:	0 Not Applicable

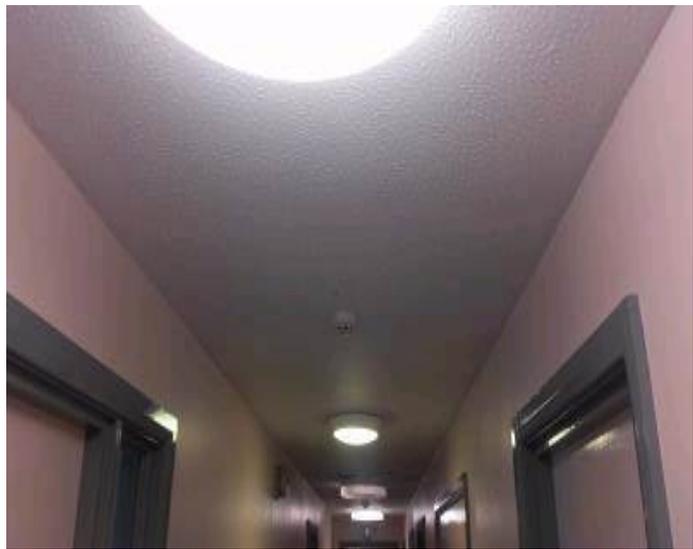
Location:	X117 Corridor	Block:	Severn Building	Floor Level: 1st Floor
Item No.:	17	Sample No.:	178/925 {AT004156}

Item:	Textured coating to ceiling			
Asbestos Content:		Result Based on:		
No Asbestos Detected		Analysis of sample using PLM		
Sample Analysed By:	Refer to original report	Extent:	35 sq m	
Comments: Present to ceilings throughout, representative sampling conducted.

Material Assessment Total Score: 0		Likelihood of Disturbance Assessment Total Score: 0		Management Assessment Licensable: Not applicable Recommendations: Not Applicable Reinspection Interval: Not Applicable Overall Risk Category: E0
Product Type:	0 Not Applicable	Location:	0 Not Applicable	
Condition:	0 Not Applicable	Accessibility:	0 Not Applicable	
Surface Treatment:	0 Not Applicable			
Asbestos Type:	0 Not Applicable	Extent Score:	0 Not Applicable	
Management Detail

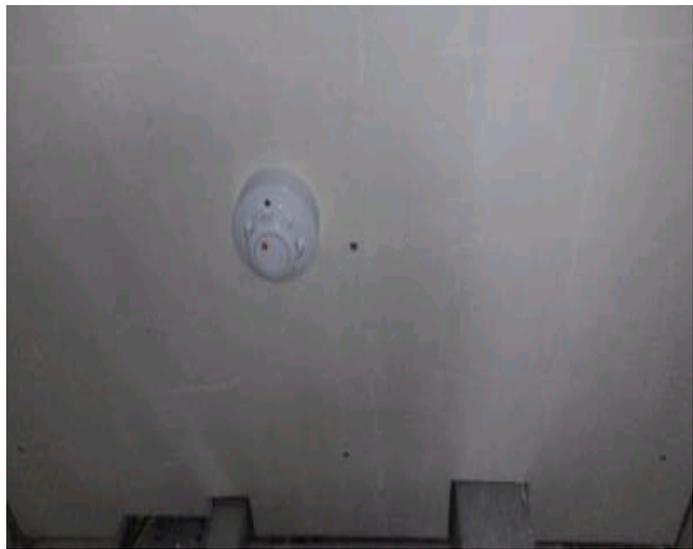
Location:	X123 Plantroom	Block:	Severn Building	Floor Level: 1st Floor
Item No.:	18	Sample No.:	178/926 {AT004157}

Item:	Insulating board ceiling panel			
Asbestos Content:		Result Based on:		
No Asbestos Detected		Analysis of sample using PLM		
Sample Analysed By:	Refer to original report	Extent:	1 sq m	
Comments:

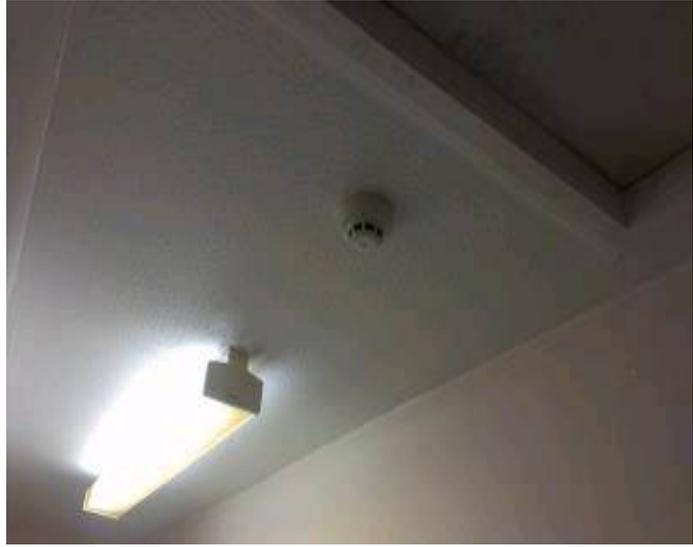
Location:	X130 Stairwell	Block:	Severn Building	Floor Level: 1st Floor
Item No.:	19	Sample No.:	178/927 {AT004158}

Item:	Textured coating to ceiling			
Asbestos Content:		Result Based on:		
No Asbestos Detected		Analysis of sample using PLM		
Sample Analysed By:	Refer to original report	Extent:	15 sq m	
Comments: Present to ceilings throughout, representative sampling conducted.

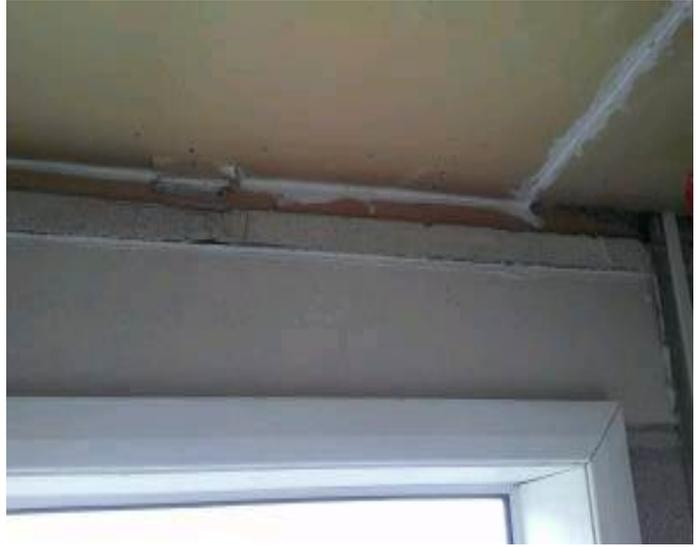
Location:	X131 Plantroom	Block:	Severn Building	Floor Level: 1st Floor
Item No.:	20	Sample No.:	178/928 {AT004159}

Item:	Insulating board window header panel			
Asbestos Content:		Result Based on:		
No Asbestos Detected		Analysis of sample using PLM		
Sample Analysed By:	Refer to original report	Extent:	<1 sq m	
Comments:

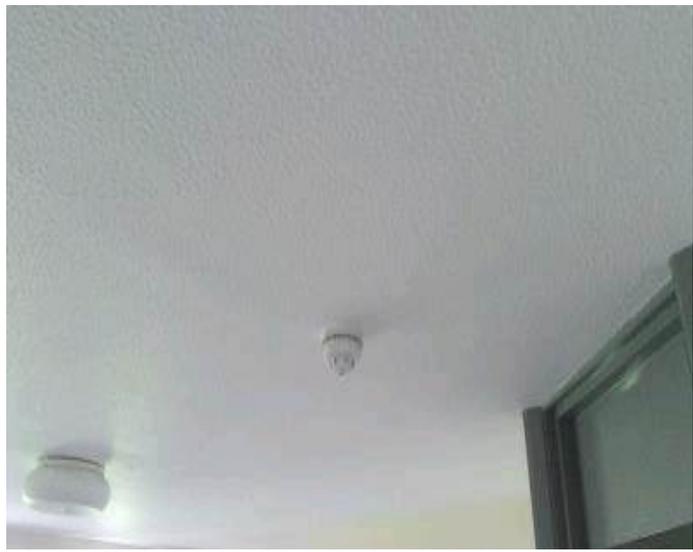
Location:	23 Bedroom	Block:	Severn Building	Floor Level: 1st Floor
Item No.:	21	Sample No.:	178/929 {AT004160}

Item:	Textured coating to ceiling			
Asbestos Content:		Result Based on:		
No Asbestos Detected		Analysis of sample using PLM		
Sample Analysed By:	Refer to original report	Extent:	22 sq m	
Comments: Present to ceilings throughout, representative sampling conducted.

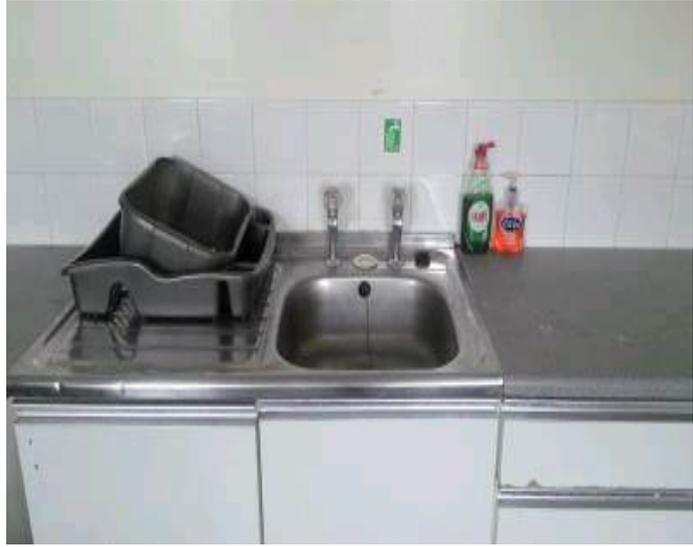
Location:	K3 Kitchen	Block:	Severn Building	Floor Level: 1st Floor
Item No.:	22	Sample No.:	178/930 {AT004161}

Item:	Bitumen sink pad(s)			
Asbestos Content:		Result Based on:		
No Asbestos Detected		Analysis of sample using PLM		
Sample Analysed By:	Refer to original report	Extent:	<1 sq m	
Comments:

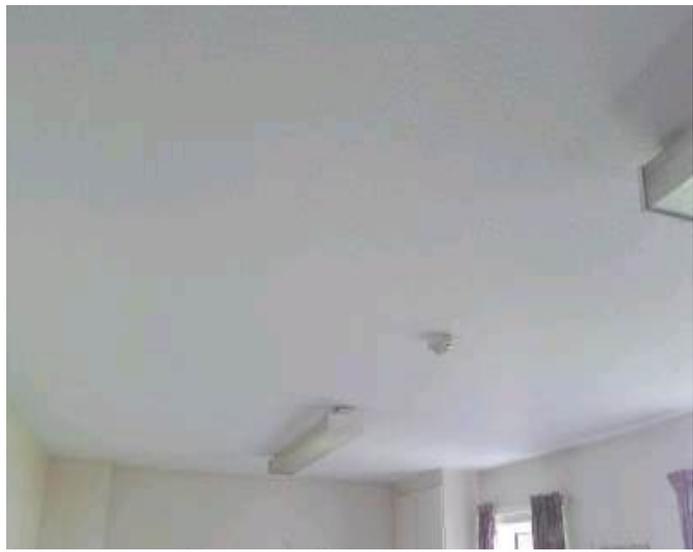
Location:	K3 Kitchen	Block:	Severn Building	Floor Level: 1st Floor
Item No.:	23	Sample No.:	178/931 {AT004162}

Item:	Textured coating to ceiling			
Asbestos Content:		Result Based on:		
No Asbestos Detected		Analysis of sample using PLM		
Sample Analysed By:	Refer to original report	Extent:	30 sq m	
Comments: Present to ceilings throughout, representative sampling conducted.

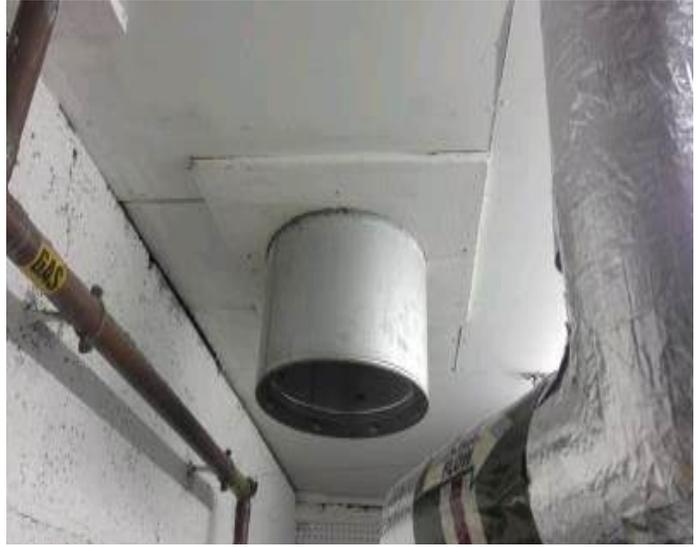
Location:	X135 Plantroom	Block:	Severn Building	Floor Level: 1st Floor
Item No.:	24	Sample No.:	178/932 {AT004163}

Item:	Insulating board ceiling panels			
Asbestos Content:		Result Based on:		
No Asbestos Detected		Analysis of sample using PLM		
Sample Analysed By:	Refer to original report	Extent:	<1 sq m	
Comments:

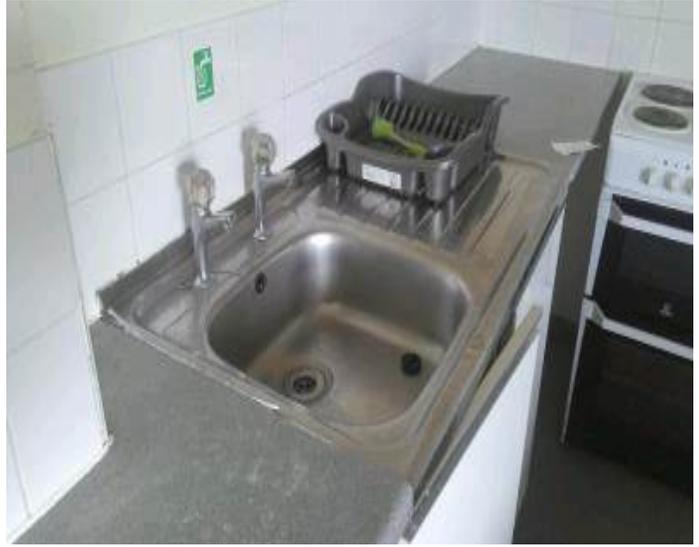
Location:	K5 Kitchen	Block:	Severn Building	Floor Level: 1st Floor
Item No.:	25	Sample No.:	178/933 {AT004164}

Item:	Bitumen sink pad(s)			
Asbestos Content:		Result Based on:		
No Asbestos Detected		Analysis of sample using PLM		
Sample Analysed By:	Refer to original report	Extent:	<1 sq m	
Comments:

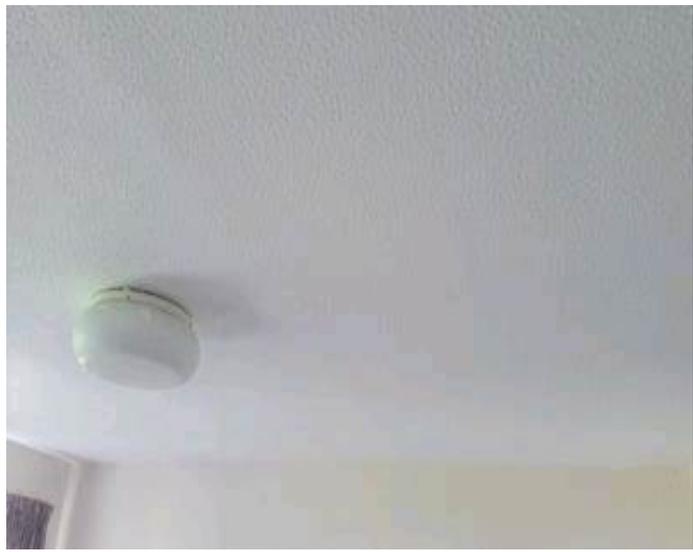
Location:	31 Bedroom	Block:	Severn Building	Floor Level: 1st Floor
Item No.:	26	Sample No.:	178/934 {AT004165}

Item:	Textured coating to ceiling			
Asbestos Content:		Result Based on:		
No Asbestos Detected		Analysis of sample using PLM		
Sample Analysed By:	Refer to original report	Extent:	20 sq m	
Comments: Present to ceilings throughout, representative sampling conducted.

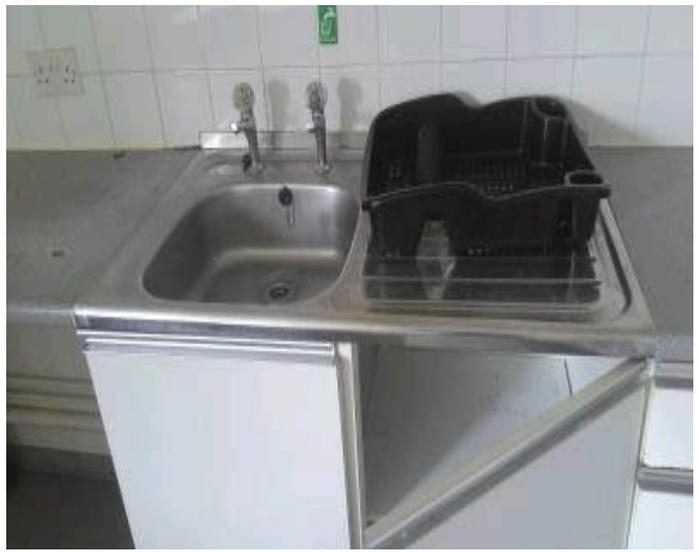
Location:	K4 Kitchen	Block:	Severn Building	Floor Level: 1st Floor
Item No.:	27	Sample No.:	178/935 {AT004166}

Item:	Bitumen sink pad(s)			
Asbestos Content:		Result Based on:		
No Asbestos Detected		Analysis of sample using PLM		
Sample Analysed By:	Refer to original report	Extent:	<1 sq m	
Comments:

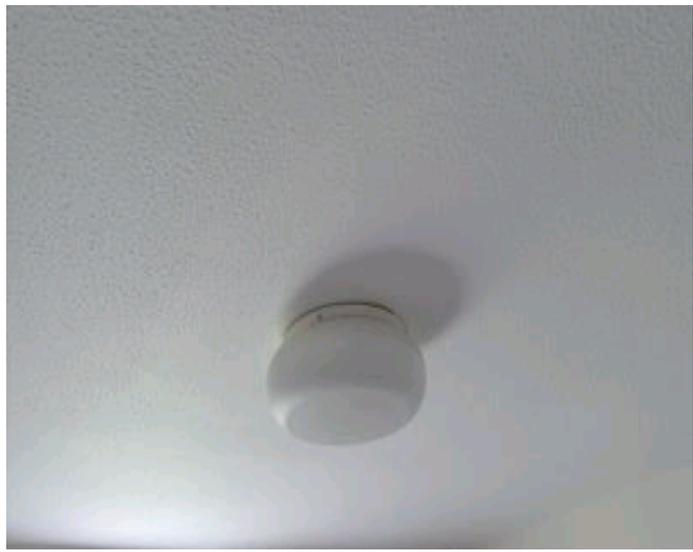
Location:	01 Bedroom	Block:	Severn Building	Floor Level: Ground Floor
Item No.:	28	Sample No.:	178/936 {AT004167}

Item:	Textured coating to ceiling			
Asbestos Content:		Result Based on:		
No Asbestos Detected		Analysis of sample using PLM		
Sample Analysed By:	Refer to original report	Extent:	15 sq m	
Comments: Present to ceilings throughout, representative sampling conducted.

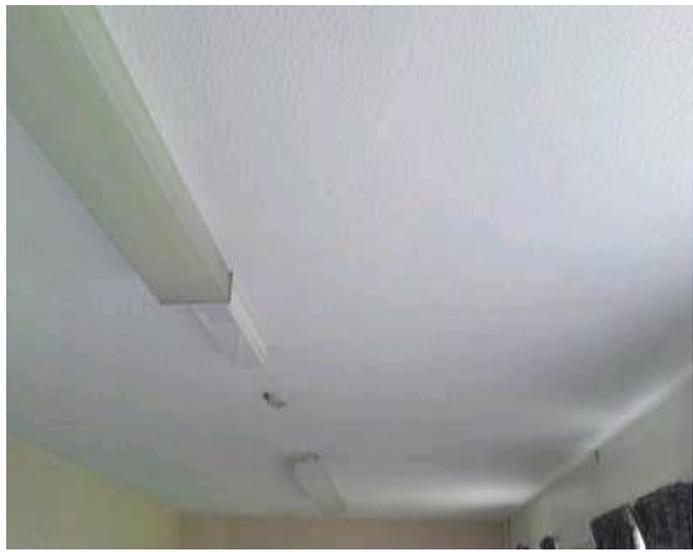
Location:	K1 Kitchen	Block:	Severn Building	Floor Level: Ground Floor
Item No.:	29	Sample No.:	178/937 {AT004168}

Item:	Textured coating to ceiling			
Asbestos Content:		Result Based on:		
No Asbestos Detected		Analysis of sample using PLM		
Sample Analysed By:	Refer to original report	Extent:	30 sq m	
Comments: Present to ceilings throughout, representative sampling conducted.

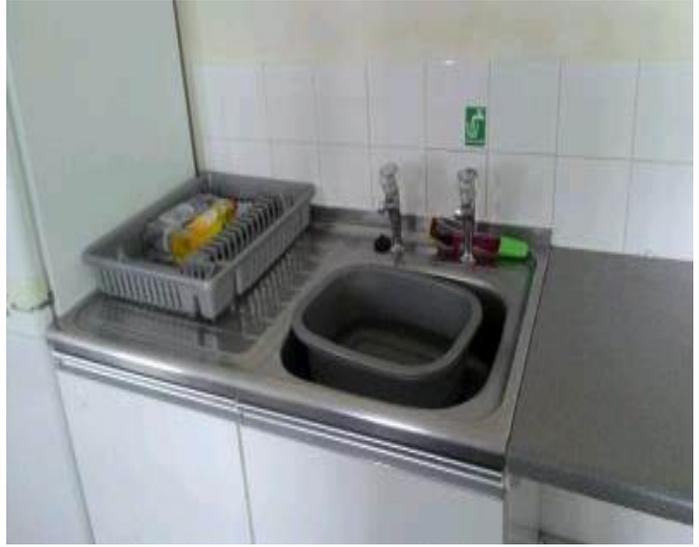
Location:	K1 Kitchen	Block:	Severn Building	Floor Level:	Ground Floor
Item No.:	30	Sample No.:	178/938 {AT004169}

Item:	Bitumen sink pad(s)				
Asbestos Content:		Result Based on:			
No Asbestos Detected		Analysis of sample using PLM			
Sample Analysed By:	Refer to original report	Extent:	<1 sq m		
Comments:

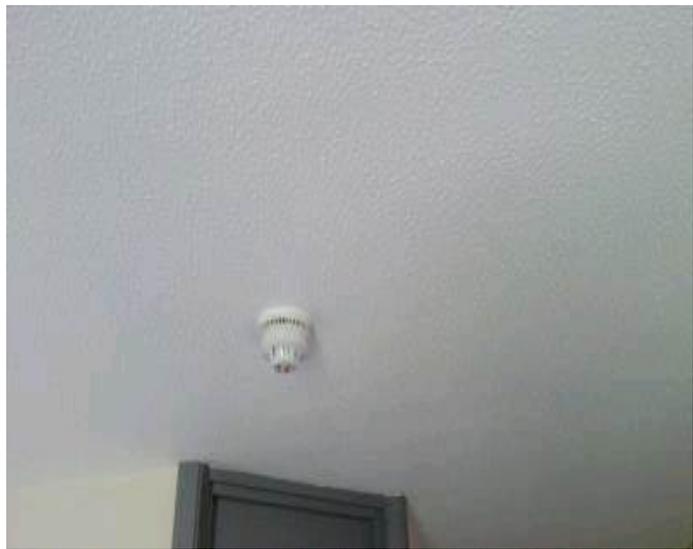
Location:	08 Bedroom	Block:	Severn Building	Floor Level: Ground Floor
Item No.:	31	Sample No.:	178/939 {AT004170}

Item:	Textured coating to ceiling			
Asbestos Content:		Result Based on:		
No Asbestos Detected		Analysis of sample using PLM		
Sample Analysed By:	Refer to original report	Extent:	15 sq m	
Comments: Present to ceilings throughout, representative sampling conducted.

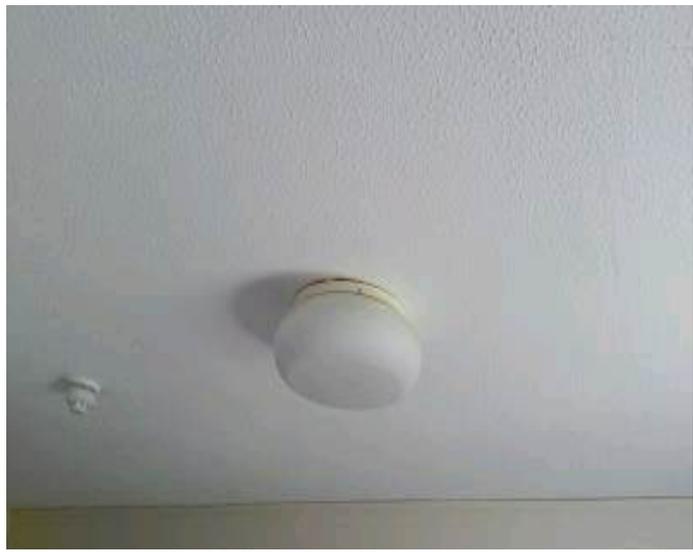
Location:	16 Bedroom	Block:	Severn Building	Floor Level: Ground Floor
Item No.:	32	Sample No.:	178/940 {AT004171}

Item:	Textured coating to ceiling			
Asbestos Content:		Result Based on:		
No Asbestos Detected		Analysis of sample using PLM		
Sample Analysed By:	Refer to original report	Extent:	15 sq m	
Comments: Present to ceilings throughout, representative sampling conducted.

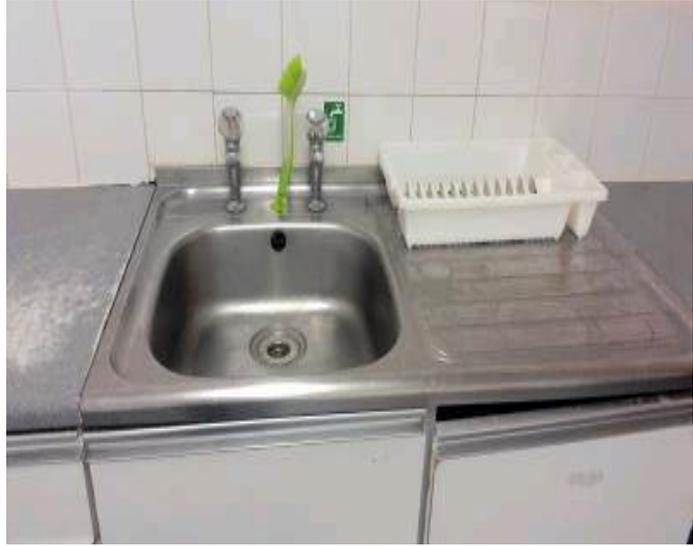
Location:	K2 Kitchen	Block:	Severn Building	Floor Level:	Ground Floor
Item No.:	33	Sample No.:	178/941 {AT004172}

Item:	Bitumen sink pad(s)				
Asbestos Content:		Result Based on:			
No Asbestos Detected		Analysis of sample using PLM			
Sample Analysed By:	Refer to original report	Extent:	<1 sq m		
Comments:

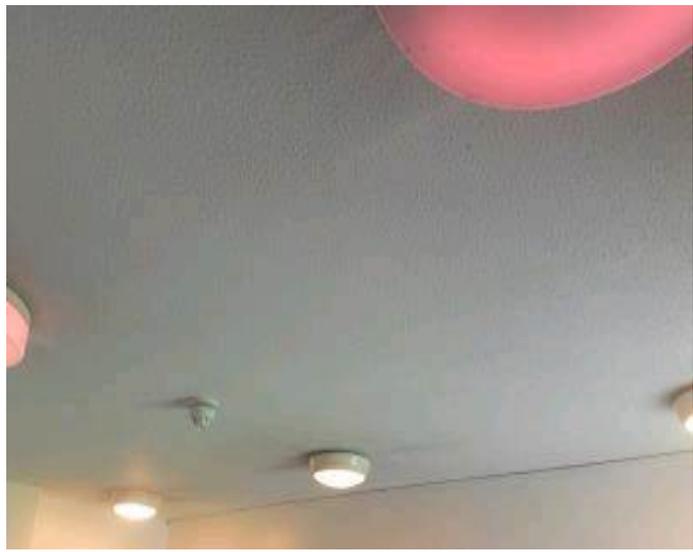
Location:	X144 Lobby	Block:	Thames Building	Floor Level: Ground Floor
Item No.:	34	Sample No.:	178/942 {AT004173}

Item:	Textured coating to ceiling			
Asbestos Content:		Result Based on:		
No Asbestos Detected		Analysis of sample using PLM		
Sample Analysed By:	Refer to original report	Extent:	22 sq m	
Comments: Present to ceilings throughout, representative sampling conducted.

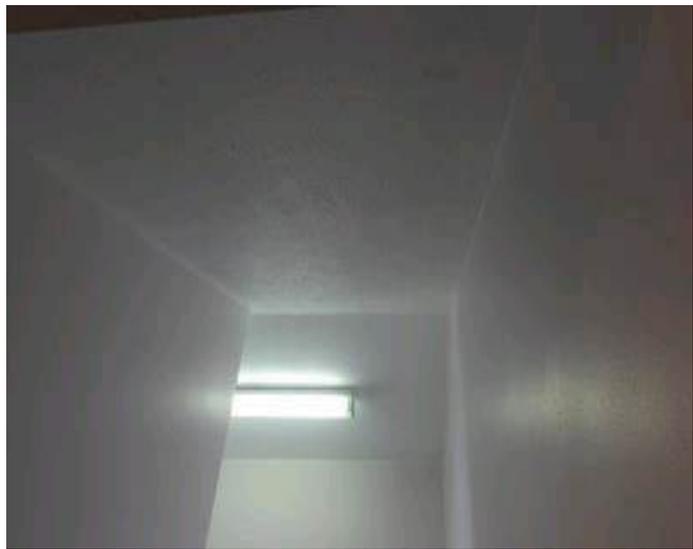
Location:	X153 Stairwell	Block:	Thames Building	Floor Level: Ground Floor
Item No.:	35	Sample No.:	178/943 {AT004174}

Item:	Textured coating to ceiling			
Asbestos Content:		Result Based on:		
No Asbestos Detected		Analysis of sample using PLM		
Sample Analysed By:	Refer to original report	Extent:	5 sq m	
Comments: Present to ceilings throughout, representative sampling conducted.

Material Assessment Total Score: 0		Likelihood of Disturbance Assessment Total Score: 0		Management Assessment Licensable: Not applicable Recommendations: Not Applicable Reinspection Interval: Not Applicable Overall Risk Category: E0
Product Type:	0 Not Applicable	Location:	0 Not Applicable	
Condition:	0 Not Applicable	Accessibility:	0 Not Applicable	
Surface Treatment:	0 Not Applicable			
Asbestos Type:	0 Not Applicable	Extent Score:	0 Not Applicable

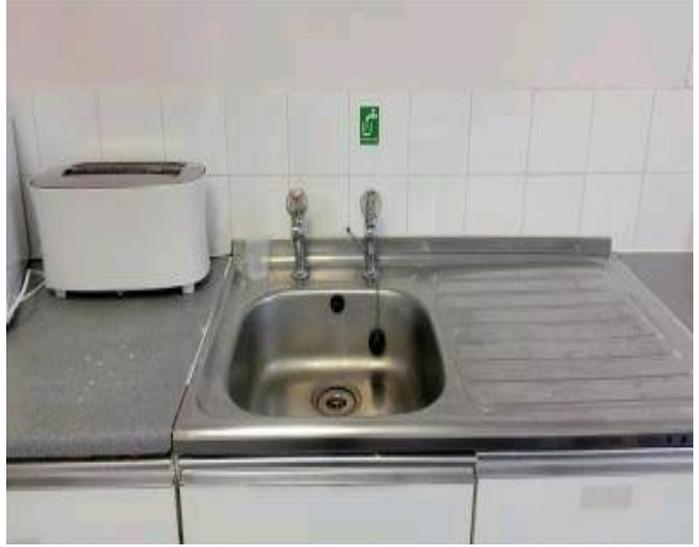
Location:	K1 Kitchen	Block:	Thames Building	Floor Level: Ground Floor
Item No.:	36	Sample No.:	178/944 {AT004175}

Item:	Bitumen sink pad(s)			
Asbestos Content:		Result Based on:		
No Asbestos Detected		Analysis of sample using PLM		
Sample Analysed By:	Refer to original report	Extent:	<1 sq m	
Comments:

Material Assessment Total Score: 0		Likelihood of Disturbance Assessment Total Score: 0		Management Assessment Licensable: Not applicable Recommendations: Not Applicable Reinspection Interval: Not Applicable Overall Risk Category: E0
Product Type:	0 Not Applicable	Location:	0 Not Applicable	
Condition:	0 Not Applicable	Accessibility:	0 Not Applicable	
Surface Treatment:	0 Not Applicable			
Asbestos Type:	0 Not Applicable	Extent Score:	0 Not Applicable

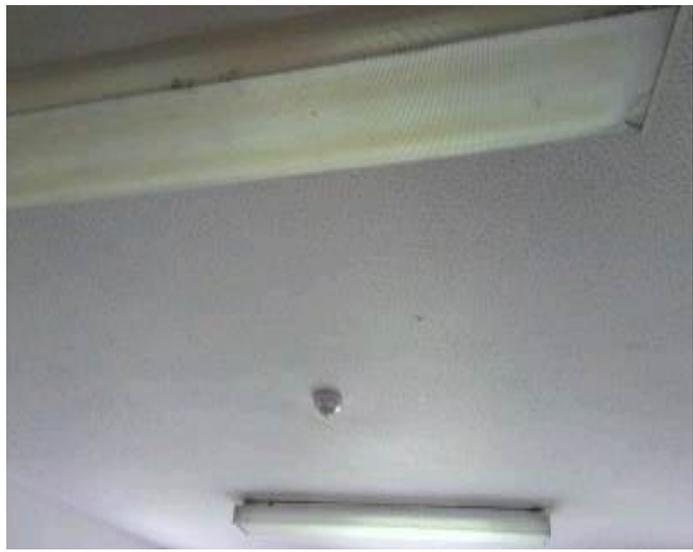
Location:	K2 Kitchen	Block:	Thames Building	Floor Level: Ground Floor
Item No.:	37	Sample No.:	178/945 {AT004176}

Item:	Textured coating to ceiling			
Asbestos Content:		Result Based on:		
No Asbestos Detected		Analysis of sample using PLM		
Sample Analysed By:	Refer to original report	Extent:	22 sq m	
Comments: Present to ceilings throughout, representative sampling conducted.

Material Assessment Total Score: 0		Likelihood of Disturbance Assessment Total Score: 0		Management Assessment Licensable: Not applicable Recommendations: Not Applicable Reinspection Interval: Not Applicable Overall Risk Category: E0
Product Type:	0 Not Applicable	Location:	0 Not Applicable	
Condition:	0 Not Applicable	Accessibility:	0 Not Applicable	
Surface Treatment:	0 Not Applicable			
Asbestos Type:	0 Not Applicable	Extent Score:	0 Not Applicable

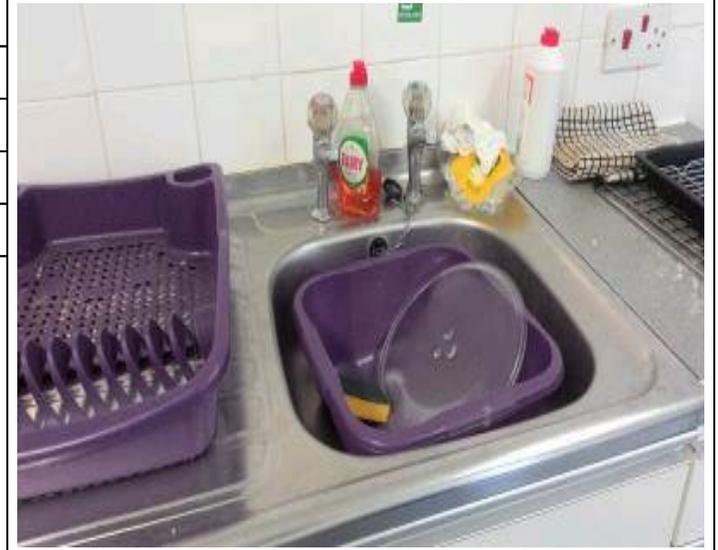
Location:	K2 Kitchen	Block:	Thames Building	Floor Level: Ground Floor
Item No.:	38	Sample No.:	178/946 {AT004177}	
Item:	Bitumen sink pad(s)			
Asbestos Content:		Result Based on:		
No Asbestos Detected		Analysis of sample using PLM		
Sample Analysed By:	Refer to original report	Extent:	<1 sq m	
Comments:

Material Assessment Total Score: 0		Likelihood of Disturbance Assessment Total Score: 0		Management Assessment Licensable: Not applicable Recommendations: Not Applicable Reinspection Interval: Not Applicable Overall Risk Category: E0
Product Type:	0 Not Applicable	Location:	0 Not Applicable	
Condition:	0 Not Applicable	Accessibility:	0 Not Applicable	
Surface Treatment:	0 Not Applicable			
Asbestos Type:	0 Not Applicable	Extent Score:	0 Not Applicable

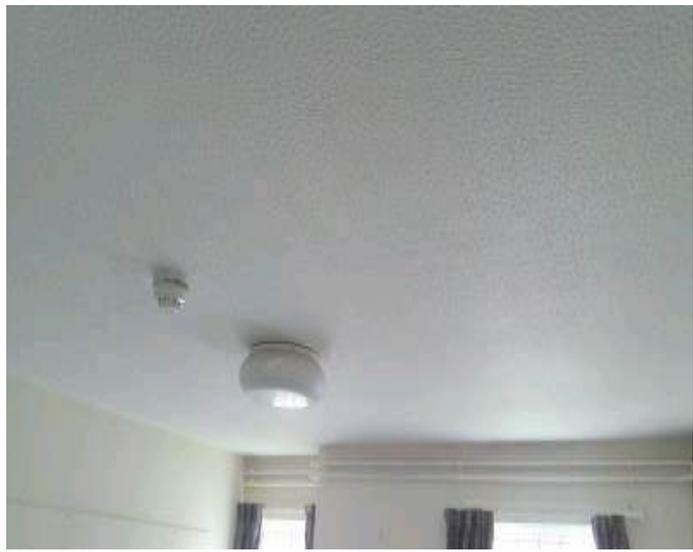
Location:	11 Bedroom	Block:	Thames Building	Floor Level: Ground Floor
Item No.:	39	Sample No.:	178/947 {AT004178}

Item:	Textured coating to ceiling			
Asbestos Content:		Result Based on:		
No Asbestos Detected		Analysis of sample using PLM		
Sample Analysed By:	Refer to original report	Extent:	15 sq m	
Comments: Present to ceilings throughout, representative sampling conducted.

Material Assessment Total Score: 0		Likelihood of Disturbance Assessment Total Score: 0		Management Assessment Licensable: Not applicable Recommendations: Not Applicable Reinspection Interval: Not Applicable Overall Risk Category: E0
Product Type:	0 Not Applicable	Location:	0 Not Applicable	
Condition:	0 Not Applicable	Accessibility:	0 Not Applicable	
Surface Treatment:	0 Not Applicable			
Asbestos Type:	0 Not Applicable	Extent Score:	0 Not Applicable

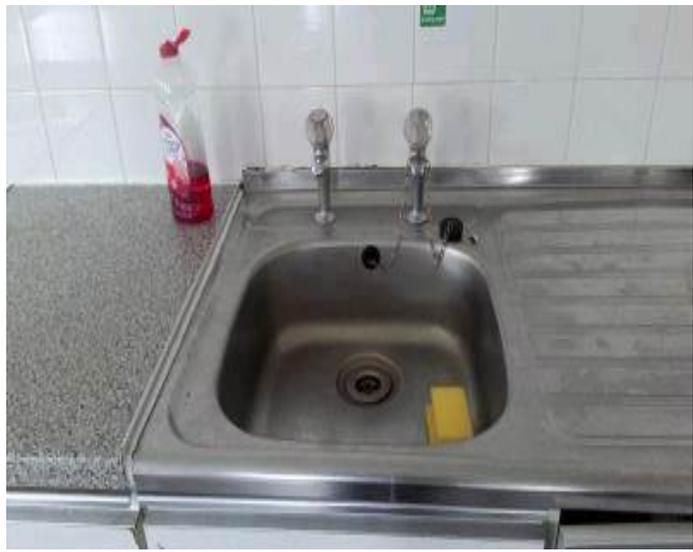
Location:	K3 Kitchen	Block:	Thames Building	Floor Level: Ground Floor
Item No.:	40	Sample No.:	178/948 {AT004179}

Item:	Bitumen sink pad(s)			
Asbestos Content:		Result Based on:		
No Asbestos Detected		Analysis of sample using PLM		
Sample Analysed By:	Refer to original report	Extent:	<1 sq m	
Comments:

Material Assessment Total Score: 0		Likelihood of Disturbance Assessment Total Score: 0		Management Assessment Licensable: Not applicable Recommendations: Not Applicable Reinspection Interval: Not Applicable Overall Risk Category: E0
Product Type:	0 Not Applicable	Location:	0 Not Applicable	
Condition:	0 Not Applicable	Accessibility:	0 Not Applicable	
Surface Treatment:	0 Not Applicable			
Asbestos Type:	0 Not Applicable	Extent Score:	0 Not Applicable
