Report No.: J042025

Nature of Work: Reinspection of Asbestos Containing Materials

University of Gloucestershire
The Park
Cheltenham
Gloucestershire
GL50 2RH

Hardwick Campus
St Pauls Road
Cheltenham
Gloucestershire
GL50 4BS

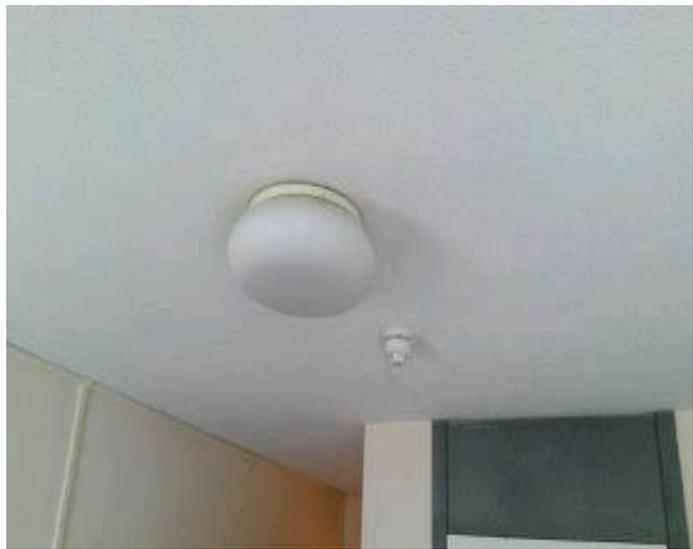
Location:	15 Bedroom	Block:	Thames Building	Floor Level: Ground Floor
Item No.:	41	Sample No.:	178/949 {AT004180}

Item:	Textured coating to ceiling			
Asbestos Content:		Result Based on:		
No Asbestos Detected		Analysis of sample using PLM		
Sample Analysed By:	Refer to original report	Extent:	20 sq m	
Comments: Present to ceilings throughout, representative sampling conducted.

Material Assessment Total Score: 0		Likelihood of Disturbance Assessment Total Score: 0		Management Assessment Licensable: Not applicable Recommendations: Not Applicable Reinspection Interval: Not Applicable Overall Risk Category: E0
Product Type:	0 Not Applicable	Location:	0 Not Applicable	
Condition:	0 Not Applicable	Accessibility:	0 Not Applicable	
Surface Treatment:	0 Not Applicable			
Asbestos Type:	0 Not Applicable	Extent Score:	0 Not Applicable

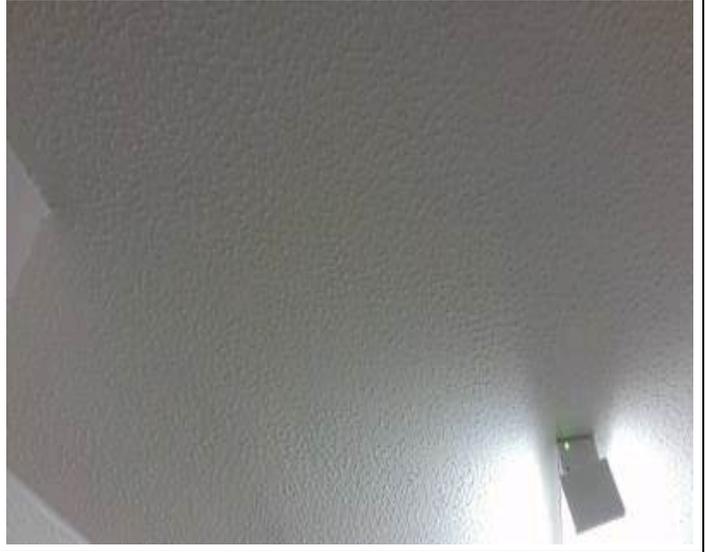
Location:	X165 Landing	Block:	Thames Building	Floor Level: 1st Floor
Item No.:	42	Sample No.:	178/950 {AT004181}

Item:	Textured coating to ceiling			
Asbestos Content:		Result Based on:		
No Asbestos Detected		Analysis of sample using PLM		
Sample Analysed By:	Refer to original report	Extent:	12 sq m	
Comments: Present to ceilings throughout, representative sampling conducted.

Material Assessment Total Score: 0		Likelihood of Disturbance Assessment Total Score: 0		Management Assessment Licensable: Not applicable Recommendations: Not Applicable Reinspection Interval: Not Applicable Overall Risk Category: E0
Product Type:	0 Not Applicable	Location:	0 Not Applicable	
Condition:	0 Not Applicable	Accessibility:	0 Not Applicable	
Surface Treatment:	0 Not Applicable			
Asbestos Type:	0 Not Applicable	Extent Score:	0 Not Applicable

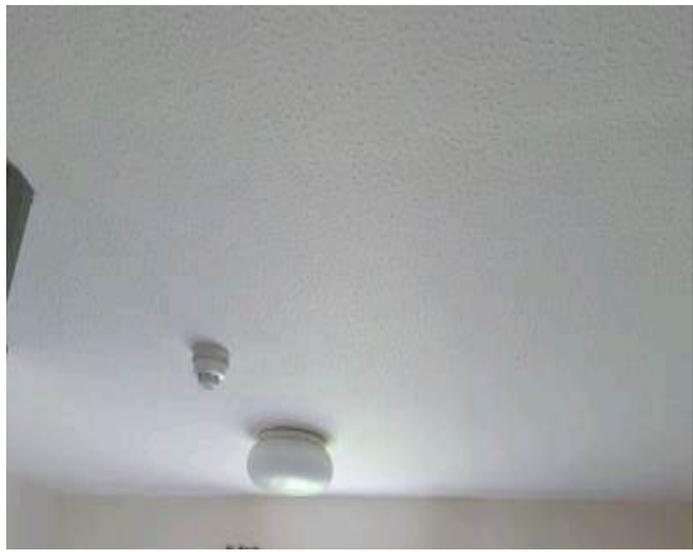
Location:	20 Bedroom	Block:	Thames Building	Floor Level: 1st Floor
Item No.:	43	Sample No.:	178/952 {AT004182}

Item:	Textured coating to ceiling			
Asbestos Content:		Result Based on:		
No Asbestos Detected		Analysis of sample using PLM		
Sample Analysed By:	Refer to original report	Extent:	15 sq m	
Comments: Present to ceilings throughout, representative sampling conducted.

Material Assessment Total Score: 0		Likelihood of Disturbance Assessment Total Score: 0		Management Assessment Licensable: Not applicable Recommendations: Not Applicable Reinspection Interval: Not Applicable Overall Risk Category: E0
Product Type:	0 Not Applicable	Location:	0 Not Applicable	
Condition:	0 Not Applicable	Accessibility:	0 Not Applicable	
Surface Treatment:	0 Not Applicable			
Asbestos Type:	0 Not Applicable	Extent Score:	0 Not Applicable

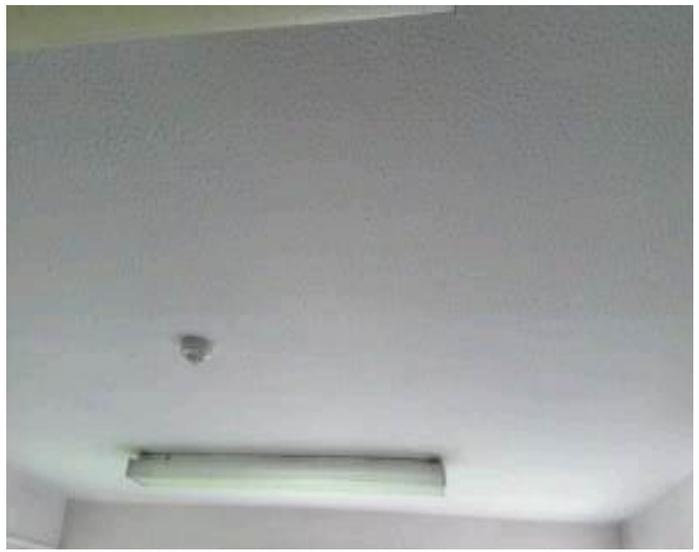
Location:	K5 Kitchen	Block:	Thames Building	Floor Level: 1st Floor
Item No.:	44	Sample No.:	178/953 {AT004183}

Item:	Textured coating to ceiling			
Asbestos Content:		Result Based on:		
No Asbestos Detected		Analysis of sample using PLM		
Sample Analysed By:	Refer to original report	Extent:	22 sq m	
Comments: Present to ceilings throughout, representative sampling conducted.

Material Assessment Total Score: 0		Likelihood of Disturbance Assessment Total Score: 0		Management Assessment Licensable: Not applicable Recommendations: Not Applicable Reinspection Interval: Not Applicable Overall Risk Category: E0
Product Type:	0 Not Applicable	Location:	0 Not Applicable	
Condition:	0 Not Applicable	Accessibility:	0 Not Applicable	
Surface Treatment:	0 Not Applicable			
Asbestos Type:	0 Not Applicable	Extent Score:	0 Not Applicable

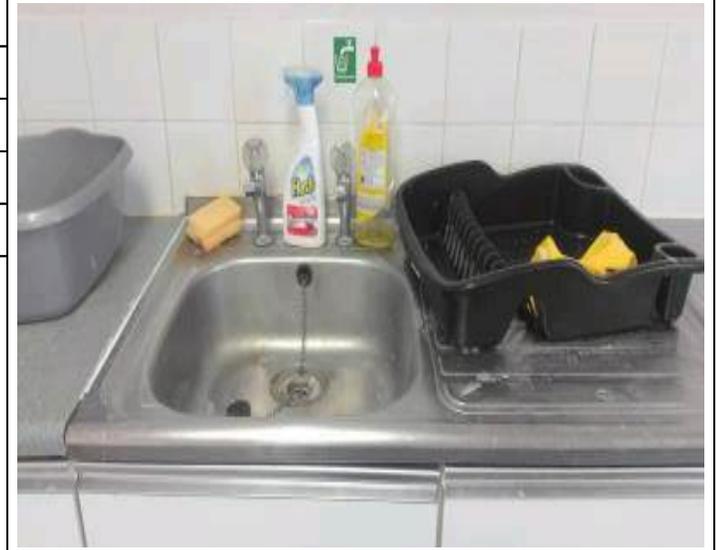
Location:	K4 Kitchen	Block:	Thames Building	Floor Level: 1st Floor
Item No.:	45	Sample No.:	178/951 {AT004184}	
Item:	Bitumen sink pad(s)			
Asbestos Content:		Result Based on:		
No Asbestos Detected		Analysis of sample using PLM		
Sample Analysed By:	Refer to original report	Extent:	<1 sq m	
Comments:

Material Assessment Total Score: 0		Likelihood of Disturbance Assessment Total Score: 0		Management Assessment Licensable: Not applicable Recommendations: Not Applicable Reinspection Interval: Not Applicable Overall Risk Category: E0
Product Type:	0 Not Applicable	Location:	0 Not Applicable	
Condition:	0 Not Applicable	Accessibility:	0 Not Applicable	
Surface Treatment:	0 Not Applicable			
Asbestos Type:	0 Not Applicable	Extent Score:	0 Not Applicable

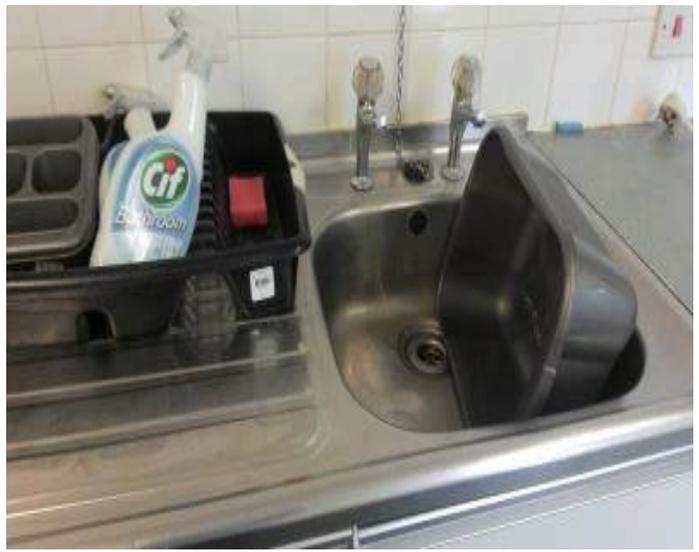
Location:	K5 Kitchen	Block:	Thames Building	Floor Level: 1st Floor
Item No.:	46	Sample No.:	178/954 {AT004185}

Item:	Bitumen sink pad(s)			
Asbestos Content:		Result Based on:		
No Asbestos Detected		Analysis of sample using PLM		
Sample Analysed By:	Refer to original report	Extent:	<1 sq m	
Comments:

Material Assessment Total Score: 0		Likelihood of Disturbance Assessment Total Score: 0		Management Assessment Licensable: Not applicable Recommendations: Not Applicable Reinspection Interval: Not Applicable Overall Risk Category: E0
Product Type:	0 Not Applicable	Location:	0 Not Applicable	
Condition:	0 Not Applicable	Accessibility:	0 Not Applicable	
Surface Treatment:	0 Not Applicable			
Asbestos Type:	0 Not Applicable	Extent Score:	0 Not Applicable

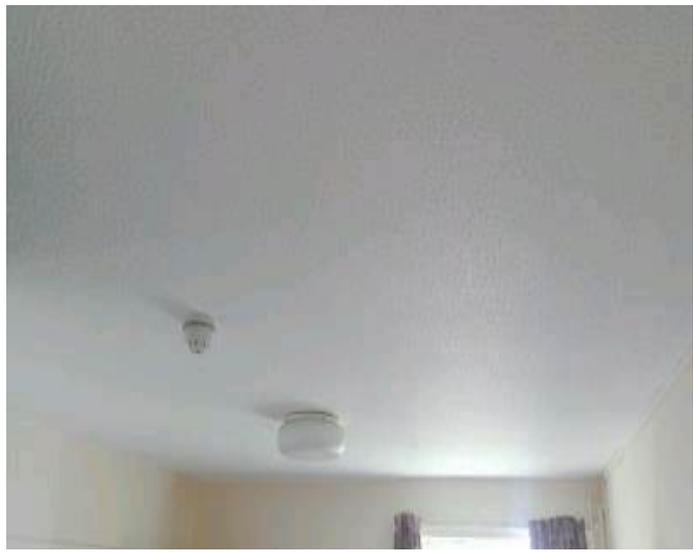
Location:	30 Bedroom	Block:	Thames Building	Floor Level: 1st Floor
Item No.:	47	Sample No.:	178/955 {AT004186}

Item:	Textured coating to ceiling			
Asbestos Content:		Result Based on:		
No Asbestos Detected		Analysis of sample using PLM		
Sample Analysed By:	Refer to original report	Extent:	15 sq m	
Comments: Present to ceilings throughout, representative sampling conducted.

Material Assessment Total Score: 0		Likelihood of Disturbance Assessment Total Score: 0		Management Assessment Licensable: Not applicable Recommendations: Not Applicable Reinspection Interval: Not Applicable Overall Risk Category: E0
Product Type:	0 Not Applicable	Location:	0 Not Applicable	
Condition:	0 Not Applicable	Accessibility:	0 Not Applicable	
Surface Treatment:	0 Not Applicable			
Asbestos Type:	0 Not Applicable	Extent Score:	0 Not Applicable

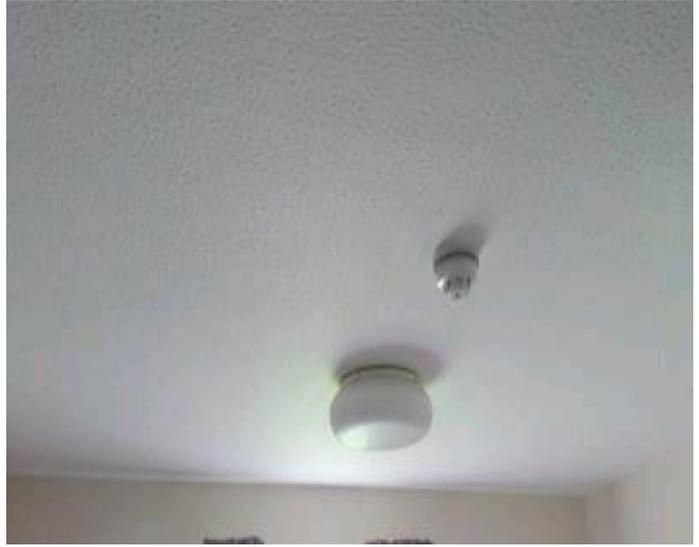
Location:	35 Bedroom	Block:	Thames Building	Floor Level: 1st Floor
Item No.:	48	Sample No.:	178/956 {AT004187}

Item:	Textured coating to ceiling			
Asbestos Content:		Result Based on:		
No Asbestos Detected		Analysis of sample using PLM		
Sample Analysed By:	Refer to original report	Extent:	15 sq m	
Comments: Present to ceilings throughout, representative sampling conducted.

Material Assessment Total Score: 0		Likelihood of Disturbance Assessment Total Score: 0		Management Assessment Licensable: Not applicable Recommendations: Not Applicable Reinspection Interval: Not Applicable Overall Risk Category: E0
Product Type:	0 Not Applicable	Location:	0 Not Applicable	
Condition:	0 Not Applicable	Accessibility:	0 Not Applicable	
Surface Treatment:	0 Not Applicable			
Asbestos Type:	0 Not Applicable	Extent Score:	0 Not Applicable

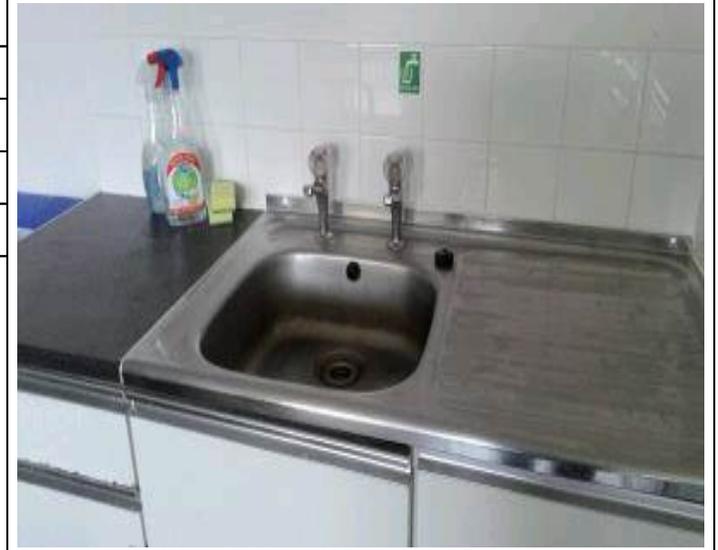
Location:	K6 Kitchen	Block:	Thames Building	Floor Level: 1st Floor
Item No.:	49	Sample No.:	178/957 {AT004188}	
Item:	Bitumen sink pad(s)			
Asbestos Content:		Result Based on:		
No Asbestos Detected		Analysis of sample using PLM		
Sample Analysed By:	Refer to original report	Extent:	<1 sq m	
Comments:

Material Assessment Total Score: 0		Likelihood of Disturbance Assessment Total Score: 0		Management Assessment Licensable: Not applicable Recommendations: Not Applicable Reinspection Interval: Not Applicable Overall Risk Category: E0
Product Type:	0 Not Applicable	Location:	0 Not Applicable	
Condition:	0 Not Applicable	Accessibility:	0 Not Applicable	
Surface Treatment:	0 Not Applicable			
Asbestos Type:	0 Not Applicable	Extent Score:	0 Not Applicable

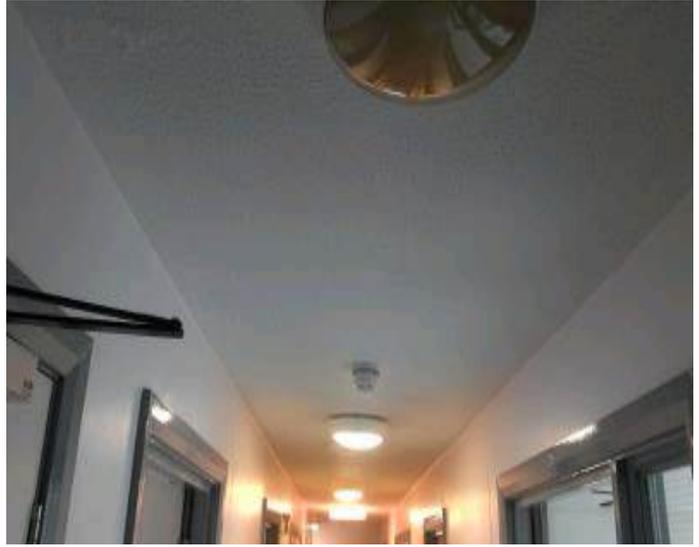
Location:	X184 Corridor	Block:	Thames Building	Floor Level: 2nd Floor
Item No.:	50	Sample No.:	178/958 {AT004189}

Item:	Textured coating to ceiling			
Asbestos Content:		Result Based on:		
No Asbestos Detected		Analysis of sample using PLM		
Sample Analysed By:	Refer to original report	Extent:	40 sq m	
Comments: Present to ceilings throughout, representative sampling conducted.

Material Assessment Total Score: 0		Likelihood of Disturbance Assessment Total Score: 0		Management Assessment Licensable: Not applicable Recommendations: Not Applicable Reinspection Interval: Not Applicable Overall Risk Category: E0
Product Type:	0 Not Applicable	Location:	0 Not Applicable	
Condition:	0 Not Applicable	Accessibility:	0 Not Applicable	
Surface Treatment:	0 Not Applicable			
Asbestos Type:	0 Not Applicable	Extent Score:	0 Not Applicable

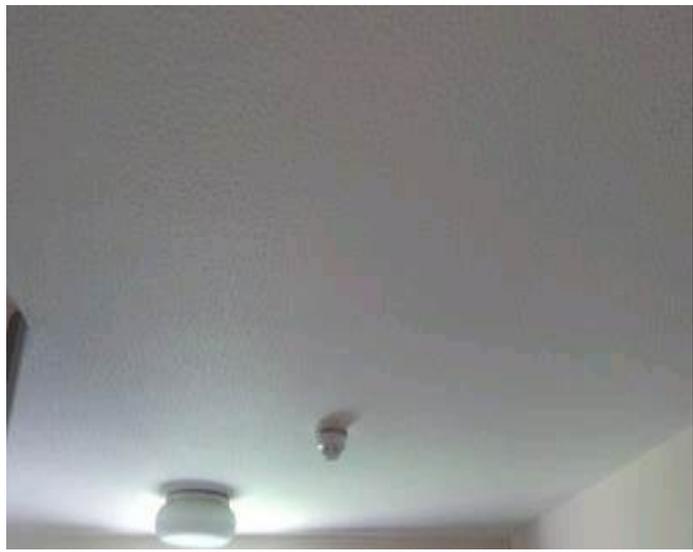
Location:	41 Bedroom	Block:	Thames Building	Floor Level: 2nd Floor
Item No.:	51	Sample No.:	178/959 {AT004190}

Item:	Textured coating to ceiling			
Asbestos Content:		Result Based on:		
No Asbestos Detected		Analysis of sample using PLM		
Sample Analysed By:	Refer to original report	Extent:	15 sq m	
Comments: Present to ceilings throughout, representative sampling conducted.

Material Assessment Total Score: 0		Likelihood of Disturbance Assessment Total Score: 0		Management Assessment Licensable: Not applicable Recommendations: Not Applicable Reinspection Interval: Not Applicable Overall Risk Category: E0
Product Type:	0 Not Applicable	Location:	0 Not Applicable	
Condition:	0 Not Applicable	Accessibility:	0 Not Applicable	
Surface Treatment:	0 Not Applicable			
Asbestos Type:	0 Not Applicable	Extent Score:	0 Not Applicable

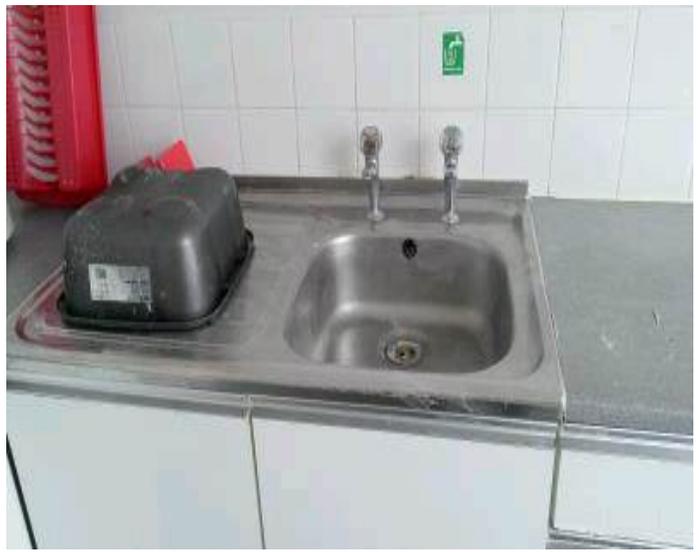
Location:	K7 Kitchen	Block:	Thames Building	Floor Level: 2nd Floor
Item No.:	52	Sample No.:	178/960 {AT004191}

Item:	Bitumen sink pad(s)			
Asbestos Content:		Result Based on:		
No Asbestos Detected		Analysis of sample using PLM		
Sample Analysed By:	Refer to original report	Extent:	<1 sq m	
Comments:

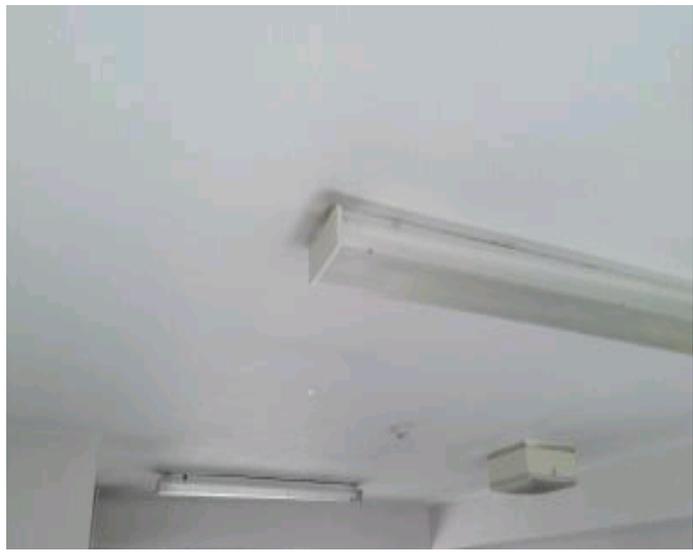
Location:	K8 Kitchen	Block:	Thames Building	Floor Level: 2nd Floor
Item No.:	53	Sample No.:	178/961 {AT004192}

Item:	Textured coating to ceiling			
Asbestos Content:		Result Based on:		
No Asbestos Detected		Analysis of sample using PLM		
Sample Analysed By:	Refer to original report	Extent:	35 sq m	
Comments: Present to ceilings throughout, representative sampling conducted.

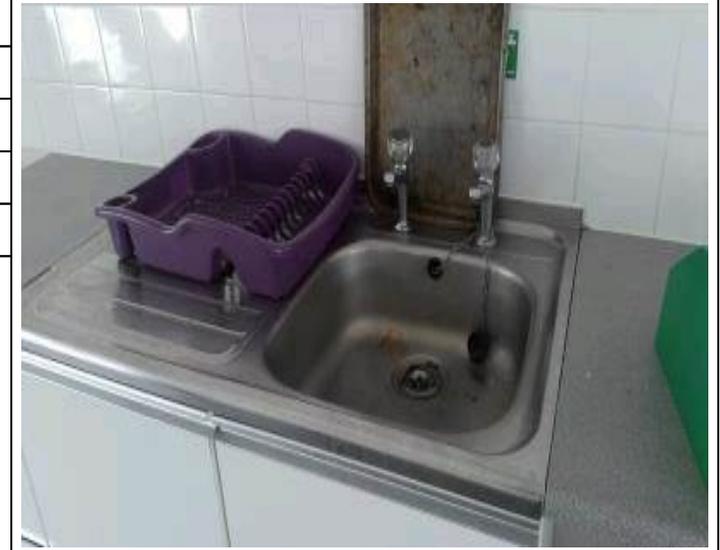
Location:	K8 Kitchen	Block:	Thames Building	Floor Level: 2nd Floor
Item No.:	54	Sample No.:	178/962 {AT004193}	
Item:	Bitumen sink pad(s)			
Asbestos Content:		Result Based on:		
No Asbestos Detected		Analysis of sample using PLM		
Sample Analysed By:	Refer to original report	Extent:	<1 sq m	
Comments:

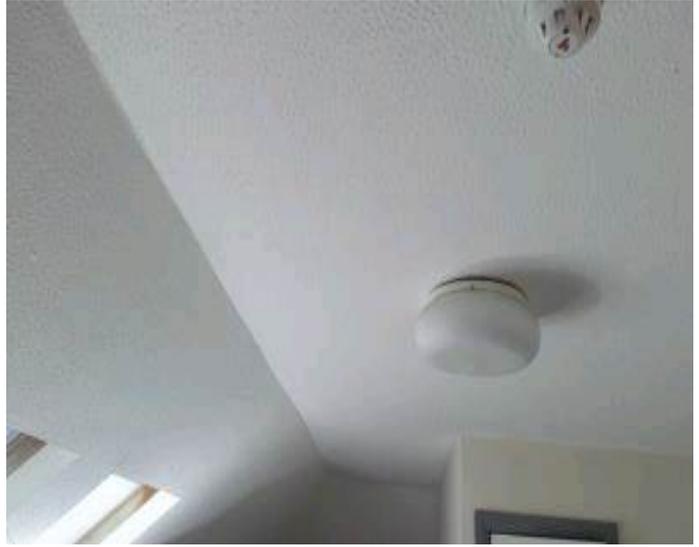
Location:	45 Bedroom	Block:	Thames Building	Floor Level: 2nd Floor
Item No.:	55	Sample No.:	178/963 {AT004194}

Item:	Textured coating to ceiling			
Asbestos Content:		Result Based on:		
No Asbestos Detected		Analysis of sample using PLM		
Sample Analysed By:	Refer to original report	Extent:	25 sq m	
Comments: Present to ceilings throughout, representative sampling conducted.

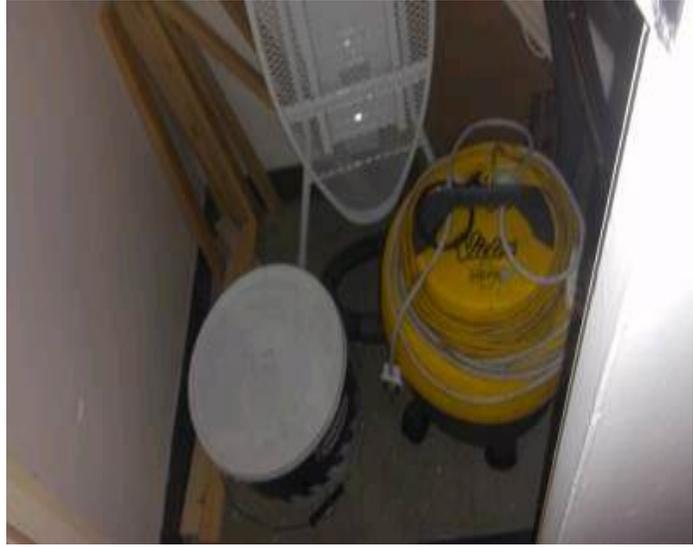
Location:	X012 Store	Block:	Maidenhorn Building	Floor Level: Ground Floor
Item No.:	57	Sample No.:	178/964 {AT004195}

Item:	Thermoplastic floor tiles			
Asbestos Content:		Result Based on:		
No Asbestos Detected		Analysis of sample using PLM		
Sample Analysed By:	Refer to original report	Extent:	1 sq m	
Comments: Item may be present throughout ground floor beneath fitted carpet or flooring.

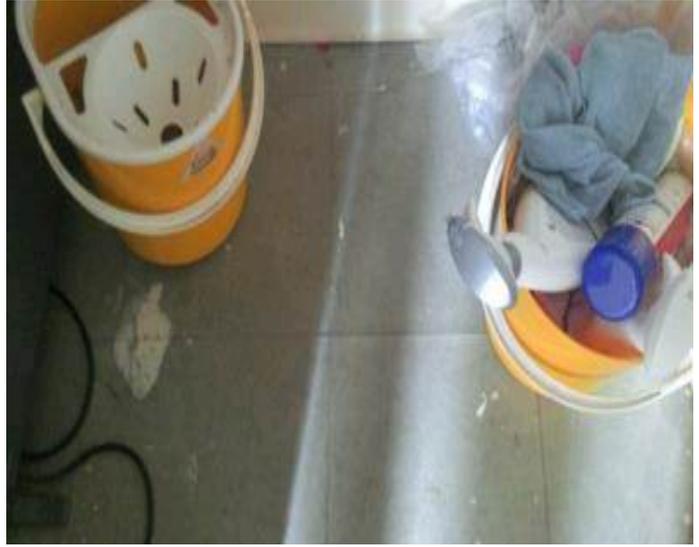
Location:	X024 Store	Block:	Maidenhorn Building	Floor Level: 1st Floor
Item No.:	58	Sample No.:	178/965 {AT004196}

Item:	Thermoplastic floor tiles			
Asbestos Content:		Result Based on:		
No Asbestos Detected		Analysis of sample using PLM		
Sample Analysed By:	Refer to original report	Extent:	1 sq m	
Comments: Item may be present throughout first floor beneath fitted carpet or flooring.

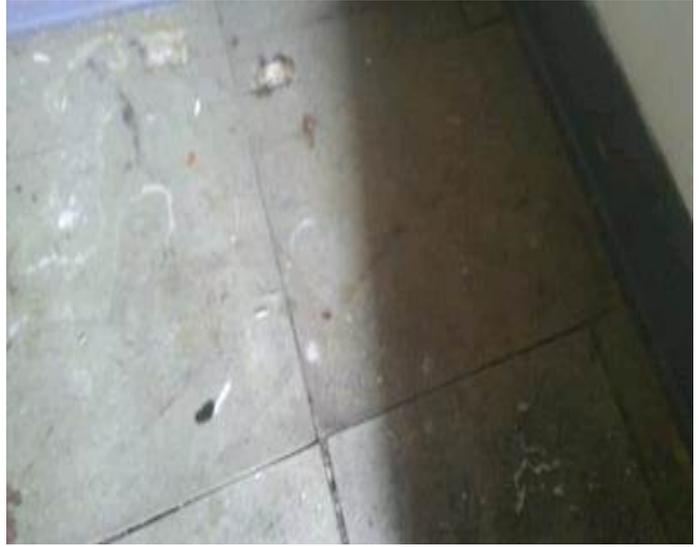
Location:	X035 Store	Block:	Maidenhorn Building	Floor Level: 2nd Floor
Item No.:	59	Sample No.:	178/966 {AT004197}

Item:	Thermoplastic floor tiles			
Asbestos Content:		Result Based on:		
No Asbestos Detected		Analysis of sample using PLM		
Sample Analysed By:	Refer to original report	Extent:	1 sq m	
Comments: Item may be present throughout second floor beneath fitted carpet or flooring.

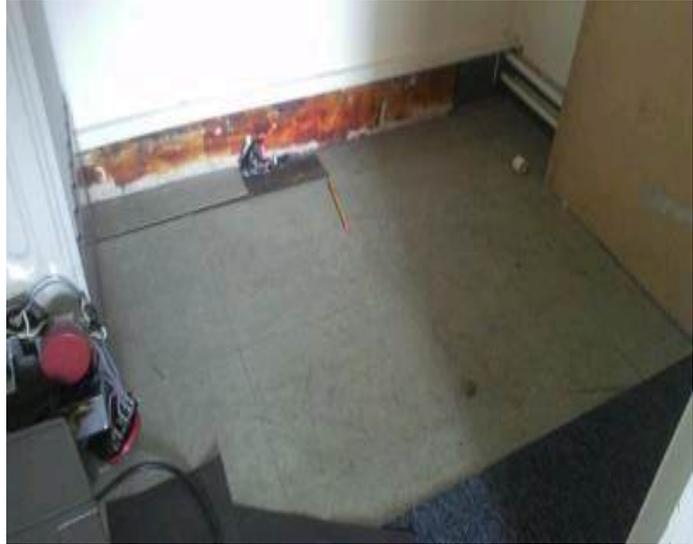
Location:	X036 Store	Block:	Maidenhorn Building	Floor Level: 2nd Floor
Item No.:	60	Sample No.:	As 178/966 {AT004197}

Item:	Thermoplastic floor tiles			
Asbestos Content:		Result Based on:		
No Asbestos Detected		Strongly presumed		
Sample Analysed By:	Not applicable	Extent:	1 sq m	
Comments: Item may be present throughout second floor beneath fitted carpet or flooring.

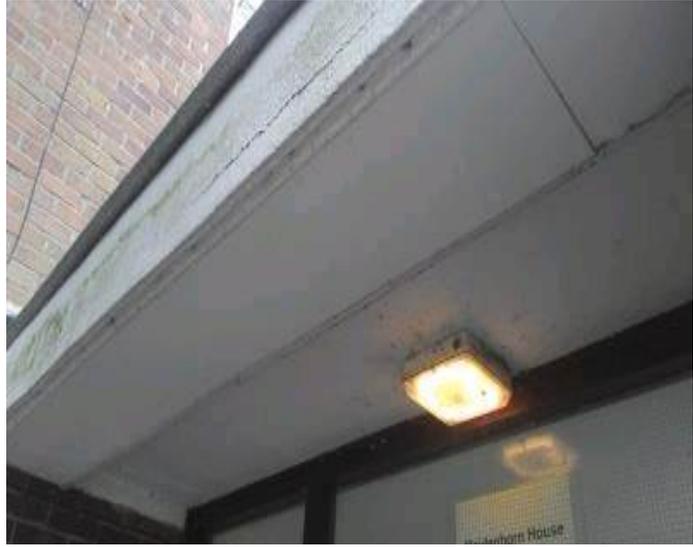
Location:	External	Block:	Maidenhorn Building	Floor Level: E - External
Item No.:	61	Sample No.:	178/967 {AT004199}

Item:	Insulating board soffit to canopy			
Asbestos Content:		Result Based on:		
No Asbestos Detected		Analysis of sample using PLM		
Sample Analysed By:	Refer to original report	Extent:	2 linear metres	
Comments:

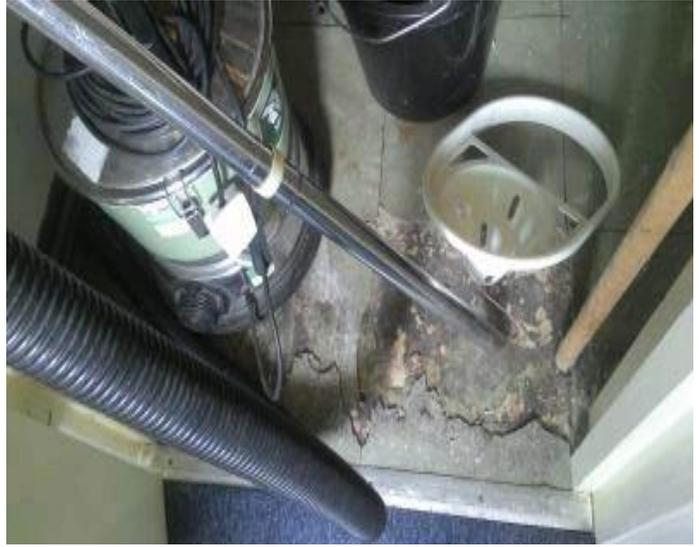
Location:	X011 Store	Block:	Maidenhorn Building	Floor Level:	Ground Floor
Item No.:	62	Sample No.:	As 178/964 {AT004195}

Item:	Thermoplastic floor tiles				
Asbestos Content:		Result Based on:			
No Asbestos Detected		Strongly presumed			
Sample Analysed By:	Not applicable	Extent:	1 sq m		
Comments: Item may be present throughout ground floor beneath fitted carpet or flooring.

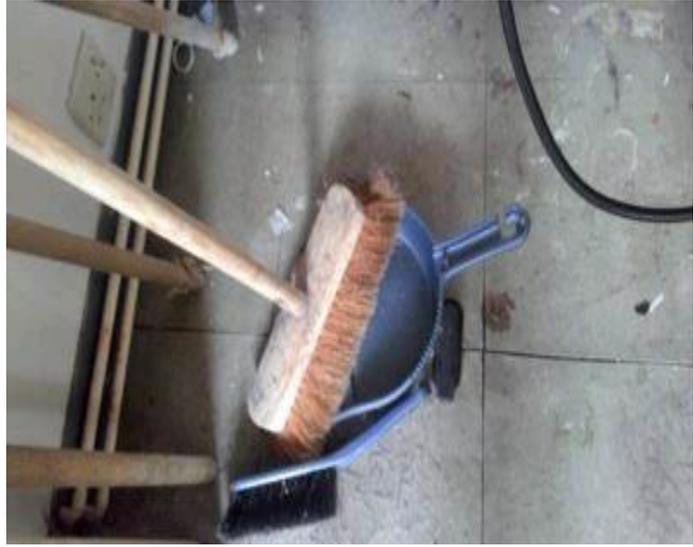
Location:	X023 Store	Block:	Maidenhorn Building	Floor Level: 1st Floor
Item No.:	63	Sample No.:	As 178/965 {AT004196}

Item:	Thermoplastic floor tiles			
Asbestos Content:		Result Based on:		
No Asbestos Detected		Strongly presumed		
Sample Analysed By:	Not applicable	Extent:	1 sq m	
Comments: Item may be present throughout first floor beneath fitted carpet or flooring.

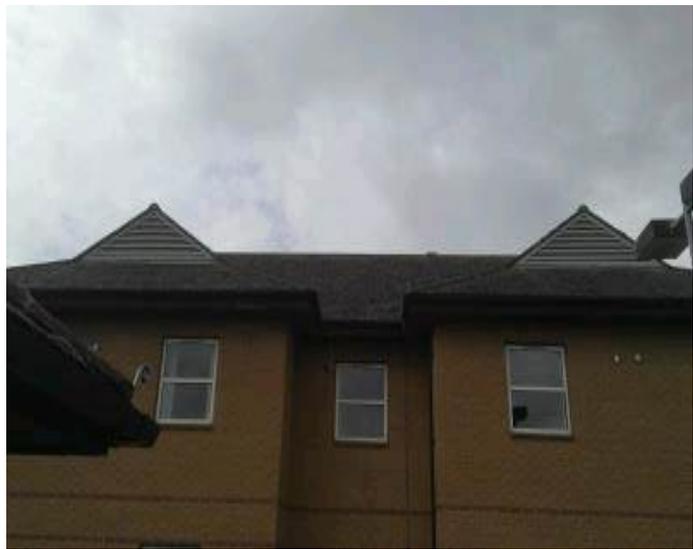
Location:	External	Block:	Severn Building	Floor Level: E - External
Item No.:	65	Sample No.:	No sample - presumed

Item:	Asbestos Cement undercloaking			
Asbestos Content:		Result Based on:		
Crocidolite		Presumed		
Sample Analysed By:	Not applicable	Extent:	4 linear metres	
Comments: Asbestos content presumed as no safe access was available to sample the material.

Material Assessment Total Score: 5		Likelihood of Disturbance Assessment Total Score: 1		Management Assessment Licensable: No Recommendations: Monitor condition Reinspection Interval: 12 Months Overall Risk Category: D6
Product Type:	1 (Asbestos Cement)	Location:	0 (Outdoors)	
Condition:	0 (Perfect)	Accessibility:	0 (Usually inaccessible or unlikely to be disturbed)	
Surface Treatment:	1 (Unencapsulated asbestos cement)			
Asbestos Type:	3 (Crocidolite)	Extent Score:	1 (<10 sq m or 10m pipe run)

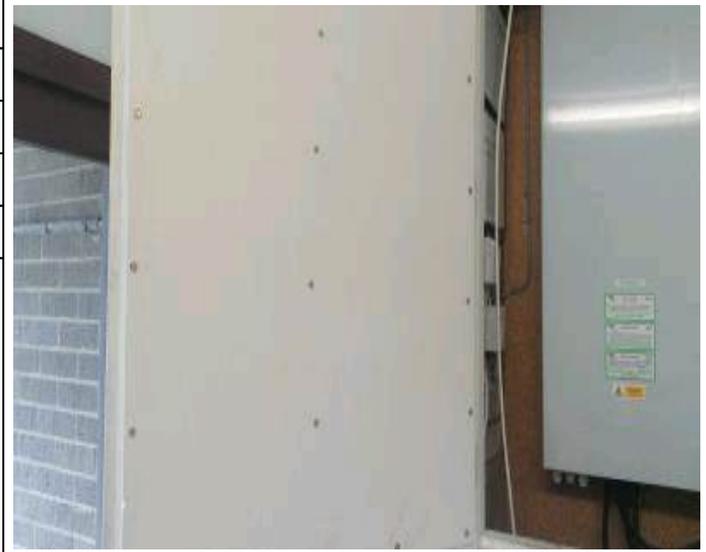
Location:	X002 Electrical Cupboard	Block:	Administration Centre	Floor Level: Ground Floor
Item No.:	66	Sample No.:	178/969 {AT004202}

Item:	Insulating board cladding to doors			
Asbestos Content:		Result Based on:		
No Asbestos Detected		Analysis of sample using PLM		
Sample Analysed By:	Refer to original report	Extent:	4 sq m	
Comments: Previously item 067 in J016666.

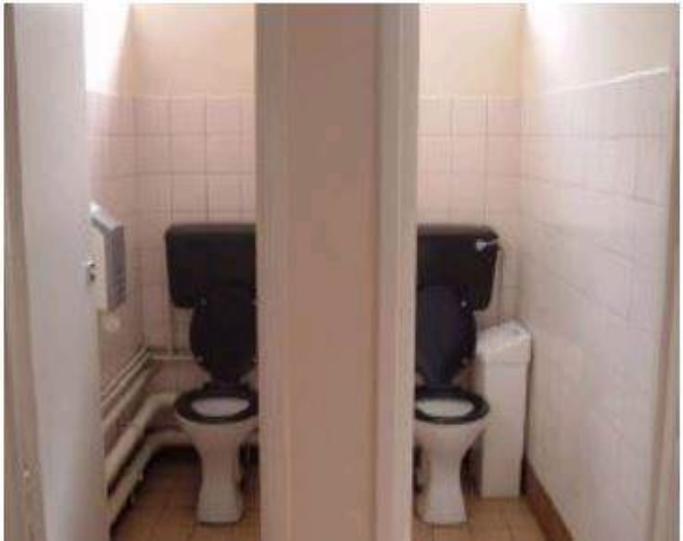
Location:	TC003 W.C.	Block:	Administration Centre	Floor Level: Ground Floor
Item No.:	68	Sample No.:	178/970 {AT004203}

Item:	Reinforced plastic toilet cisterns			
Asbestos Content:		Result Based on:		
No Asbestos Detected		Analysis of sample using PLM		
Sample Analysed By:	Refer to original report	Extent:	2 units	
Comments: Previously item 069 in J016666.

Removed

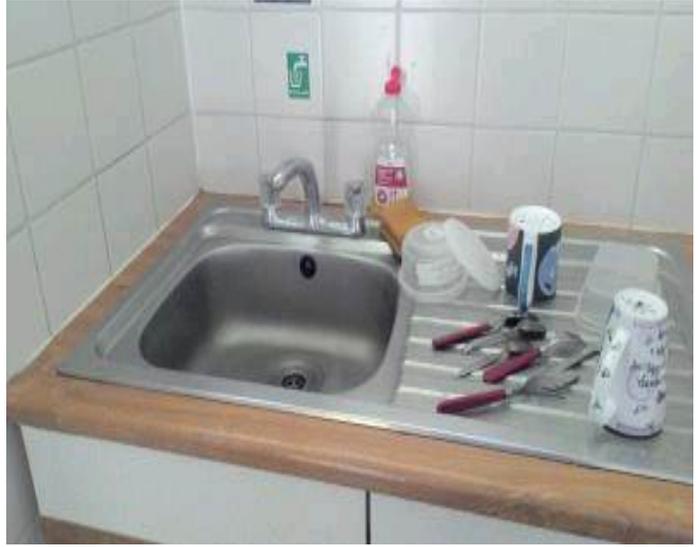
Location:	HA007 Kitchen	Block:	Administration Centre	Floor Level: Ground Floor
Item No.:	69	Sample No.:	178/971 {AT004204}

Item:	Bitumen sink pad(s)			
Asbestos Content:		Result Based on:		
No Asbestos Detected		Analysis of sample using PLM		
Sample Analysed By:	Refer to original report	Extent:	<1 sq m	
Comments: Previously item 071 in J016666.

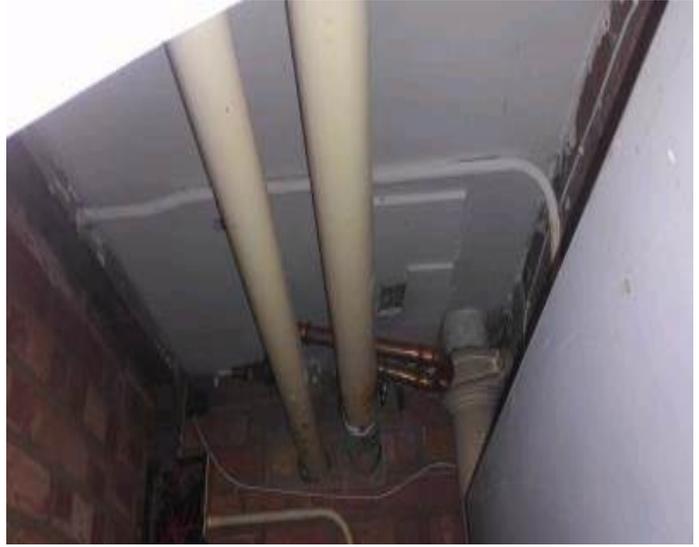
Location:	HA011a Cupboard	Block:	Administration Centre	Floor Level: Ground Floor
Item No.:	70	Sample No.:	178/972 {AT004205}

Item:	Insulating board ceiling panel			
Asbestos Content:		Result Based on:		
No Asbestos Detected		Analysis of sample using PLM		
Sample Analysed By:	Refer to original report	Extent:	<1 sq m	
Comments: Previously item 072 in J016666.

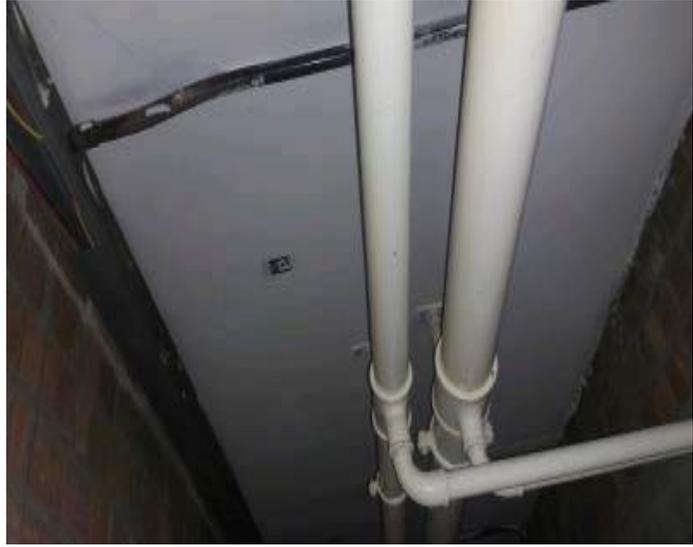
Location:	HA011b Cupboard	Block:	Administration Centre	Floor Level: Ground Floor
Item No.:	72	Sample No.:	As 178/973 {AT004213}

Item:	Asbestos Insulating board ceiling panels			
Asbestos Content:			Result Based on:	
Amosite		Strongly presumed		
Sample Analysed By:	Not applicable	Extent:	3 sq m	
Comments: Previously item 074 in J016666. Labelled up.

Material Assessment Total Score: 5		Likelihood of Disturbance Assessment Total Score: 4		Management Assessment Licensable: Not applicable Recommendations: Monitor condition Reinspection Interval: 12 Months Overall Risk Category: C9
Product Type:	2 (Asbestos insulating board)	Location:	2 (Rooms up to 100 sq m)	
Condition:	0 (Perfect)	Accessibility:	1 (Occasionally likely to be disturbed)	
Surface Treatment:	1 (Encapsulated asbestos insulating board)			
Asbestos Type:	2 (Amosite)	Extent Score:	1 (<10 sq m or 10m pipe run)

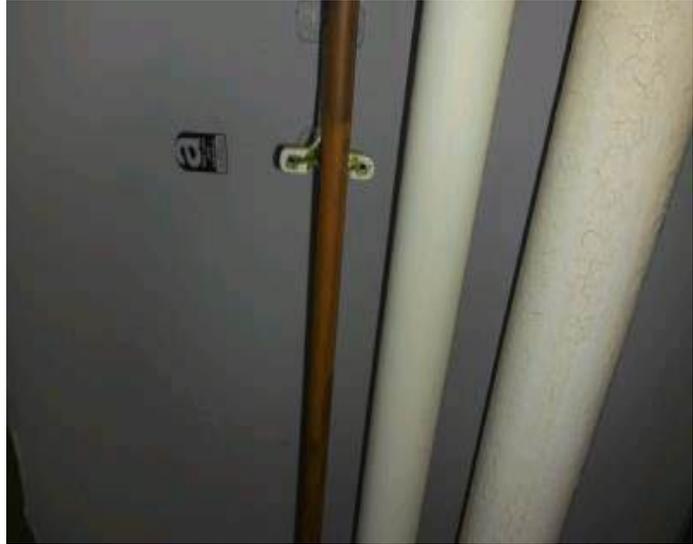
Location:	HA020b Cupboard	Block:	Administration Centre	Floor Level: Ground Floor
Item No.:	76	Sample No.:	As 178/974 {AT004209}

Item:	Asbestos Insulating board ceiling panels			
Asbestos Content:		Result Based on:		
Chrysotile Amosite		Strongly presumed		
Sample Analysed By:	Not applicable	Extent:	3 sq m	
Comments: Previously item 078 in J016666. Labelled up.

Material Assessment Total Score: 5		Likelihood of Disturbance Assessment Total Score: 4		Management Assessment Licensable: Yes Recommendations: Monitor condition Reinspection Interval: 12 Months Overall Risk Category: C9
Product Type:	2 (Asbestos insulating board)	Location:	2 (Rooms up to 100 sq m)	
Condition:	0 (Perfect)	Accessibility:	1 (Occasionally likely to be disturbed)	
Surface Treatment:	1 (Encapsulated asbestos insulating board)			
Asbestos Type:	2 (Chrysotile Amosite)	Extent Score:	1 (<10 sq m or 10m pipe run)	
Management Detail

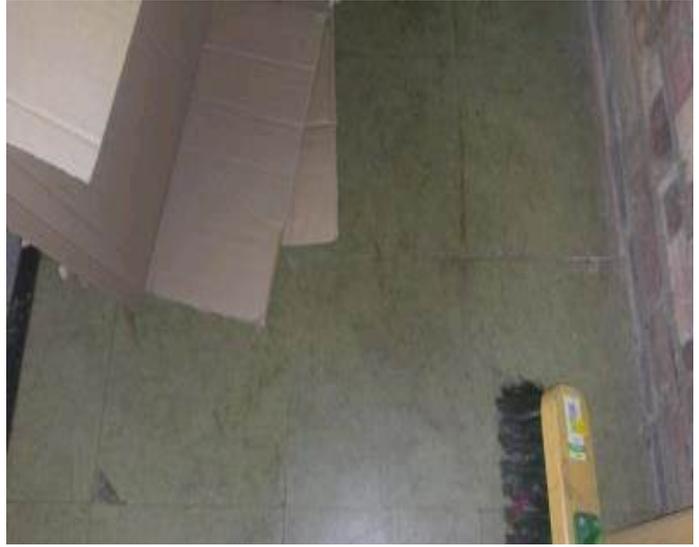
Location:	HA020b Cupboard	Block:	Administration Centre	Floor Level: Ground Floor
Item No.:	77	Sample No.:	178/976 {AT004212}

Item:	Thermoplastic floor tiles			
Asbestos Content:		Result Based on:		
No Asbestos Detected		Analysis of sample using PLM		
Sample Analysed By:	Refer to original report	Extent:	3 sq m	
Comments: Previously item 079 in J016666.

Material Assessment Total Score: 0		Likelihood of Disturbance Assessment Total Score: 0		Management Assessment Licensable: Not applicable Recommendations: Not Applicable Reinspection Interval: Not Applicable Overall Risk Category: E0
Product Type:	0 Not Applicable	Location:	0 Not Applicable	
Condition:	0 Not Applicable	Accessibility:	0 Not Applicable	
Surface Treatment:	0 Not Applicable			
Asbestos Type:	0 Not Applicable	Extent Score:	0 Not Applicable	
Management Detail

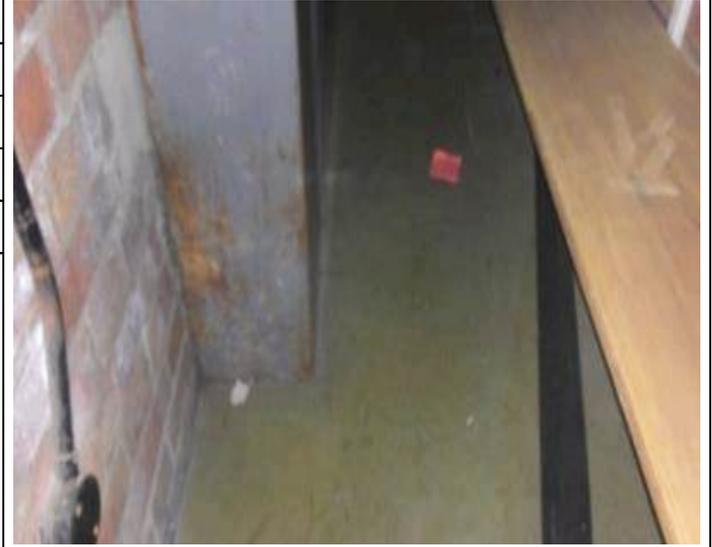
Location:	HA020a Cupboard	Block:	Administration Centre	Floor Level: Ground Floor
Item No.:	79	Sample No.:	As 178/976 {AT004218}

Item:	Thermoplastic floor tiles			
Asbestos Content:		Result Based on:		
N/A		Strongly presumed		
Sample Analysed By:	Not applicable	Extent:	3 sq m	
Comments: Previously item 081 in J016666.

Material Assessment Total Score: 0		Likelihood of Disturbance Assessment Total Score: 0		Management Assessment Licensable: Not applicable Recommendations: Not Applicable Reinspection Interval: Not Applicable Overall Risk Category: E0
Product Type:	0 Not Applicable	Location:	0 Not Applicable	
Condition:	0 Not Applicable	Accessibility:	0 Not Applicable	
Surface Treatment:	0 Not Applicable			
Asbestos Type:	0 Not Applicable	Extent Score:	0 Not Applicable	
Management Detail

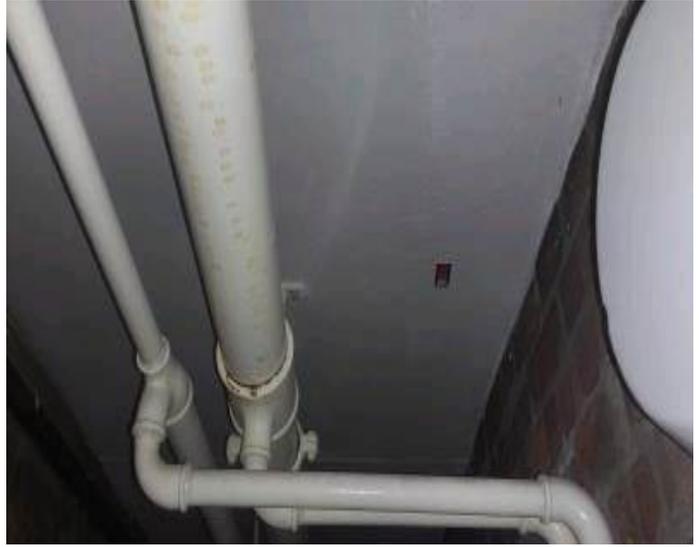
Location:	HA012a Cupboard	Block:	Administration Centre	Floor Level: Ground Floor
Item No.:	80	Sample No.:	178/977 {AT004215}

Item:	Asbestos Insulating board ceiling panels			
Asbestos Content:		Result Based on:		
Chrysotile Amosite		Analysis of sample using PLM		
Sample Analysed By:	Refer to original report	Extent:	3 sq m	
Comments: Previously item 082 in J016666. Labelled up.

Material Assessment Total Score: 5		Likelihood of Disturbance Assessment Total Score: 4		Management Assessment Licensable: Yes Recommendations: Monitor condition Reinspection Interval: 12 Months Overall Risk Category: C9
Product Type:	2 (Asbestos insulating board)	Location:	2 (Rooms up to 100 sq m)	
Condition:	0 (Perfect)	Accessibility:	1 (Occasionally likely to be disturbed)	
Surface Treatment:	1 (Encapsulated asbestos insulating board)			
Asbestos Type:	2 (Chrysotile Amosite)	Extent Score:	1 (<10 sq m or 10m pipe run)	
Management Detail

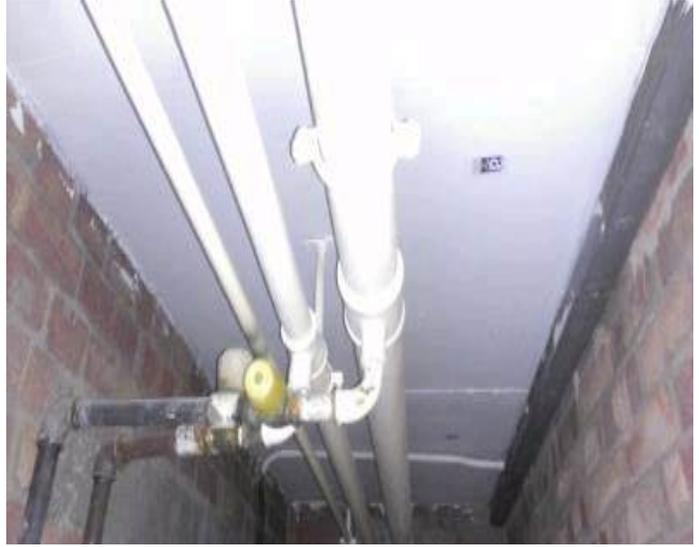
Location:	HA019a Cupboard	Block:	Administration Centre	Floor Level: Ground Floor
Item No.:	81	Sample No.:	As 178/977 {AT004215}

Item:	Asbestos Insulating board ceiling panels			
Asbestos Content:		Result Based on:		
Chrysotile Amosite		Strongly presumed		
Sample Analysed By:	Not applicable	Extent:	3 sq m	
Comments: Previously item 083 in J016666. Labelled up.

Material Assessment Total Score: 5		Likelihood of Disturbance Assessment Total Score: 4		Management Assessment Licensable: Yes Recommendations: Monitor condition Reinspection Interval: 12 Months Overall Risk Category: C9
Product Type:	2 (Asbestos insulating board)	Location:	2 (Rooms up to 100 sq m)	
Condition:	0 (Perfect)	Accessibility:	1 (Occasionally likely to be disturbed)	
Surface Treatment:	1 (Encapsulated asbestos insulating board)			
Asbestos Type:	2 (Chrysotile Amosite)	Extent Score:	1 (<10 sq m or 10m pipe run)

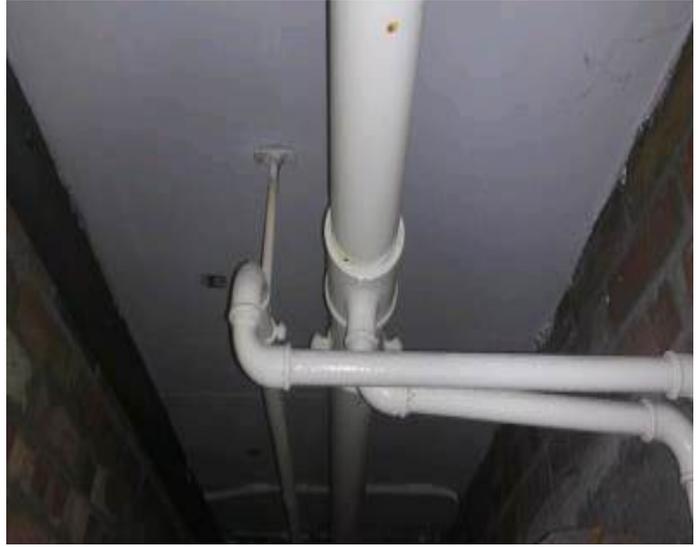
Location:	HA013a Cupboard	Block:	Administration Centre	Floor Level: Ground Floor
Item No.:	82	Sample No.:	As 178/977 {AT004215}

Item:	Asbestos Insulating board ceiling panels			
Asbestos Content:		Result Based on:		
Chrysotile Amosite		Strongly presumed		
Sample Analysed By:	Not applicable	Extent:	3 sq m	
Comments: Previously item 084 in J016666. Labelled up.

Material Assessment Total Score: 5		Likelihood of Disturbance Assessment Total Score: 4		Management Assessment Licensable: Yes Recommendations: Monitor condition Reinspection Interval: 12 Months Overall Risk Category: C9
Product Type:	2 (Asbestos insulating board)	Location:	2 (Rooms up to 100 sq m)	
Condition:	0 (Perfect)	Accessibility:	1 (Occasionally likely to be disturbed)	
Surface Treatment:	1 (Encapsulated asbestos insulating board)			
Asbestos Type:	2 (Chrysotile Amosite)	Extent Score:	1 (<10 sq m or 10m pipe run)

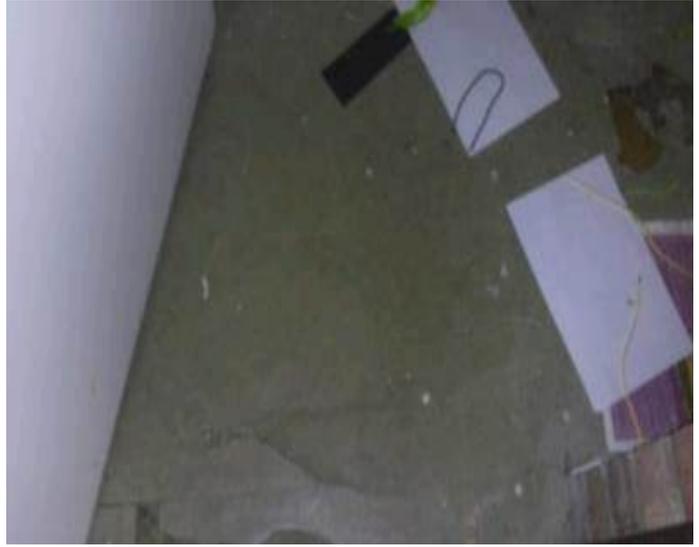
Location:	HA013a Cupboard	Block:	Administration Centre	Floor Level: Ground Floor
Item No.:	83	Sample No.:	As 178/976 {AT004212}

Item:	Thermoplastic floor tiles			
Asbestos Content:		Result Based on:		
No Asbestos Detected		Strongly presumed		
Sample Analysed By:	Not applicable	Extent:	3 sq m	
Comments: Previously item 085 in J016666.

Material Assessment Total Score: 0		Likelihood of Disturbance Assessment Total Score: 0		Management Assessment Licensable: Not applicable Recommendations: Not Applicable Reinspection Interval: Not Applicable Overall Risk Category: E0
Product Type:	0 Not Applicable	Location:	0 Not Applicable	
Condition:	0 Not Applicable	Accessibility:	0 Not Applicable	
Surface Treatment:	0 Not Applicable			
Asbestos Type:	0 Not Applicable	Extent Score:	0 Not Applicable

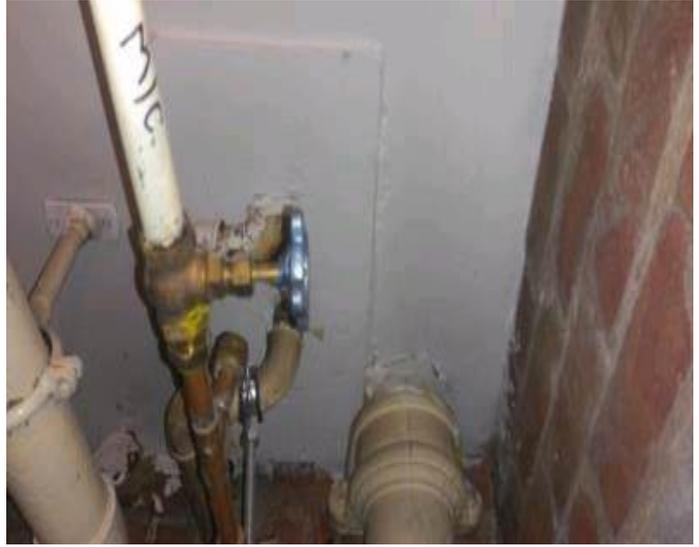
Location:	HA018a Cupboard	Block:	Administration Centre	Floor Level: Ground Floor
Item No.:	84	Sample No.:	As 178/972 {AT004205}

Item:	Insulating board ceiling panel			
Asbestos Content:		Result Based on:		
No Asbestos Detected		Strongly presumed		
Sample Analysed By:	Not applicable	Extent:	<1 sq m	
Comments: Previously item 086 in J016666.

Material Assessment Total Score: 0		Likelihood of Disturbance Assessment Total Score: 0		Management Assessment Licensable: Not applicable Recommendations: Not Applicable Reinspection Interval: Not Applicable Overall Risk Category: E0
Product Type:	0 Not Applicable	Location:	0 Not Applicable	
Condition:	0 Not Applicable	Accessibility:	0 Not Applicable	
Surface Treatment:	0 Not Applicable			
Asbestos Type:	0 Not Applicable	Extent Score:	0 Not Applicable

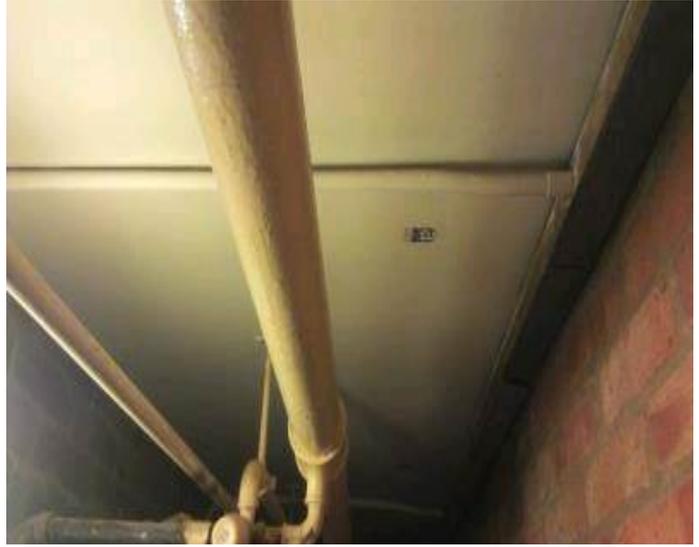
Location:	HA018a Cupboard	Block:	Administration Centre	Floor Level: Ground Floor
Item No.:	85	Sample No.:	As 178/977 {AT004215}

Item:	Asbestos Insulating board ceiling panels			
Asbestos Content:	Result Based on:			
Chrysotile Amosite	Strongly presumed			
Sample Analysed By:	Not applicable	Extent:	3 sq m	
Comments: Previously item 087 in J016666. Labelled up.

Material Assessment Total Score: 5		Likelihood of Disturbance Assessment Total Score: 4		Management Assessment Licensable: Yes Recommendations: Monitor condition Reinspection Interval: 12 Months Overall Risk Category: C9
Product Type:	2 (Asbestos insulating board)	Location:	2 (Rooms up to 100 sq m)	
Condition:	0 (Perfect)	Accessibility:	1 (Occasionally likely to be disturbed)	
Surface Treatment:	1 (Encapsulated asbestos insulating board)			
Asbestos Type:	2 (Chrysotile Amosite)	Extent Score:	1 (<10 sq m or 10m pipe run)

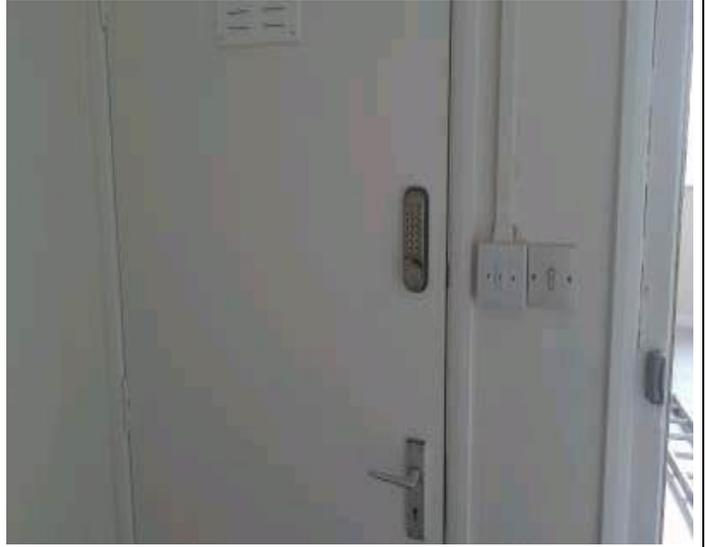
Location:	X003 Store	Block:	Maidenhorn Building	Floor Level: Ground Floor
Item No.:	86	Sample No.:	178/979 {AT004221}

Item:	Thermoplastic floor tiles			
Asbestos Content:		Result Based on:		
No Asbestos Detected		Analysis of sample using PLM		
Sample Analysed By:	Refer to original report	Extent:	3 sq m	
Comments: Previously item 090 in J016666. Presume item remains in situ as unable to gain access despite using all codes available from the security being attempted.

Material Assessment Total Score: 0		Likelihood of Disturbance Assessment Total Score: 0		Management Assessment Licensable: Not applicable Recommendations: Not Applicable Reinspection Interval: Not Applicable Overall Risk Category: E0
Product Type:	0 Not Applicable	Location:	0 Not Applicable	
Condition:	0 Not Applicable	Accessibility:	0 Not Applicable	
Surface Treatment:	0 Not Applicable			
Asbestos Type:	0 Not Applicable	Extent Score:	0 Not Applicable

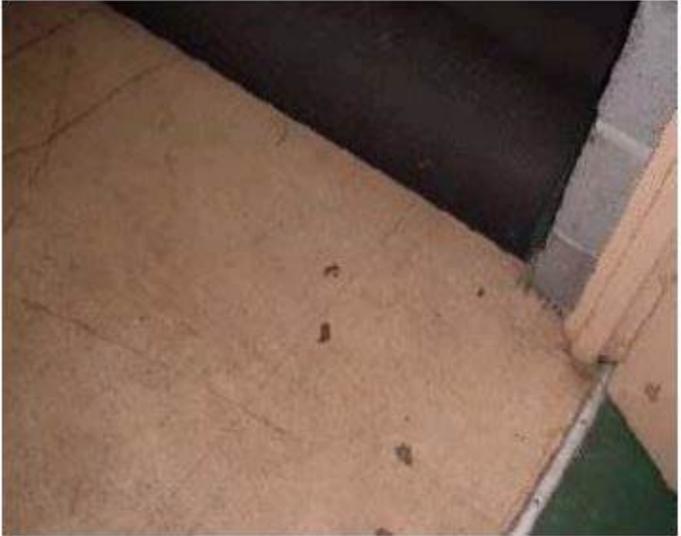
Location:	X013 Sports Hall Store	Block:	Sports Centre	Floor Level: Ground Floor
Item No.:	87	Sample No.:	178/980 {AT004222}

Item:	Thermoplastic floor tiles			
Asbestos Content:		Result Based on:		
No Asbestos Detected		Analysis of sample using PLM		
Sample Analysed By:	Refer to original report	Extent:	35 sq m	
Comments: Previously item 091 in J016666.

Removed

Material Assessment Total Score: 0		Likelihood of Disturbance Assessment Total Score: 0		Management Assessment Licensable: Not applicable Recommendations: Not Applicable Reinspection Interval: Not Applicable Overall Risk Category: E0
Product Type:	0 Not Applicable	Location:	0 Not Applicable	
Condition:	0 Not Applicable	Accessibility:	0 Not Applicable	
Surface Treatment:	0 Not Applicable			
Asbestos Type:	0 Not Applicable	Extent Score:	0 Not Applicable	
Management Detail
