Report No.: J042025

Nature of Work: Reinspection of Asbestos Containing Materials

University of Gloucestershire
The Park
Cheltenham
Gloucestershire
GL50 2RH

Hardwick Campus
St Pauls Road
Cheltenham
Gloucestershire
GL50 4BS

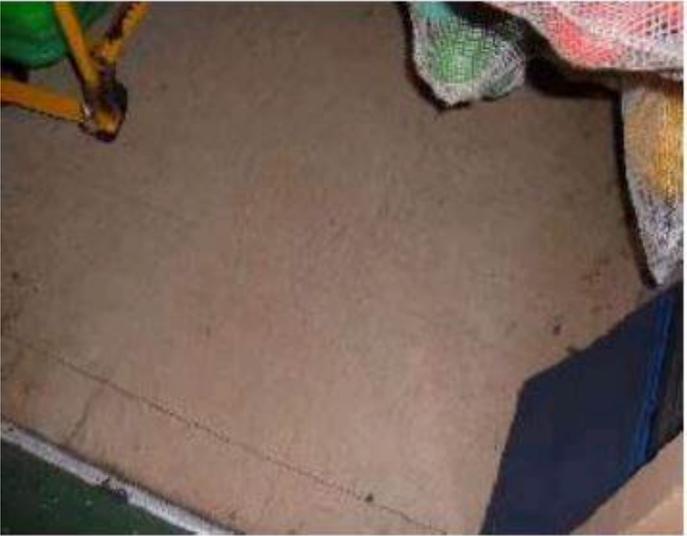
Location:	SP027 Equipment Store	Block:	Sports Centre	Floor Level: Ground Floor
Item No.:	88	Sample No.:	178/980 {AT004223}

Item:	Thermoplastic floor tiles			
Asbestos Content:		Result Based on:		
No Asbestos Detected		Analysis of sample using PLM		
Sample Analysed By:	Refer to original report	Extent:	7 sq m	
Comments: Previously item 092 in J016666.				
Removed

Material Assessment Total Score: 0		Likelihood of Disturbance Assessment Total Score: 0		Management Assessment Licensable: Not applicable Recommendations: Not Applicable Reinspection Interval: Not Applicable Overall Risk Category: E0
Product Type:	0 Not Applicable	Location:	0 Not Applicable	
Condition:	0 Not Applicable	Accessibility:	0 Not Applicable	
Surface Treatment:	0 Not Applicable			
Asbestos Type:	0 Not Applicable	Extent Score:	0 Not Applicable

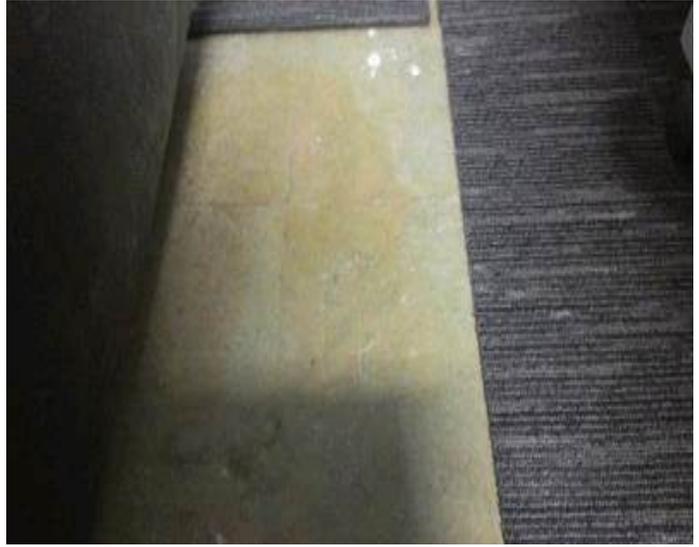
Location:	HA016 Server Room	Block:	Administration Centre	Floor Level: Ground Floor
Item No.:	89	Sample No.:	178/981 {AT004224}

Item:	Thermoplastic floor tiles			
Asbestos Content:		Result Based on:		
No Asbestos Detected		Analysis of sample using PLM		
Sample Analysed By:	Refer to original report	Extent:	4 sq m	
Comments: Previously item 093 in J016666. Present beneath carpet.

Material Assessment Total Score: 0		Likelihood of Disturbance Assessment Total Score: 0		Management Assessment Licensable: Not applicable Recommendations: Not Applicable Reinspection Interval: Not Applicable Overall Risk Category: E0
Product Type:	0 Not Applicable	Location:	0 Not Applicable	
Condition:	0 Not Applicable	Accessibility:	0 Not Applicable	
Surface Treatment:	0 Not Applicable			
Asbestos Type:	0 Not Applicable	Extent Score:	0 Not Applicable

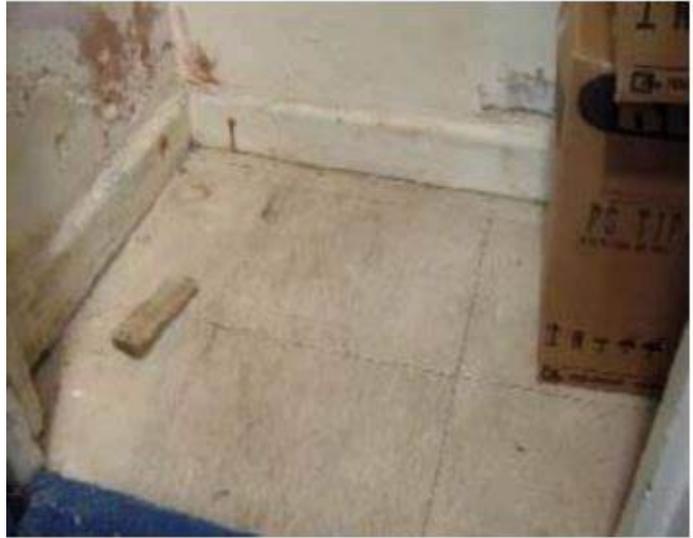
Location:	SP016 Foyer	Block:	Sports Centre	Floor Level: Ground Floor
Item No.:	90	Sample No.:	178/982 {AT004225}

Item:	Thermoplastic floor tiles			
Asbestos Content:		Result Based on:		
No Asbestos Detected		Analysis of sample using PLM		
Sample Analysed By:	Refer to original report	Extent:	<1 sq m	
Comments: Previously item 094 in J016666. Item may be present throughout ground floor beneath fitted carpet or flooring.

Removed

Material Assessment Total Score: 0		Likelihood of Disturbance Assessment Total Score: 0		Management Assessment Licensable: Not applicable Recommendations: Not Applicable Reinspection Interval: Not Applicable Overall Risk Category: E0
Product Type:	0 Not Applicable	Location:	0 Not Applicable	
Condition:	0 Not Applicable	Accessibility:	0 Not Applicable	
Surface Treatment:	0 Not Applicable			
Asbestos Type:	0 Not Applicable	Extent Score:	0 Not Applicable

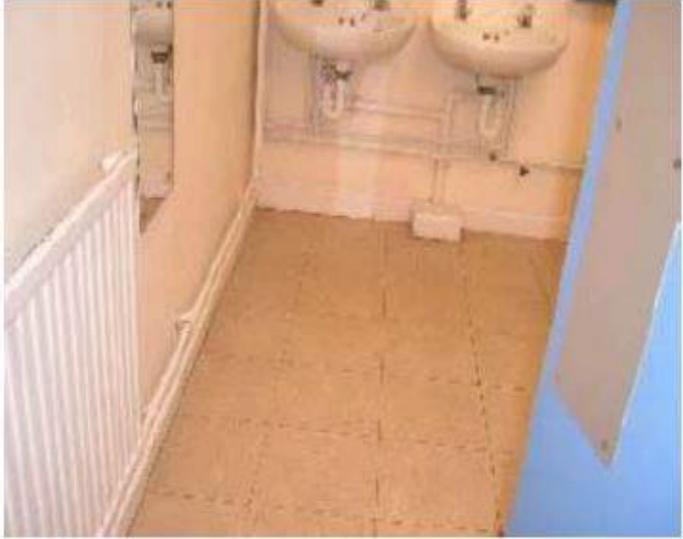
Location:	SP017 Male W.C.	Block:	Sports Centre	Floor Level: Ground Floor
Item No.:	91	Sample No.:	As 178/982 {AT004225}

Item:	Thermoplastic floor tiles			
Asbestos Content:		Result Based on:		
No Asbestos Detected		Strongly presumed		
Sample Analysed By:	Not applicable	Extent:	8 sq m	
Comments: Previously item 095 in J016666.

Removed

Material Assessment Total Score: 0		Likelihood of Disturbance Assessment Total Score: 0		Management Assessment Licensable: Not applicable Recommendations: Not Applicable Reinspection Interval: Not Applicable Overall Risk Category: E0
Product Type:	0 Not Applicable	Location:	0 Not Applicable	
Condition:	0 Not Applicable	Accessibility:	0 Not Applicable	
Surface Treatment:	0 Not Applicable			
Asbestos Type:	0 Not Applicable	Extent Score:	0 Not Applicable

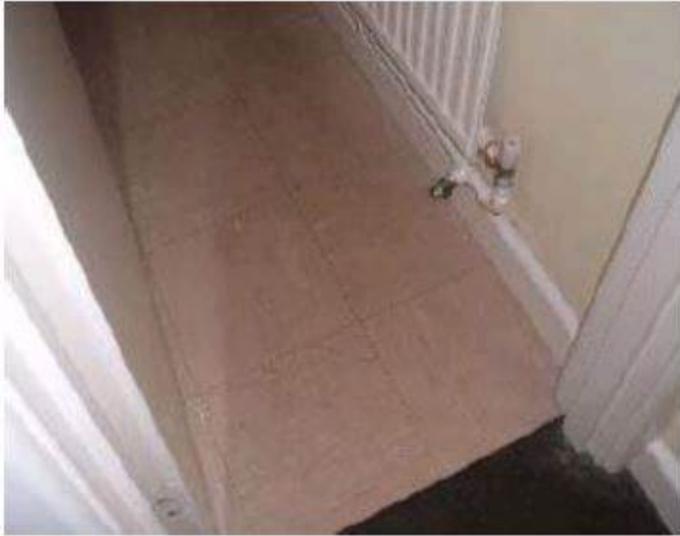
Location:	SP018 Staff Changing Room	Block:	Sports Centre	Floor Level: Ground Floor
Item No.:	92	Sample No.:	As 178/982 {AT004225}

Item:	Thermoplastic floor tiles			
Asbestos Content:		Result Based on:		
No Asbestos Detected		Strongly presumed		
Sample Analysed By:	Not applicable	Extent:	2 sq m	
Comments: Previously item 096 in J016666.

Removed

Material Assessment Total Score: 0		Likelihood of Disturbance Assessment Total Score: 0		Management Assessment Licensable: Not applicable Recommendations: Not Applicable Reinspection Interval: Not Applicable Overall Risk Category: E0
Product Type:	0 Not Applicable	Location:	0 Not Applicable	
Condition:	0 Not Applicable	Accessibility:	0 Not Applicable	
Surface Treatment:	0 Not Applicable			
Asbestos Type:	0 Not Applicable	Extent Score:	0 Not Applicable

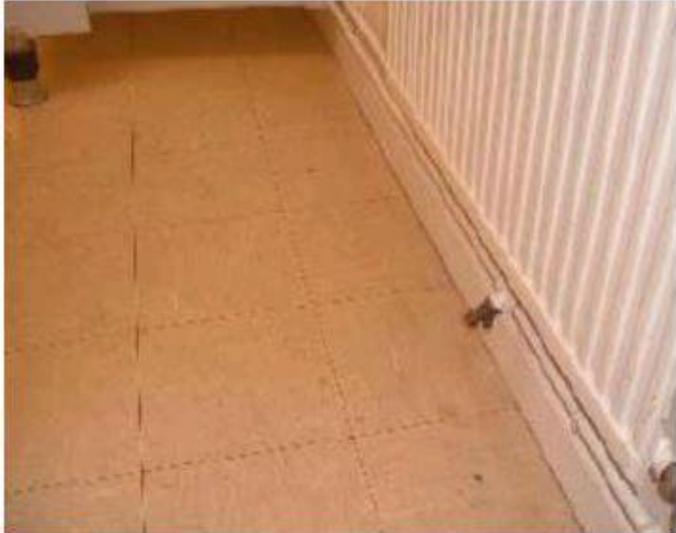
Location:	SP019 Female W.C.	Block:	Sports Centre	Floor Level: Ground Floor
Item No.:	93	Sample No.:	178/983 {AT004228}

Item:	Thermoplastic floor tiles			
Asbestos Content:		Result Based on:		
No Asbestos Detected		Analysis of sample using PLM		
Sample Analysed By:	Refer to original report	Extent:	9 sq m	
Comments: Previously item 097 in J016666.

Removed

Material Assessment Total Score: 0		Likelihood of Disturbance Assessment Total Score: 0		Management Assessment Licensable: Not applicable Recommendations: Not Applicable Reinspection Interval: Not Applicable Overall Risk Category: E0
Product Type:	0 Not Applicable	Location:	0 Not Applicable	
Condition:	0 Not Applicable	Accessibility:	0 Not Applicable	
Surface Treatment:	0 Not Applicable			
Asbestos Type:	0 Not Applicable	Extent Score:	0 Not Applicable

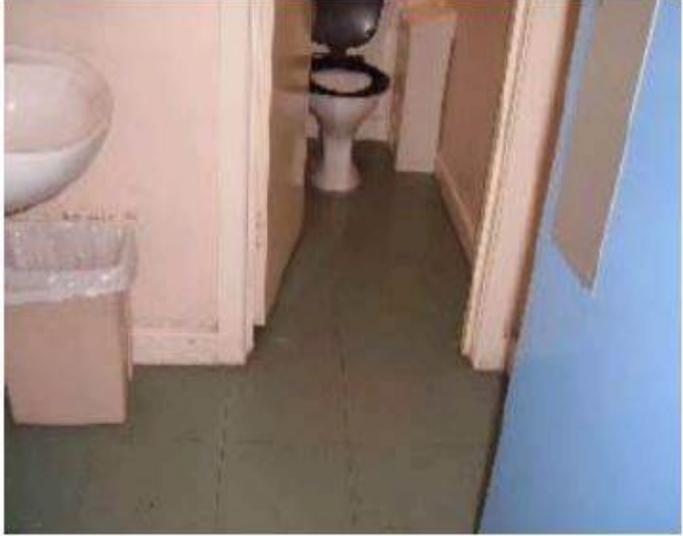
Location:	SP022 Female W.C.	Block:	Sports Centre	Floor Level: Ground Floor
Item No.:	95	Sample No.:	178/984 {AT004230}

Item:	Thermoplastic floor tiles			
Asbestos Content:		Result Based on:		
No Asbestos Detected		Analysis of sample using PLM		
Sample Analysed By:	Refer to original report	Extent:	5 sq m	
Comments: Previously item 099 in J016666.

Material Assessment Total Score: 0		Likelihood of Disturbance Assessment Total Score: 0		Management Assessment Licensable: Not applicable Recommendations: Not Applicable Reinspection Interval: Not Applicable Overall Risk Category: E0
Product Type:	0 Not Applicable	Location:	0 Not Applicable	
Condition:	0 Not Applicable	Accessibility:	0 Not Applicable	
Surface Treatment:	0 Not Applicable			
Asbestos Type:	0 Not Applicable	Extent Score:	0 Not Applicable

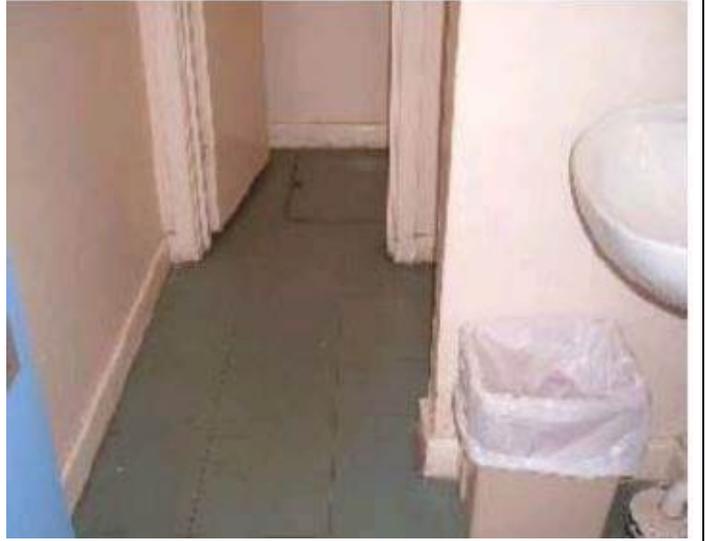
Location:	SP023 Male W.C.	Block:	Sports Centre	Floor Level: Ground Floor
Item No.:	96	Sample No.:	As 178/984 {AT004230}

Item:	Thermoplastic floor tiles			
Asbestos Content:		Result Based on:		
No Asbestos Detected		Strongly presumed		
Sample Analysed By:	Not applicable	Extent:	6 sq m	
Comments: Previously item 100 in J016666.

Removed

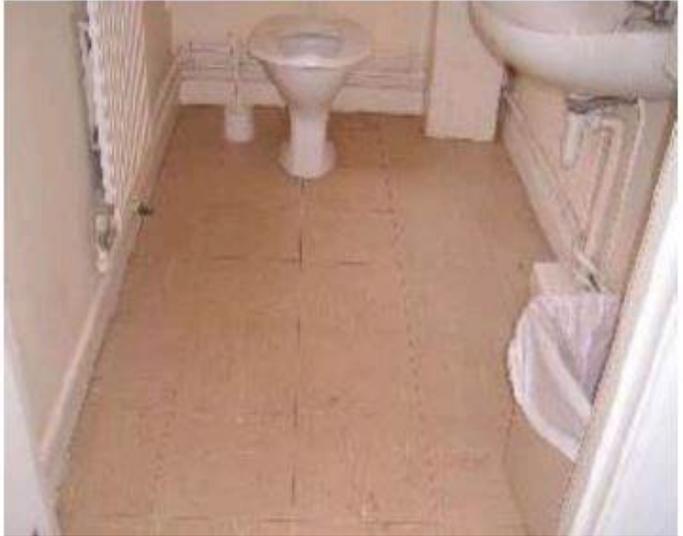
Location:	X016 Disabled W.C.	Block:	Sports Centre	Floor Level: Ground Floor
Item No.:	97	Sample No.:	178/985 {AT004232}

Item:	Thermoplastic floor tiles			
Asbestos Content:		Result Based on:		
No Asbestos Detected		Analysis of sample using PLM		
Sample Analysed By:	Refer to original report	Extent:	3 sq m	
Comments: Previously item 101 in J016666.

Removed

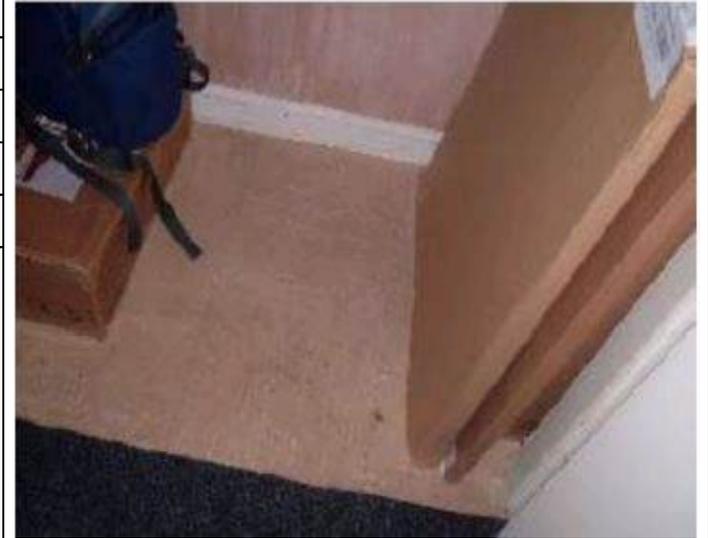
Location:	X021 Office	Block:	Sports Centre	Floor Level: Ground Floor
Item No.:	98	Sample No.:	As 178/985 {AT004232}	
Item:	Thermoplastic floor tiles			
Asbestos Content:		Result Based on:		
No Asbestos Detected		Strongly presumed		
Sample Analysed By:	Not applicable	Extent:	2 sq m	
Comments: Previously item 102 in J016666.				
Removed

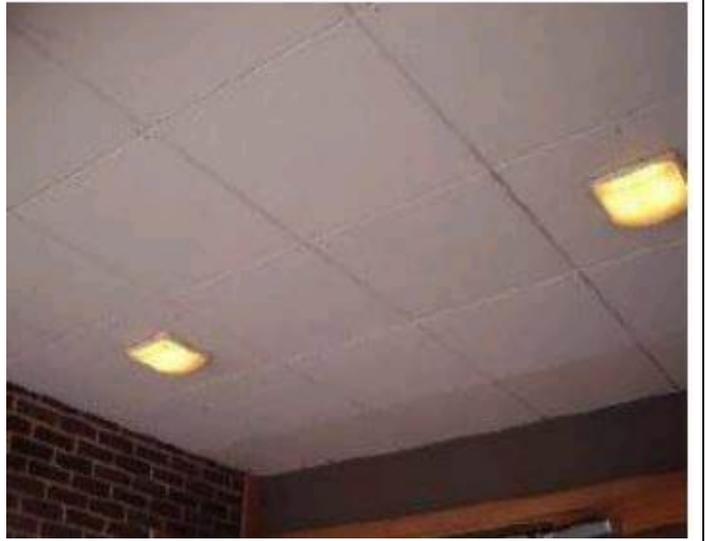
Location:	X018 Foyer	Block:	Sports Centre	Floor Level: Ground Floor
Item No.:	99	Sample No.:	178/986 {AT004234}	
Item:	Insulating board ceiling tiles			
Asbestos Content:		Result Based on:		
No Asbestos Detected		Analysis of sample using PLM		
Sample Analysed By:	Refer to original report	Extent:	10 sq m	
Comments: Previously item 103 in J016666.

Removed

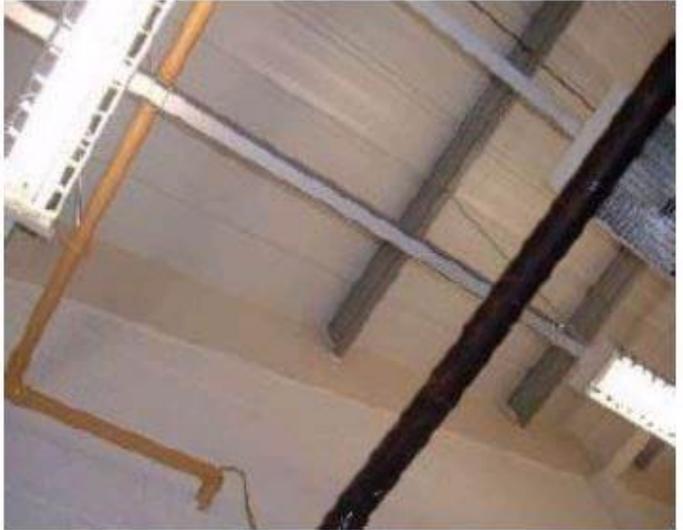
Location:	SP009 Fitness Suite Warm Up	Block:	Sports Centre	Floor Level: 1st Floor
Item No.:	100	Sample No.:	178/987 {AT004235}	
Item:	Insulating board upstands			
Asbestos Content:		Result Based on:		
No Asbestos Detected		Analysis of sample using PLM		
Sample Analysed By:	Refer to original report	Extent:	2 linear metres	
<p>Comments: Previously item 104 in J016666. Present at high level.</p> <p style="text-align: center; color: red; font-size: 2em; font-weight: bold;">Removed</p>

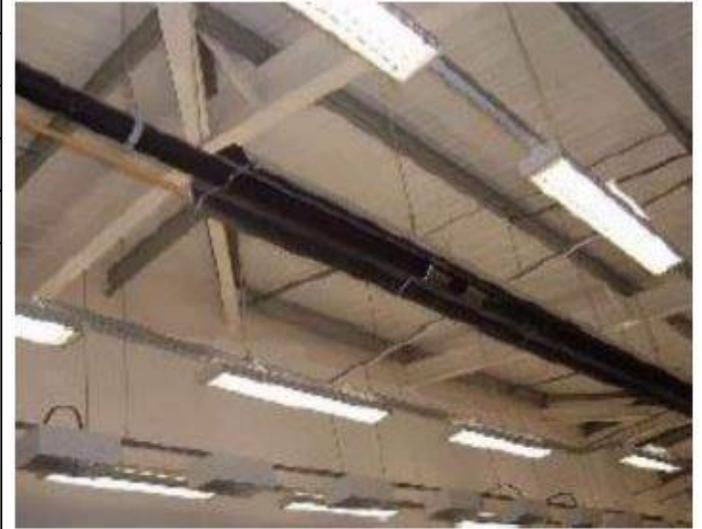
Location:	SP006 Fitness Suite	Block:	Sports Centre	Floor Level: Ground Floor
Item No.:	101	Sample No.:	As 178/987 {AT004239}	
Item:	Insulating board upstands			
Asbestos Content:		Result Based on:		
N/A		Strongly presumed		
Sample Analysed By:	Not applicable	Extent:	20 linear metres	
<p>Comments: Previously item 105 in J016666. Present at high level.</p> <p style="text-align: center; color: red; font-size: 2em; font-weight: bold;">Removed</p>

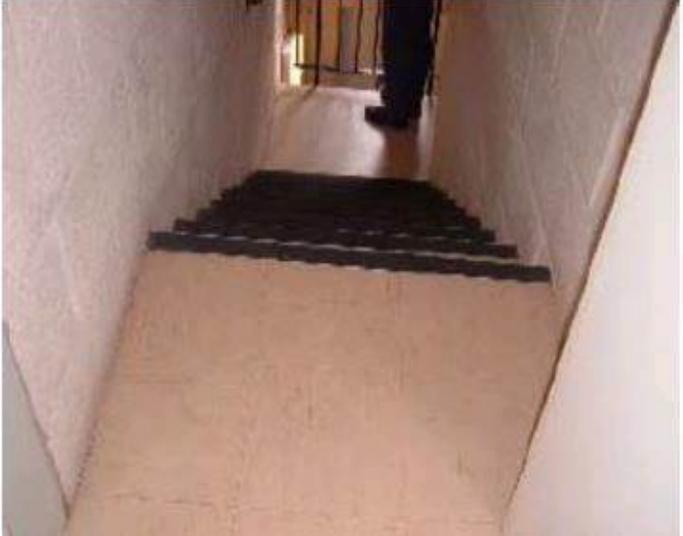
Location:	SP104 Stairwell	Block:	Sports Centre	Floor Level: 1st Floor
Item No.:	102	Sample No.:	178/988 {AT004237}

Item:	Thermoplastic floor tiles			
Asbestos Content:		Result Based on:		
No Asbestos Detected		Analysis of sample using PLM		
Sample Analysed By:	Refer to original report	Extent:	20 sq m	
Comments: Previously item 106 in J016666

Removed

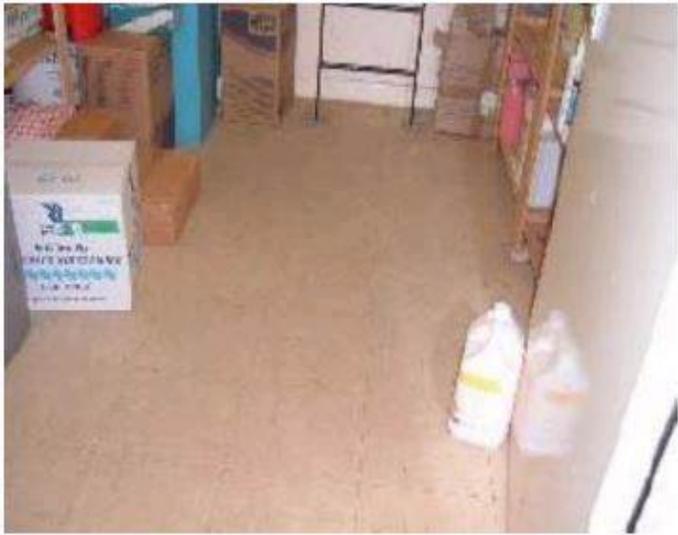
Location:	SP013 Chemical Store	Block:	Sports Centre	Floor Level: 1st Floor
Item No.:	103	Sample No.:	As 178/988 {AT004237}

Item:	Thermoplastic floor tiles			
Asbestos Content:		Result Based on:		
No Asbestos Detected		Strongly presumed		
Sample Analysed By:	Not applicable	Extent:	10 sq m	
Comments: Previously item 107 in J016666

Removed

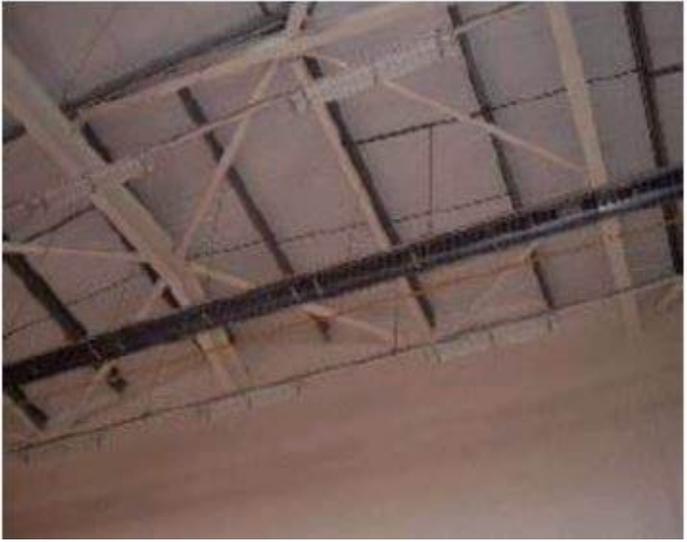
Location:	SP010 Gym	Block:	Sports Centre	Floor Level: Ground Floor
Item No.:	104	Sample No.:	As 178/987 {AT004235}

Item:	Insulating board upstands			
Asbestos Content:		Result Based on:		
No Asbestos Detected		Strongly presumed		
Sample Analysed By:	Not applicable	Extent:	25 linear metres	
Comments: Previously item 108 in J016666. Present at high level.				
Removed

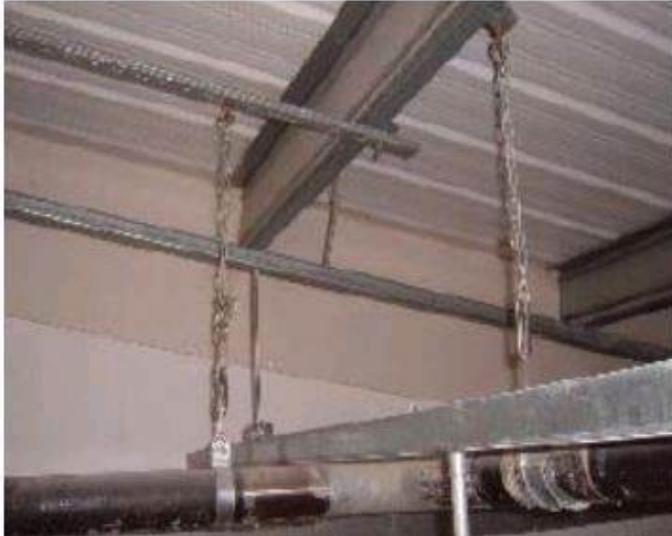
Location:	SP012 Sun Showers	Block:	Sports Centre	Floor Level: Ground Floor
Item No.:	105	Sample No.:	178/989 {AT004240}	
Item:	Insulating board upstands			
Asbestos Content:		Result Based on:		
No Asbestos Detected		Analysis of sample using PLM		
Sample Analysed By:	Refer to original report	Extent:	4 linear metres	
<p>Comments: Previously item 109 in J016666. Accessible from roof of Staff Room (SP013).</p> <p style="text-align: center; color: red; font-size: 2em; font-weight: bold;">Removed</p>

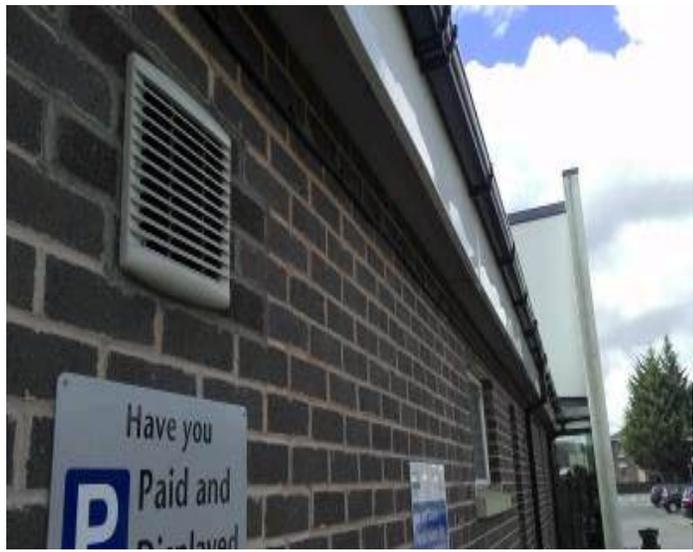
Location:	External	Block:	Sports Centre	Floor Level: E - External
Item No.:	106	Sample No.:	185/003 {AT004241}

Item:	Insulating board soffits			
Asbestos Content:		Result Based on:		
No Asbestos Detected		Analysis of sample using PLM		
Sample Analysed By:	Refer to original report	Extent:	45 linear metres	
Comments: Previously item 126 in J016666.

Material Assessment Total Score: 0		Likelihood of Disturbance Assessment Total Score: 0		Management Assessment Licensable: Not applicable Recommendations: Not Applicable Reinspection Interval: Not Applicable Overall Risk Category: E0
Product Type:	0 Not Applicable	Location:	0 Not Applicable	
Condition:	0 Not Applicable	Accessibility:	0 Not Applicable	
Surface Treatment:	0 Not Applicable			
Asbestos Type:	0 Not Applicable	Extent Score:	0 Not Applicable

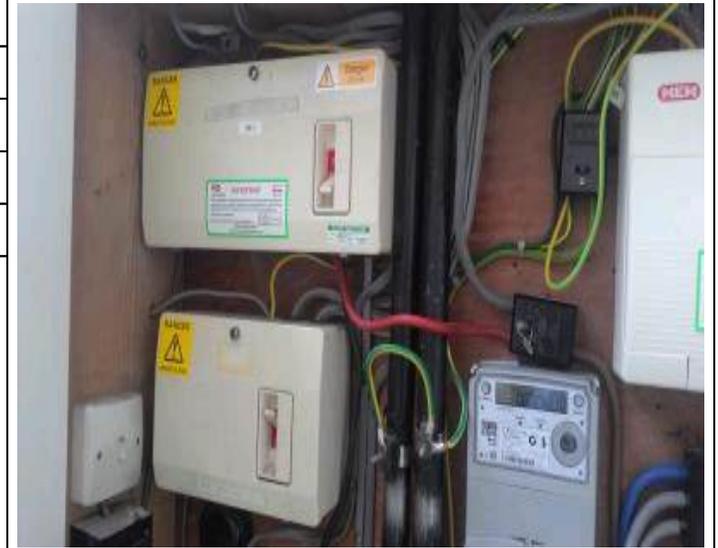
Location:	X001 Lobby	Block:	Maidenhorn Building	Floor Level: Ground Floor
Item No.:	107	Sample No.:	No sample - presumed	
Item:	Asbestos Textile fuse tapes			
Asbestos Content:	Result Based on:			
Chrysotile	Presumed			
Sample Analysed By:	Not applicable	Extent:	2 units	
<p>Comments: Previously item 128 in J016666. The electrical boxes were opened up by the UoG electrician revealing the presence of asbestos textile fuse tapes within. Asbestos content presumed as no safe access was available to sample the material as the electrical boxes remained live and connected and the fuse tapes are to remain in situ.</p>

Material Assessment Total Score: 5		Likelihood of Disturbance Assessment Total Score: 2		<p>Management Assessment</p> <p>Licensable: No</p> <p>Recommendations: Monitor condition</p> <p>Reinspection Interval: 12 Months</p> <p>Overall Risk Category: C7</p>
Product Type:	2 (Asbestos Textiles/Paper)	Location:	2 (Rooms up to 100 sq m)	
Condition:	0 (Perfect)	Accessibility:	0 (Usually inaccessible or unlikely to be disturbed)	
Surface Treatment:	2 (Unencapsulated textile/paper)			
Asbestos Type:	1 (Chrysotile)	Extent Score:	0 (Small amounts or items)

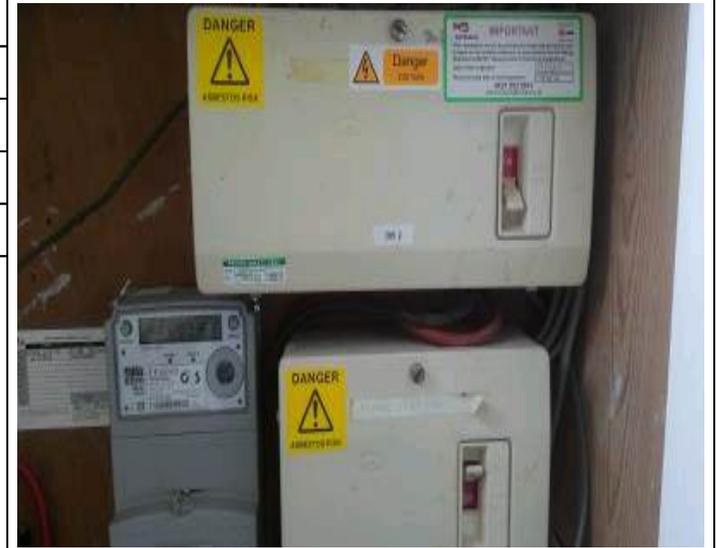
Location:	X015 Stairwell	Block:	Maidenhorn Building	Floor Level: 1st Floor
Item No.:	108	Sample No.:	No sample - presumed	
Item:	Asbestos Textile fuse tapes			
Asbestos Content:	Result Based on:			
Chrysotile	Presumed			
Sample Analysed By:	Not applicable	Extent:	2 units	
<p>Comments: Previously item 129 in J016666. The electrical boxes were opened up by the UoG electrician revealing the presence of asbestos textile fuse tapes within. Asbestos content presumed as no safe access was available to sample the material as the electrical boxes remained live and connected and the fuse tapes are to remain in situ.</p>

Material Assessment Total Score: 5		Likelihood of Disturbance Assessment Total Score: 2		<p>Management Assessment</p> <p>Licensable: No</p> <p>Recommendations: Monitor condition</p> <p>Reinspection Interval: 12 Months</p> <p>Overall Risk Category: C7</p>
Product Type:	2 (Asbestos Textiles/Paper)	Location:	2 (Rooms up to 100 sq m)	
Condition:	0 (Perfect)	Accessibility:	0 (Usually inaccessible or unlikely to be disturbed)	
Surface Treatment:	2 (Unencapsulated textile/paper)			
Asbestos Type:	1 (Chrysotile)	Extent Score:	0 (Small amounts or items)

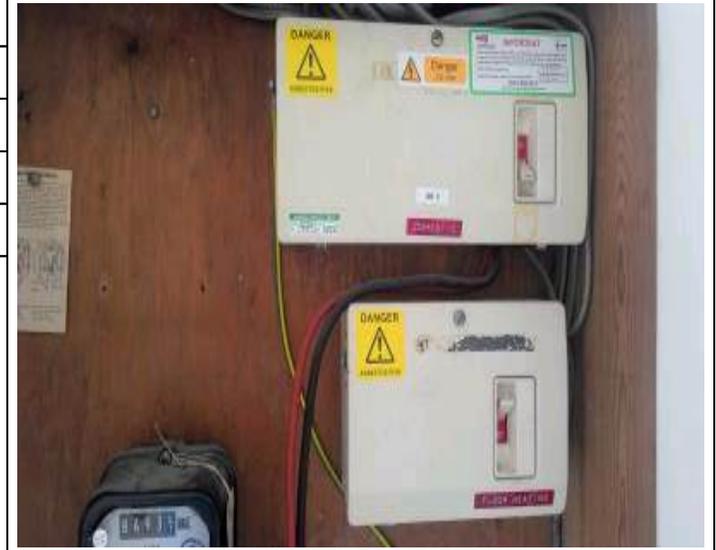
Location:	X027 Stairwell	Block:	Maidenhorn Building	Floor Level: 2nd Floor
Item No.:	109	Sample No.:	No sample - presumed	
Item:	Asbestos Textile fuse tapes			
Asbestos Content:	Result Based on:			
Chrysotile	Presumed			
Sample Analysed By:	Not applicable	Extent:	2 units	
<p>Comments: Previously item 130 in J016666. The electrical boxes were opened up by the UoG electrician revealing the presence of asbestos textile fuse tapes within. Asbestos content presumed as no safe access was available to sample the material as the electrical boxes remained live and connected and the fuse tapes are to remain in situ.</p>

Material Assessment Total Score: 5		Likelihood of Disturbance Assessment Total Score: 2		<p>Management Assessment</p> <p>Licensable: No</p> <p>Recommendations: Monitor condition</p> <p>Reinspection Interval: 12 Months</p> <p>Overall Risk Category: C7</p>
Product Type:	2 (Asbestos Textiles/Paper)	Location:	2 (Rooms up to 100 sq m)	
Condition:	0 (Perfect)	Accessibility:	0 (Usually inaccessible or unlikely to be disturbed)	
Surface Treatment:	2 (Unencapsulated textile/paper)			
Asbestos Type:	1 (Chrysotile)	Extent Score:	0 (Small amounts or items)
